Report: TAB REPORT
Function: Test, Adjust, & Balance
Date: 07/12/2024
Completed By: National TAB

PROJECT
09-16-24 FREDDY'S - FENTON, MO

Project: 09-16-24 FREDDY'S - FENTON, MO

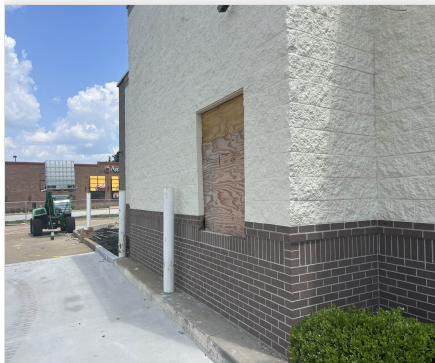
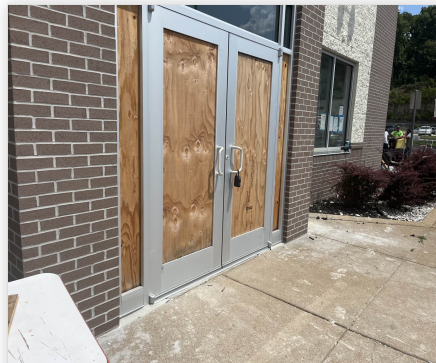
Issue Name : Building isn't sealed
Description : Building is not sealed at drive thru and front doors. Building has plywood up for windows currently. Tech will be unable to get accurate building pressure.
Created By : National TAB **Assigned To :** National TAB - Jacob Davidson
Status : Open
Priority : High **Asset Tag :**
Originated Date : 07/10/2024 - Jacob Davidson - National TAB

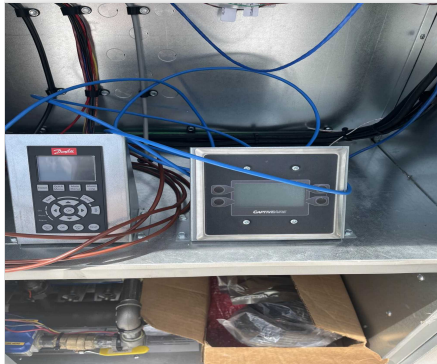
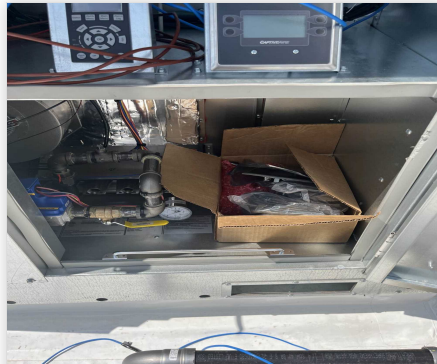
Issue Name : HMI not installed for DOAS
Description : HMIs that are supposed to go to the space are sitting in the unit. They need to be installed for the unit to run properly. Currently there are active faults for the HMIs.
Created By : National TAB **Assigned To :** National TAB - Jacob Davidson
Status : Open
Priority : Urgent **Asset Tag :**
Originated Date : 07/10/2024 - Jacob Davidson - National TAB

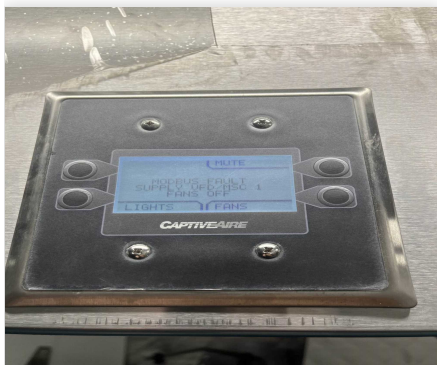
Issue Name : Hood panel alarms
Description : Hood HMI is constantly flashing alarms.
Created By : National TAB **Assigned To :** National TAB - Jacob Davidson
Status : Open
Priority : Medium **Asset Tag :**
Originated Date : 07/10/2024 - Jacob Davidson - National TAB

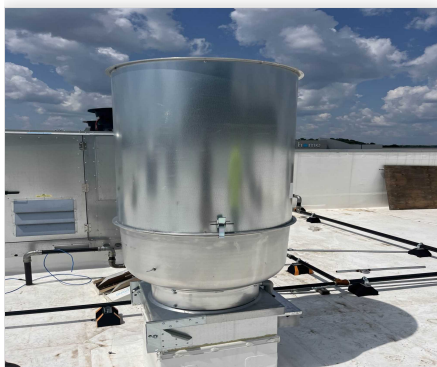
Issue Name : KEF2 not running
Description : KEF2 is not running. Disconnect is turned on and unit is wired but fan is not coming on. Tech cannot complete balance until this is resolved.
Created By : National TAB **Assigned To :** National TAB - Jacob Davidson
Status : Open
Priority : Urgent **Asset Tag :**
Originated Date : 07/10/2024 - Jacob Davidson - National TAB

Notes:
FAN DID NOT HAVE LOW VOLTAGE CONNECTED AT TIME OF TAB AND COULD NOT BE BALANCED.

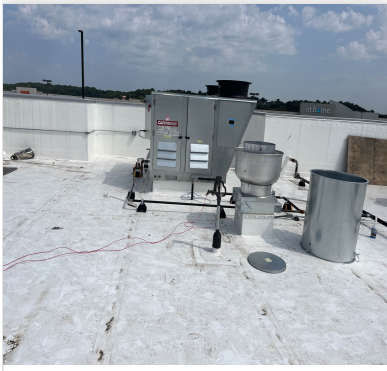
- **07/11/2024 National TAB - Jacob Davidson**
 - Low voltage wiring from the fan never got connected to the hood panel. The wire is still on the roof waiting to be fed to the hood panel.

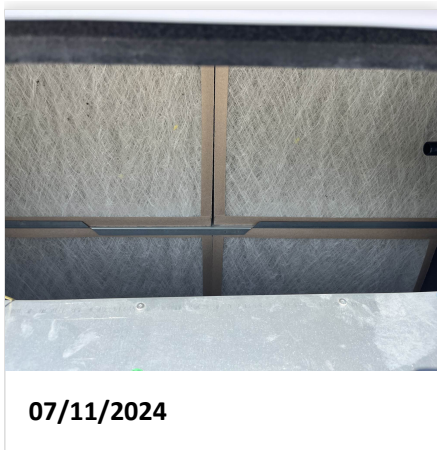
Issue Name : RTU1/RTU2 need final filters
Description : Final filters are needed for each of the RTUs. Currently they have construction filters installed. The units both take 4 16X20X2 filters.
Created By : National TAB **Assigned To :** National TAB - Jacob Davidson
Status : Open
Priority : Urgent **Asset Tag :**
Originated Date : 07/11/2024 - Jacob Davidson - National TAB

General	
	Actual
Fan Rotation Correct	YES
Unit Filters Clean	NEED FINAL FILTERS
Condensate Drain Installed	YES

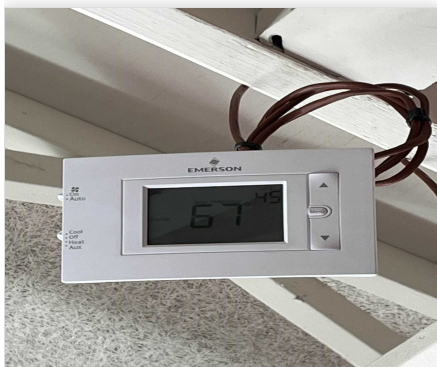
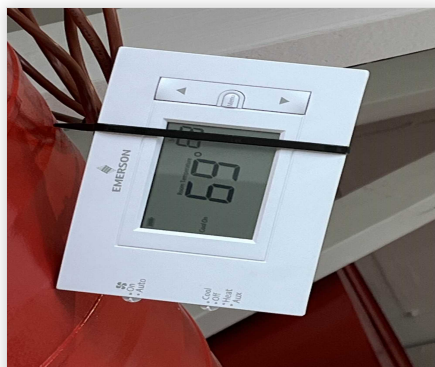
Issue Name : RTU1/RTU2 thermostats are not programmable
Description : Thermostats for the units are still hanging from the ceiling and are not programmable.
Created By : National TAB **Assigned To :** National TAB - Jacob Davidson
Status : Open
Priority : Urgent **Asset Tag :**
Originated Date : 07/11/2024 - Jacob Davidson - National TAB
