**Report: TAB Report**  
**Function: Test, Adjust, & Balance**  
**Date: 03/19/2025**  
**Completed By: National TAB**

**PROJECT**  
**03-17-25 CAVA TEMECULA, CA (REDHAWK)**

31709 TEMECULA PKWY

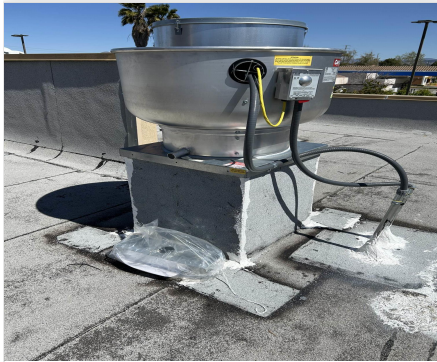
**Issue Name :** KEF GREASE CUP  
**Description :** KEF grease cup is not installed. Recommend installing grease cup to prevent grease from dripping on the roof.  
**Created By :** National TAB      **Assigned To :** National TAB - Dan Hertenstein  
**Status :** Open  
**Priority :** Low      **Asset Tag :**  
**Originated Date :** 03/19/2025 - David Nicolas Sanchez - National TAB
