**Report: TAB Report**  
**Function: Test, Adjust, & Balance**  
**Date: 03/19/2025**  
**Completed By: National TAB**

**PROJECT**  
**03-17-25 CAVA TEMECULA, CA (REDHAWK)**

31709 TEMECULA PKWY

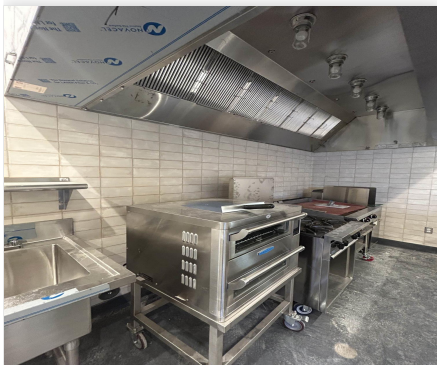
**Issue Name :** HOOD SIDE PANELS NOT INSTALLED  
**Description :** Hood left vertical side panels have not been installed. Recommend installing panels as shown in the MSET.  
**Created By :** National TAB                      **Assigned To :** National TAB - Dan Hertenstein  
**Status :** Open  
**Priority :** Medium                                      **Asset Tag :**  
**Originated Date :** 03/19/2025 - David Nicolas Sanchez - National TAB

End panels are installed Fail

In the process of getting installed.

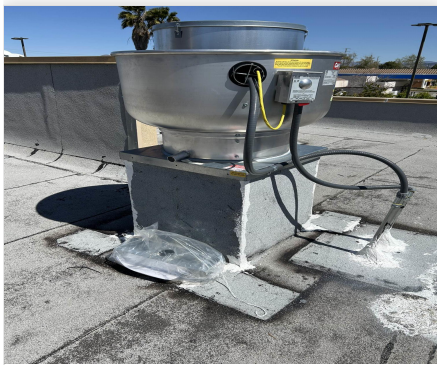
**Issue Name :** KEF GREASE CUP  
**Description :** KEF grease cup is not installed. Recommend installing grease cup to prevent grease from dripping on the roof.  
**Created By :** National TAB                      **Assigned To :** National TAB - Dan Hertenstein  
**Status :** Open  
**Priority :** Low                                      **Asset Tag :**  
**Originated Date :** 03/19/2025 - David Nicolas Sanchez - National TAB

**Grease cups are properly installed and connected to the fan base grease drain to prevent spilling outside of the grease cup**

Fail
