**Report: TAB Report**  
**Function: Test, Adjust, & Balance**  
**Date: 03/19/2025**  
**Completed By: National TAB**

**PROJECT**  
**03-17-25 CAVA TEMECULA, CA (REDHAWK)**

31709 TEMECULA PKWY

TEMECULA, CA 92592

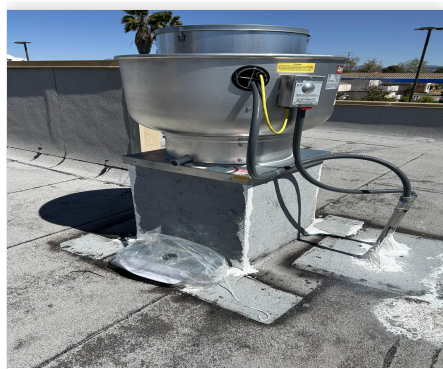
**Issue Name :** KEF GREASE CUP  
**Description :** KEF grease cup is not installed. Recommend installing grease cup to prevent grease from dripping on the roof.  
**Created By :** National TAB      **Assigned To :** National TAB - Dan Hertenstein  
**Status :** Open  
**Priority :** Low      **Asset Tag :**  
**Originated Date :** 03/19/2025 - David Nicolas Sanchez - National TAB

Grease cups are properly installed and connected to the fan base grease drain to prevent spilling outside of the grease cup

Fail
