Report: TAB Report
Function: Test, Adjust, & Balance
Date: 06/22/2025
Completed By: National TAB

PROJECT
06-23-25 CAVA AZUSA, CA

Project: 06-23-25 CAVA AZUSA, CA

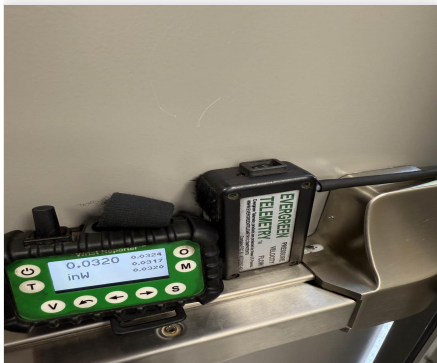
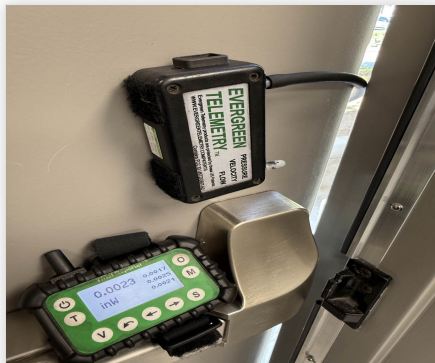
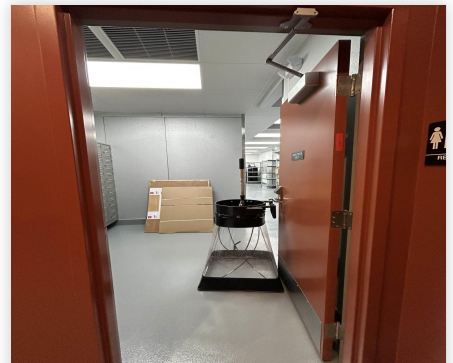
Project Issue File Details

Issue Name : UNEVEN BUIDLIING PRESSURE
Description : Uneven building pressure when all units are turned on and all doors to back of house closed. Front door: 0.0067" Side door: 0.0158" Back door: -0.032". Upon opening doors to the back of house, building pressure evens out. Front door: 0.0015" Side door: 0.0044" Back door: -0.0023".
Created By : National TAB **Assigned To :** National TAB - Brianna Biggs
Status : Open
Priority : Medium **Asset Tag :**
Originated Date : 06/19/2025 - David Nicolas Sanchez - National TAB
