Report: TAB Report
Function: Test, Adjust, & Balance
Date: 06/22/2025
Completed By: National TAB

PROJECT
06-23-25 CAVA AZUSA, CA

Project: 06-23-25 CAVA AZUSA, CA

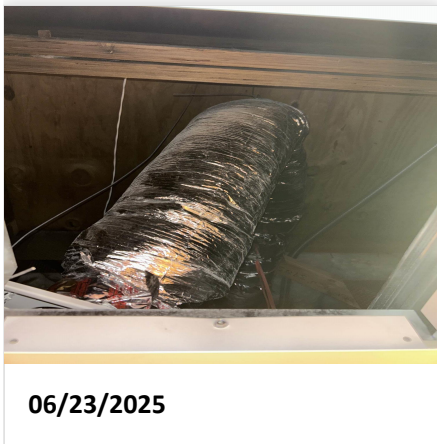
Issue Name : DIFFUSERS 2-3 & 2-14 HIGH ON AIRFLOW
Description : Diffusers 2-3 & 2-14 are high on airflow. Unable to decrease airflow due to stuck damper and inaccessible damper.
Created By : National TAB **Assigned To :** National TAB - Will Turnbough
Status : Open
Priority : Low **Asset Tag :**
Originated Date : 06/19/2025 - David Nicolas Sanchez - National TAB

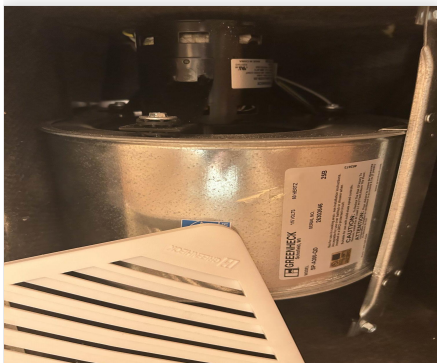
Issue Name : EF-1 & EF-2 HIGH ON AIRFLOW
Description : Bathroom exhaust fans are high on flow. Unable to lower fan speed. Speed controller not installed. Recommend installing speed controller to adjust fan speed.
Created By : National TAB **Assigned To :** National TAB - Will Turnbough
Status : Open
Priority : Low **Asset Tag :**
Originated Date : 06/23/2025 - David Nicolas Sanchez - National TAB

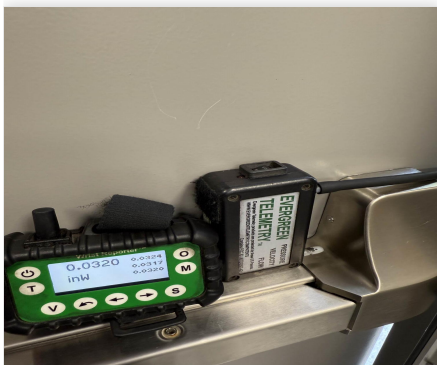
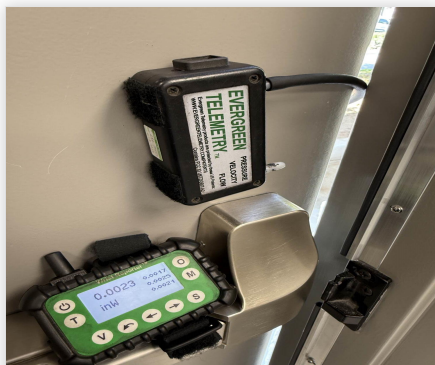
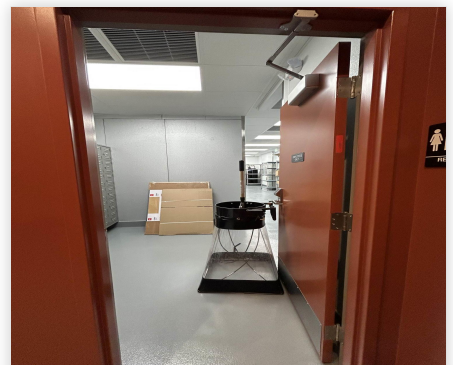
Issue Name : UNEVEN BUIDLIING PRESSURE
Description : Uneven building pressure when all units are turned on and all doors to back of house closed. Front door: 0.0067" Side door: 0.0158" Back door: -0.032". Upon opening doors to the back of house, building pressure evens out. Front door: 0.0015" Side door: 0.0044" Back door: -0.0023".
Created By : National TAB **Assigned To :** National TAB - Brianna Biggs
Status : Open
Priority : Medium **Asset Tag :**
Originated Date : 06/19/2025 - David Nicolas Sanchez - National TAB
