Report: TAB Report
Function: Test, Adjust, & Balance
Date: 01/07/2025
Completed By: National TAB

01-06-25 WAWA #6307 JESUP, GA

356 WEST ORANGE ST

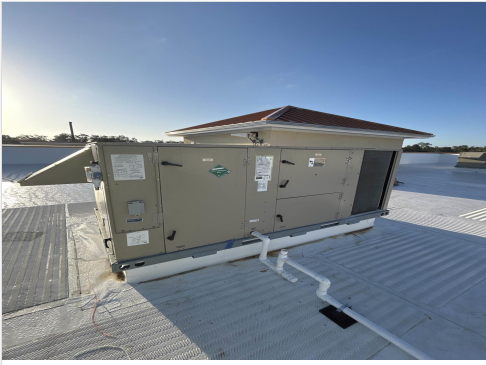
Unit Data - PHOTO LOG

Asset: RTU1

Test Data		
	Design	Actual
SF CFM	3400	3485
SF RPM	-	69%
MOTOR RPM	-	69%
RA CFM	2900	3020
OA CFM	500	465
RL Voltage	-	211
RL Amperage	-	2.09
SF System SetPt	-	69%
RA Damper Position	-	72%
RA Damper Type	-	OBD
OA Damper Position	-	28%
OA Damper Type	-	OBD

Performance Data		
	Design	Actual
MA Plenum SP	-	-0.42"
Fan Suction SP	-	-0.72"
Fan Discharge SP	-	0.17"
Total ESP	0.5"	0.59"
Fan Total SP	-	0.89"

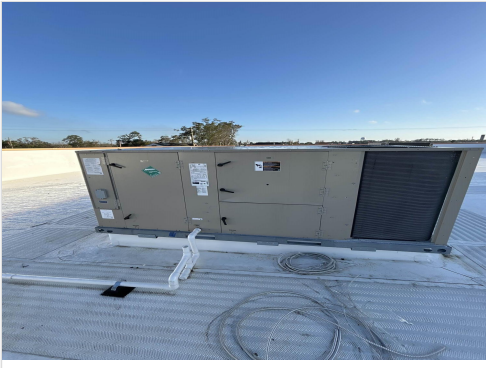
Unit Data - PHOTO LOG

Asset: RTU2

Test Data		
	Design	Actual
SF CFM	5000	5061
SF RPM	-	97%
MOTOR RPM	-	97%
RA CFM	4500	4590
OA CFM	500	471
RL Voltage	-	211
RL Amperage	-	3.0
SF System SetPt	-	97%
RA Damper Position	-	72%
RA Damper Type	-	OBD
OA Damper Position	-	28%
OA Damper Type	-	OBD

Performance Data		
	Design	Actual
MA Plenum SP	-	-0.57"
Fan Suction SP	-	-1.2"
Fan Discharge SP	-	0.92"
Total ESP	0.5"	1.49"
Fan Total SP	-	1.4"

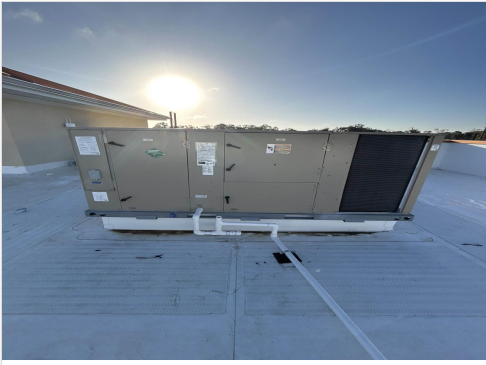
Unit Data - PHOTO LOG

Asset: RTU3

Test Data		
	Design	Actual
SF CFM	3000	3132
SF RPM	-	63%
MOTOR RPM	-	63%
RA CFM	2700	2815
OA CFM	300	317
RL Voltage	-	210
RL Amperage	-	2.45/2.5
SF System SetPt	-	63%
RA Damper Position	-	75%
RA Damper Type	-	OBD
OA Damper Position	-	25%
OA Damper Type	-	OBD

Performance Data		
	Design	Actual
MA Plenum SP	-	-0.35"
Fan Suction SP	-	-0.62"
Fan Discharge SP	-	0.32"
Total ESP	0.5"	0.67"
Fan Total SP	-	0.94"
