**Report: TAB Report
Function: Test, Adjust, & Balance
Date: 02/12/2026
Completed By: National TAB**

**PROJECT
02-09-26 QT #1061 ROCK HILL, SC**

**QUIKTRIP
4705 SOUTH 129TH EAST AVENUE
TULSA, OK 74134**

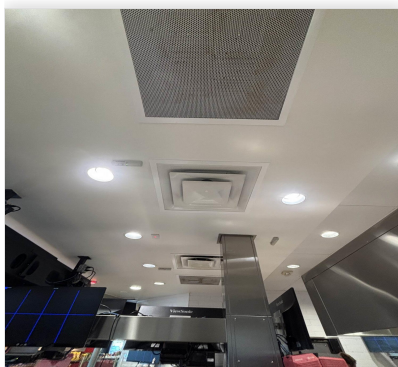
RTU's/AHU's

Evaporator coils are clean?

Pass

Condenser coils are clean?

Gas piping is installed and valves are turned on?

Unit free of noticeable noise and vibration

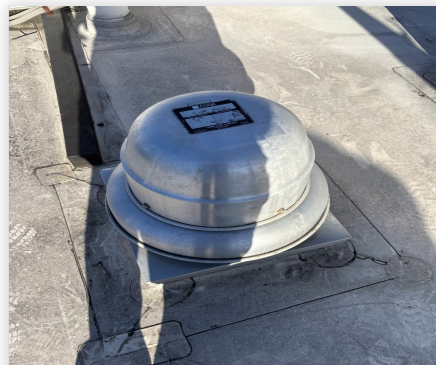
Issue Name : EF-1 not working
Description : EF-1 is not running. Upon arrival the speed controller was in the high setpoint, this may have burnt the motor out causing it to shut off. Needs immediate repair to balance.
Created By : National TAB **Assigned To :** National TAB - Dan Hertenstein
Status : Open
Priority : Urgent **Asset Tag :** EF1
Originated Date : 02/12/2026 - Christian Moller - National TAB
