**Report: TAB Report**  
**Function: Test, Adjust, & Balance**  
**Date: 01/16/2026**  
**Completed By: National TAB**

**PROJECT**  
**01-26-26 QT #1065 CHARLOTTE, NC**

QUIKTRIP  
4705 SOUTH 129TH EAST AVENUE  
TULSA, OK 74134

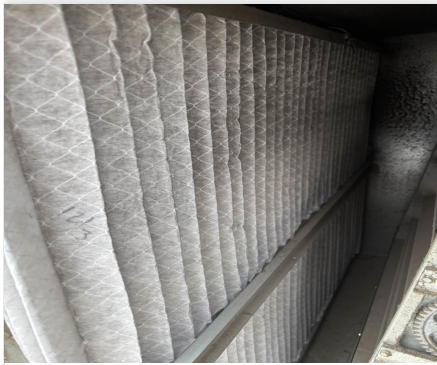
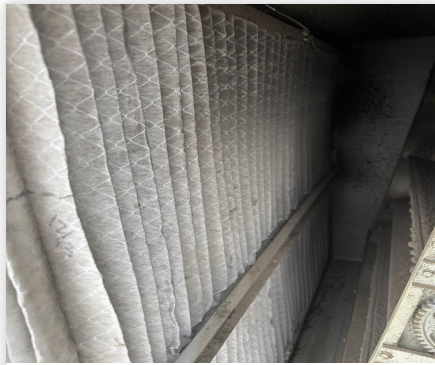
**Issue Name :** Final filters dirty  
**Description :** All of the final filters in each RTU are dirty. They should be replaced soon before dust piles up enough to alter CFM.  
**Created By :** National TAB                      **Assigned To :** National TAB - Dan Hertenstein  
**Status :** Open  
**Priority :** High                                      **Asset Tag :**  
**Originated Date :** 01/23/2026 - Christian Moller - National TAB

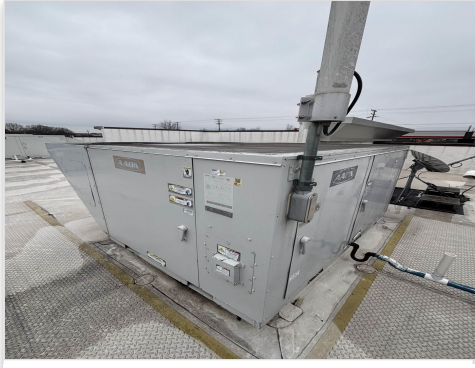
**Unit Data - PHOTO LOG**

Unit Data	
	Actual
MFG	AAON
Serial Num	201212-ANEK07687
Model Num	RN-013-8-0-EA0A-152
Num OA Filters 1	1
OA Filter Size 1	45X24
Num Final Filter 1	2
Final Filter Size 1	56X24

General	
	Actual
Fan Rotation Correct	YES
Unit Filters Clean	NO
Condensate Drain Installed	YES

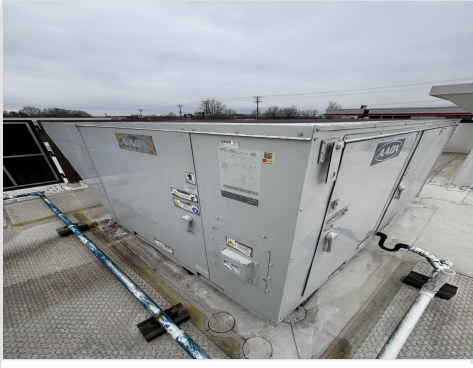
**Unit Data - PHOTO LOG**

Unit Data	
	Actual
MFG	AAON
Serial Num	201212-ANEK07685
Model Num	RN-013-8-0-EA0A-152
Num OA Filters 1	1
OA Filter Size 1	45X24
Num Final Filter 1	2
Final Filter Size 1	56X24

General	
	Actual
Fan Rotation Correct	YES
Unit Filters Clean	NO
Condensate Drain Installed	YES

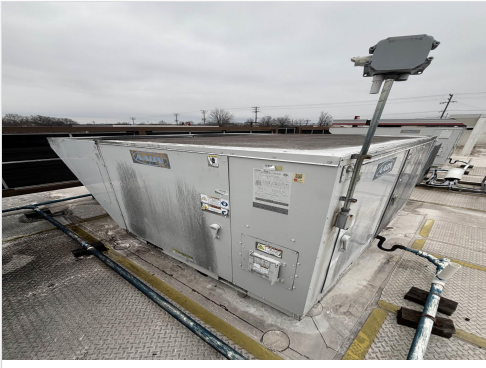
## Unit Data - PHOTO LOG

Unit Data	
	Actual
MFG	AAON
Serial Num	201212-ANEK07686
Model Num	RN-013-8-0-EA0A-152
Num OA Filters 1	1
OA Filter Size 1	45X24
Num Final Filter 1	2
Final Filter Size 1	56X24

General	
	Actual
Fan Rotation Correct	YES
Unit Filters Clean	NO
Condensate Drain Installed	YES

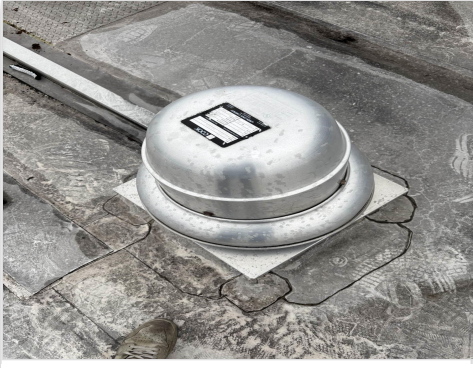
**Unit Data - PHOTO LOG**

Unit Data		
	Design	Actual
MFG	NA	COOK
Model Num	NA	90 ACEH 90C15DH
Serial Num	-	410SE32657- 00/0011412
Type	-	DOWNBLAST
Configuration	-	VERTICAL

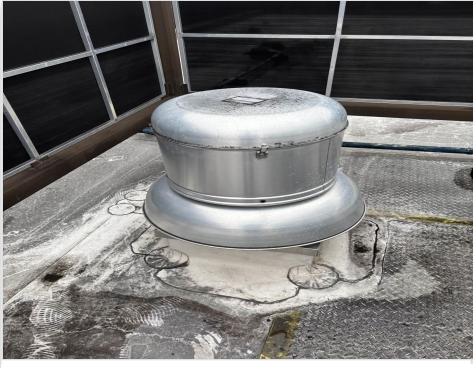
**Unit Data - PHOTO LOG**

Unit Data		
	Design	Actual
MFG	NA	COOK
Model Num	NA	120 ACE 120C15D
Serial Num	-	410SE18515- 00/0001703
Type	-	DOWNBLAST
Configuration	-	VERTICAL

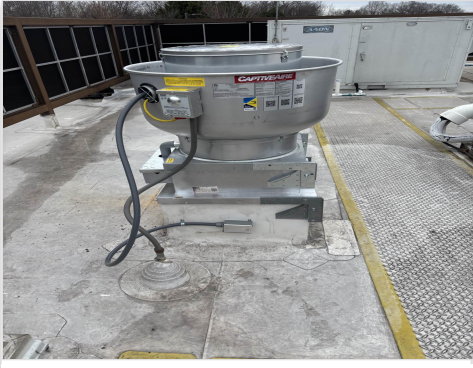
## Unit Data - PHOTO LOG

Design	Actual
MFG	NA	CAPTIVEAIRE
Model Num	NA	DU50HFA
Serial Num	-	8262099
Type	UPBLAST	UPBLAST
Configuration	VERTICAL	VERTICAL

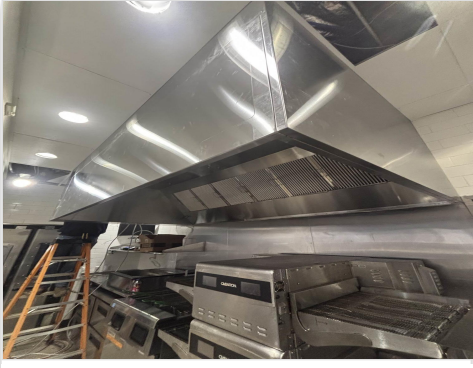
**Unit Data - PHOTO LOG**

Unit Data		
	Design	Actual
MFG	CAPTIVEAIRE	CAPTIVEAIRE
Model Num	6030ND-2-F	6030ND-2
Job / Serial Num	-	8262099
Type	TYPE I CANOPY	TYPE I CANOPY
Hood length	108"	108"
Hood Width	60"	60"

Notes:  
MEASUREMENTS MADE BY CAPTIVEAIRE TECHS W/ 2 INCH STANDOFFS, 2.302 AK FACTOR.
