Report: TAB Report
Function: Test, Adjust, & Balance
Date: 01/16/2026
Completed By: National TAB

PROJECT
01-26-26 QT #1065 CHARLOTTE, NC

Project: 01-26-26 QT #1065 CHARLOTTE, NC

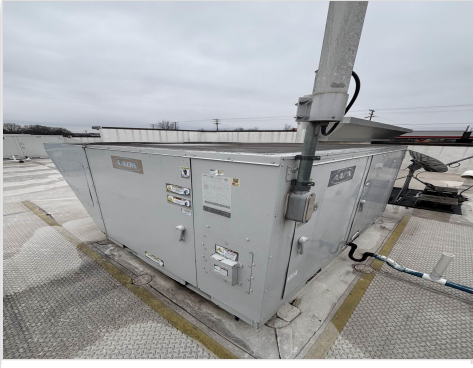
Unit Data - PHOTO LOG

Unit Data	
	Actual
MFG	AAON
Serial Num	201212-ANEK07687
Model Num	RN-013-8-0-EA0A-152
Num OA Filters 1	1
OA Filter Size 1	45X24
Num Final Filter 1	2
Final Filter Size 1	56X24

Test Data		
	Design	Actual
SF CFM	4200	4238
SF RPM	-	DD
OA CFM (Hoods On)	800	803
OA CFM (Hoods Off)	350	361
RL Voltage	-	210/211/210
RL Amperage	-	4.7/2.5/5.2
VFD Max SetPt	-	31.2Hz
VFD Min SetPt	-	24Hz
OA Damper Position (Hoods On)	-	46%
OA Damper Position (Hoods Off)	-	24%

General	
	Actual
Fan Rotation Correct	YES
Unit Filters Clean	NO
Condensate Drain Installed	YES

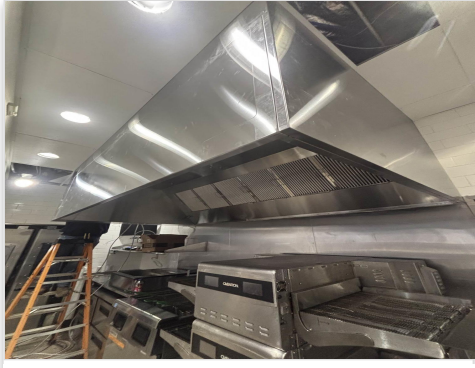
Unit Data - PHOTO LOG

Design	Actual
MFG	CAPTIVEAIRE	CAPTIVEAIRE
Model Num	6030ND-2-F	6030ND-2
Job / Serial Num	-	8262099
Type	TYPE I CANOPY	TYPE I CANOPY
Hood length	108"	108"
Hood Width	60"	60"

Design	Actual
Filter Type	-	BAFFLE FILTERS
Filter Size 1	-	16X20
Filter Qty 1	-	6
Filter AK factor size 1	-	2.302
Filter Total AK Area	-	13.9
Filter1 FPM	-	90
Filter2 FPM	-	89
Filter3 FPM	-	110
Filter4 FPM	-	108
Filter5 FPM	-	98
Filter6 FPM	-	102
Filter Ave FPM(corr)	-	100
CFM	1350	1385

Notes:
MEASUREMENTS MADE BY CAPTIVEAIRE TECHS W/ 2 INCH STANDOFFS, 2.302 AK FACTOR.
