Report: TAB Report
Function: Test, Adjust, & Balance
Date: 01/06/2026
Completed By: National TAB

PROJECT
03-09-26 QT #1004 CHARLOTTE, NC

Project: 03-09-26 QT #1004 CHARLOTTE, NC

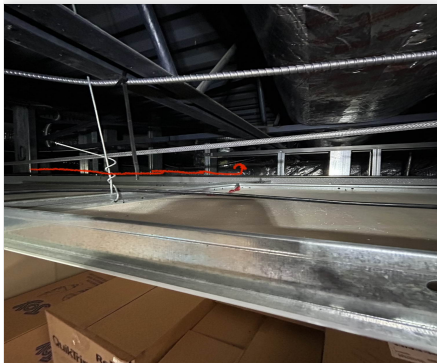
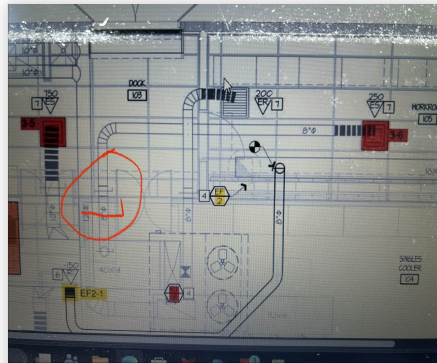
Issue Name : Damper inaccessible RTU 3
Description : Damper inaccessible for SGRD 3-6. Unable to balance diffuser and push the air to the front 4 diffusers.
Created By : National TAB **Assigned To :** National TAB - Dan Hertenstein
Status : Open
Priority : Medium **Asset Tag :** SGRD6
Originated Date : 03/04/2026 - Jearod Ferrette - National TAB

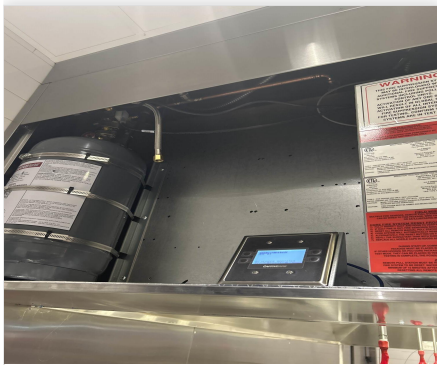
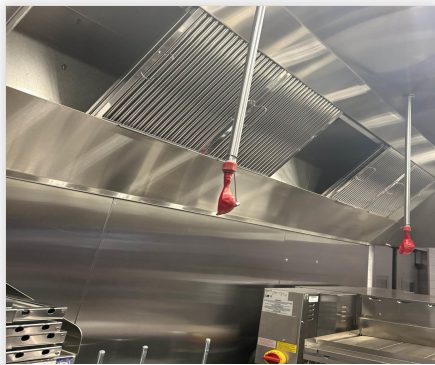
Issue Name : EF 3 exhaust fan not operational
Description : EF-3 not operational. Failed fire inspection. Fire alarm kept tripping. Per mechanical turn off at breaker number (9)
Created By : National TAB **Assigned To :** National TAB - Dan Hertenstein
Status : Open
Priority : Urgent **Asset Tag :** EF3
Originated Date : 03/04/2026 - Jearod Ferrette - National TAB

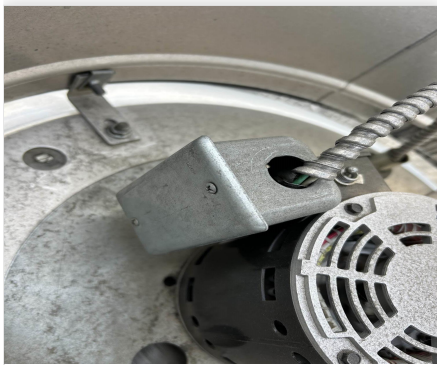
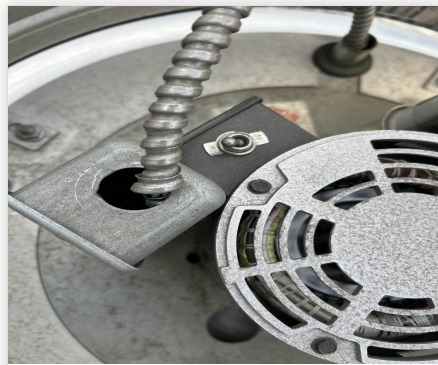
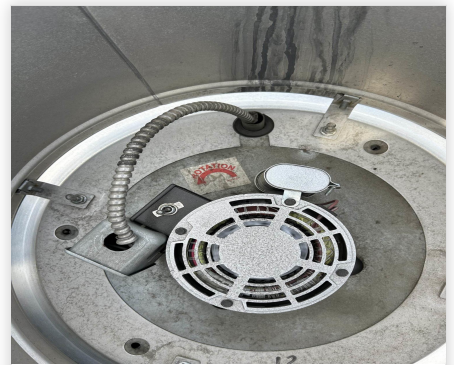
Issue Name : No speed control for EF-2
Description : No speed control for EF-2 restroom/ combo-oven grille. Currently ready at 179% of design.
Created By : National TAB **Assigned To :** National TAB - Dan Hertenstein
Status : Open
Priority : Low **Asset Tag :** EF2
Originated Date : 03/04/2026 - Jearod Ferrette - National TAB

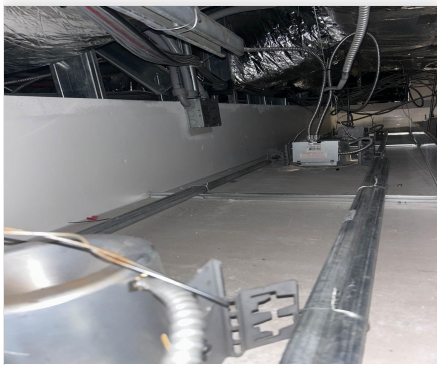
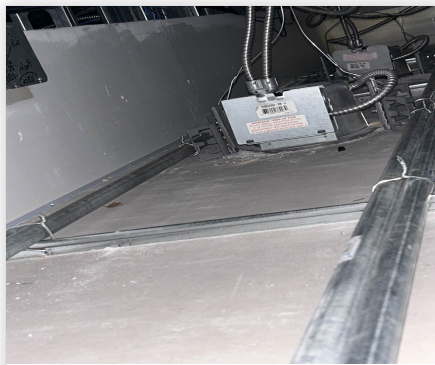
Issue Name : RTU 3 kitchen damper access.
Description : Electrical conduit wired into ceiling pads, restriction access to damper for the kitchen diffusers.
Created By : National TAB **Assigned To :** National TAB - Dan Hertenstein
Status : Open
Priority : Low **Asset Tag :** RT-3
Originated Date : 03/04/2026 - Jearod Ferrette - National TAB

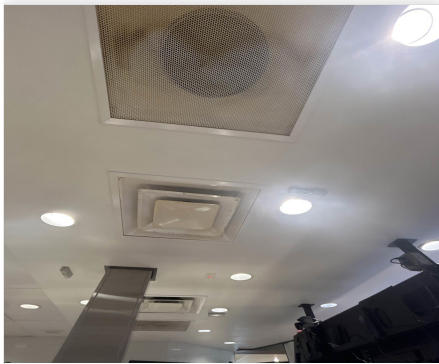
Issue Name : Specified diffusers not installed
Description : SGRD 3-1 to 3-4 diffusers not design per drawing
Created By : National TAB **Assigned To :** National TAB - Dan Hertenstein
Status : Open
Priority : **Medium** **Asset Tag :** RT-3
Originated Date : 03/04/2026 - Jearod Ferrette - National TAB

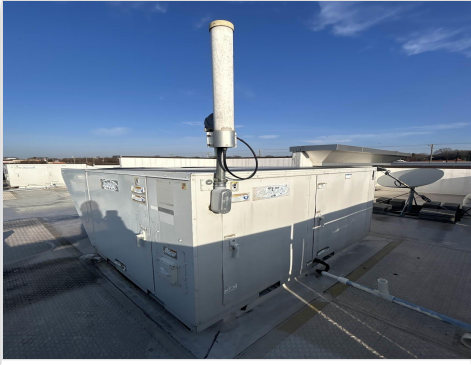
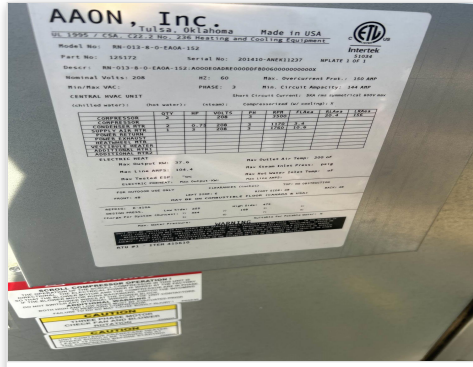
Asset: RT-1

Unit Data	
	Actual
MFG	AAON
Serial Num	201410-ANEK11237
Model Num	RN-013-8-0-EA0A-152
Num OA Filters 1	1
OA Filter Size 1	22.5X44.5
Num Final Filter 1	56X45

Test Data		
	Design	Actual
SF CFM	4200	4251
SF RPM	-	DD/ 43 HZ
OA CFM (Hoods On)	800	827
OA CFM (Hoods Off)	350	375
RL Voltage	-	143.1 VFD
RL Amperage	-	8.5 VFD
VFD Max SetPt	-	43 HZ
OA Damper Position (Hoods On)	-	46%
OA Damper Position (Hoods Off)	-	26%

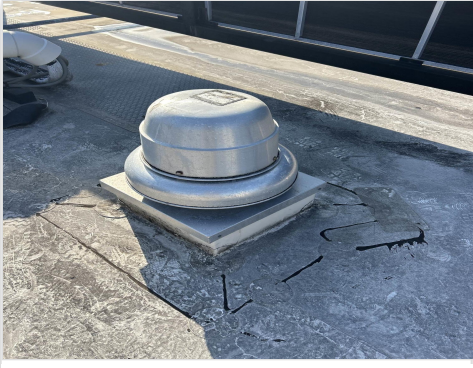
Asset: EF1

Unit Data	
	Actual
MFG	COOK
Model Num	90 ACE
Serial Num	410SF4202
Type	DOWNBLAST
Configuration	VERTICAL

Test Data		
	Design	Actual
CFM	225	226
Fan RPM	-	DD
Fan Rotation	-	CCW
Motor RPM	-	DD
System SetPt	-	50%
Total ESP	-	0.15"
Fan Inlet SP	-	-0.15"
Fan Discharge SP	-	ATMO

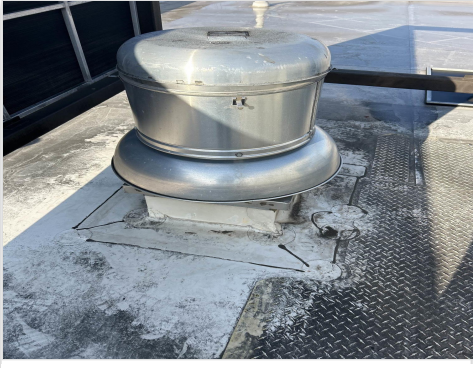
Asset: EF2

Test Data		
	Design	Actual
CFM	525	944
Fan RPM	-	DD
Fan Rotation	-	CCW
Motor RPM	-	DD
System SetPt	-	100%
Total ESP	-	0.19"
Fan Inlet SP	-	0.19"
Fan Discharge SP	-	ATMO

Notes:
NO SPEED CONTROL

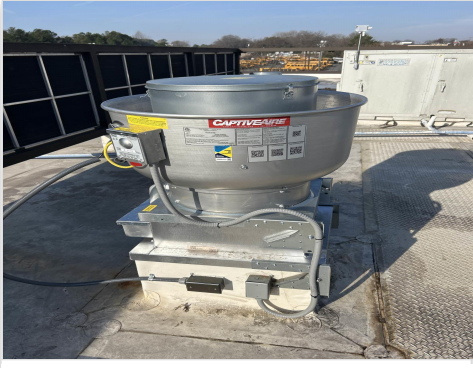
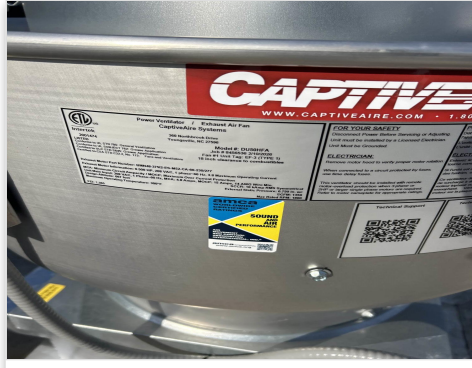
Asset: EF3

Design	Actual
MFG	COOK	CAPTIVEAIRE
Model Num	120 ACEH	DU50HFA
Serial Num	-	8456536
Type	UPBLAST	UPBLAST
Configuration	VERTICAL	VERTICAL

Design	Actual
CFM	1350	0
Fan Rotation	-	CCW
Fan Discharge SP	-	ATMO

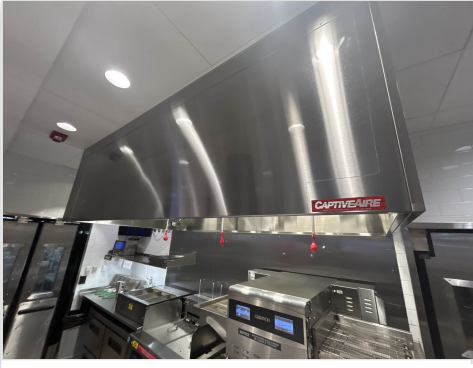
Asset: HD1

Design	Actual
MFG	CAPTIVEAIRE	CAPTIVEAIRE
Model Num	6030ND-2-F	6030ND-2-F
Job / Serial Num	-	8456536
Type	TYPE I CANOPY	TYPE I CANOPY
Hood length	108"	108"
Hood Width	60"	60"

Design	Actual
Filter Type	CAPTRATE SOLO FILTER	CAPTRATE SOLO FILTER
Filter Size 1	20X16	20X16
Filter Qty 1	6	6
Filter AK factor size 1	2.08	2.08
Filter Total AK Area	12.48	12.48
Filter Ave FPM(corr)	-	0
CFM	1350	0
