**Report: TAB REPORT
Function: Test, Adjust, & Balance
Date: 01/05/2023**

01-02-23 APPLEBEES - ALTOONA, PA

Project: 01-02-23 APPLEBEES - ALTOONA, PA

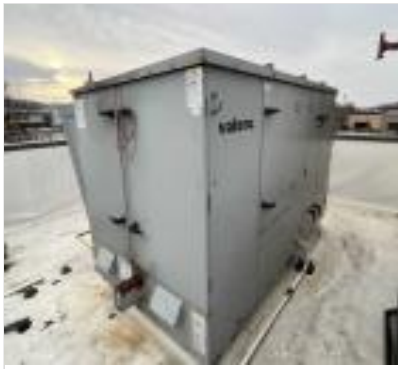
RTU_1
12/29/2022

Unit Data		
	Design	Actual
MFG	GOODMAN	GOODMAN
Serial Num	-	1306125271
Model Num	CPG1502103BXXXAB	CPG1502103BXXXAB
Type	RTU	RTU
Configuration	VERTICAL	VERTICAL
Num OA Filters 1	-	2
OA Filter Size 1	-	20X25
Num Final Filter 1	-	4
Num Final Filter 2	-	20X25X2

Test Data		
	Design	Actual
SF CFM	4200	4316
SF RPM	-	1071
RA CFM	3150	3189
OA CFM	1050	1127
RL Voltage	-	208/207/208
RL Amperage	-	9.8/9.9/10.3
SF Rotation	-	CCW
RA Damper Position	-	5.0V
Min OA Damper Position	-	2"

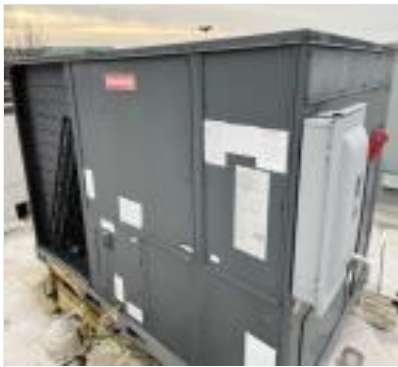
RTU-2

Unit Data		
	Design	Actual
MFG	VALENT	VALENT
Serial Num	-	6781158/20
Model Num	VPR-210-25C-40J-A-1DX	VPR-210-25C-40J-A-1DX
Type	RTU	RTU
Configuration	VERTICAL	VERTICAL
Num OA Filters 1	-	3
OA Filter Size 1	-	20X25
Num Final Filter 1	-	6
Final Filter Size 1	-	16X25X2

Test Data		
	Design	Actual
SF CFM	5250	5315
SF RPM	-	1364
RA CFM	0	0
OA CFM	5250	5315
RL Voltage	-	208/207/207
RL Amperage	-	10.3/10.4/11.0
SF Rotation	-	CCW
RA Damper Position	-	SHUT
Min OA Damper Position	-	FULL OPEN

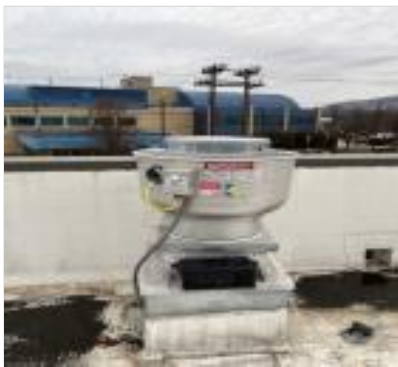
EF-1

Unit Data		
	Design	Actual
MFG	ACCUREX	CAPTIVEAIRE
Model Num	XRUD-101-VG	DU50HFA
Serial Num	-	5408196
Type	UPBLAST	UPBLAST
Configuration	CENTRIFUGAL	VERTICAL

Test Data		
	Design	Actual
CFM	1200	1293
Fan RPM	1255	1468
Fan Rotation	-	CCW
Motor RPM	-	1468
System SetPt	-	76P
RL Voltage	-	115
RL Amperage	-	4.7
Total ESP	0.63"	0.56"
Fan Inlet SP	-	-0.56"
Fan Discharge SP	-	ATM

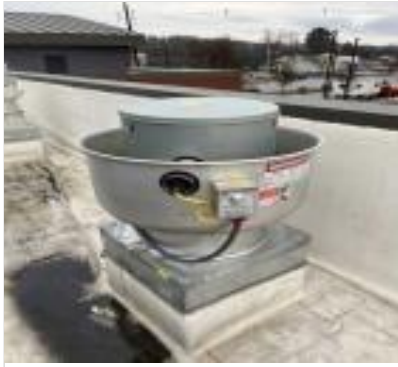
EF-2

Unit Data		
	Design	Actual
MFG	ACCUREX	CAPTIVEAIRE
Model Num	XRUD-131-VG	DU85HFA
Serial Num	-	5408196
Type	UPBLAST	UPBLAST
Configuration	CENTRIFUGAL	VERTICAL

Test Data		
	Design	Actual
CFM	1750	1804
Fan RPM	1597	1211
Fan Rotation	-	CCW
Motor RPM	-	1211
System SetPt	-	64P
RL Voltage	-	115
RL Amperage	-	5.6
Total ESP	0.75"	0.67"
Fan Inlet SP	-	-0.67"
Fan Discharge SP	-	ATM

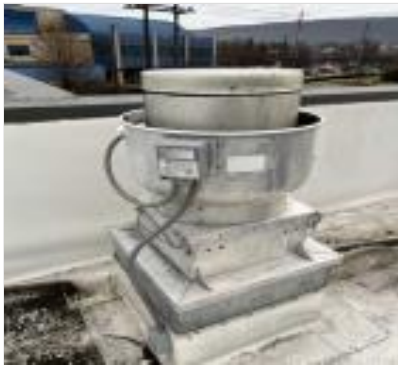
EF-3

Unit Data		
	Design	Actual
MFG	ACCUREX	ACCUREX
Model Num	XRUD-131-VG	XRUD-131-VG-7-G
Serial Num	-	13372476
Type	UPBLAST	UPBLAST
Configuration	CENTRIFUGAL	VERTICAL

Test Data		
	Design	Actual
CFM	1750	1919
Fan RPM	1597	1458
Fan Rotation	-	CCW
Motor RPM	-	1458
RL Voltage	-	115
RL Amperage	-	7.6
Total ESP	0.75	0.65"
Fan Inlet SP	-	-0.65"
Fan Discharge SP	-	ATM

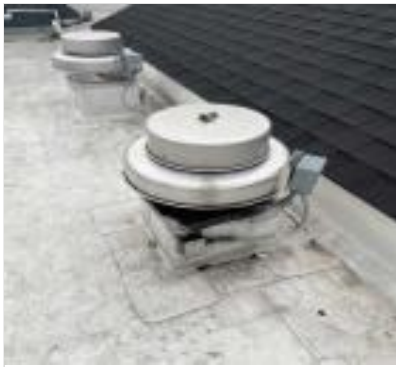
EF-4

Unit Data		
	Design	Actual
MFG	ACCUREX	ACCUREX
Model Num	XRED-095-VG	XRED-095-VG-6-X
Serial Num	-	13372478
Type	DOWNBLAST	DOWNBLAST
Configuration	CENTRIFUGAL	VERTICAL

Test Data		
	Design	Actual
CFM	800	779
Fan RPM	1495	1339
Fan Rotation	-	CCW
Motor RPM	-	1339
RL Voltage	-	115
RL Amperage	-	1.2
Total ESP	0.25"	0.16"
Fan Inlet SP	-	-0.16"
Fan Discharge SP	-	ATM

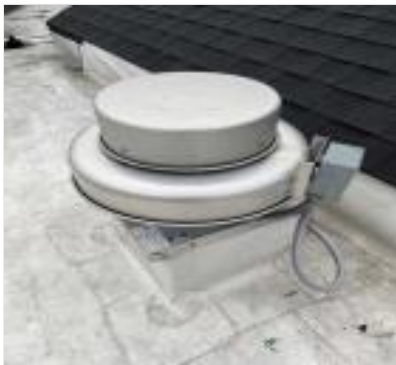
EF-5

Unit Data		
	Design	Actual
MFG	ACCUREX	ACCUREX
Model Num	XRED-080-VG	XRED-080-VG-6-X
Serial Num	-	13372479
Type	DOWNBLAST	DOWNBLAST
Configuration	CENTRIFUGAL	VERTICAL

Test Data		
	Design	Actual
CFM	300	305
Fan RPM	1663	1674
Fan Rotation	-	CCW
Motor RPM	-	1674
RL Voltage	-	115
RL Amperage	-	1.7
Total ESP	0.5"	0.37"
Fan Inlet SP	-	-0.37"
Fan Discharge SP	-	ATM

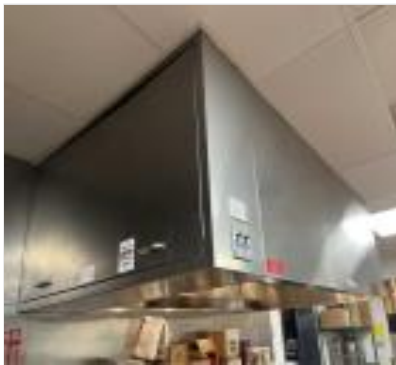
HOOD-1

Unit Data		
	Design	Actual
MFG	ACCUREX	ACCUREX
Model Num	XBEW	XBEW-86.00-S
Job / Serial Num	-	13391092
Type	TYPE I	TYPE I CANOPY
Hood length	96"	86
Hood Width	54"	54"

Test Data Exhaust		
	Design	Actual
Filter Type	-	BAFFLE
Filter Size 1	-	20X20
Filter Size 2	-	20X16
Filter Qty 1	-	1
Filter Qty 2	-	4
Filter AK factor size 1	-	2.10
Filters AK factor size 2	-	1.66
Filter Total AK Area	-	8.74
Filter1 FPM	-	154
Filter2 FPM	-	155
Filter3 FPM	-	164
Filter4 FPM	-	135
Filter5 FPM	-	131
Filter Ave FPM(corr)	-	148
CFM	1200	1293

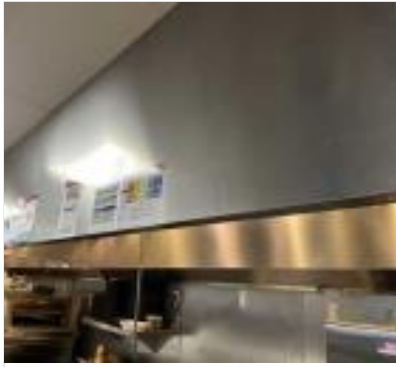
HOOD-2

Unit Data		
	Design	Actual
MFG	ACCUREX	ACCUREX
Model Num	XKEW	XKEW-131.00-S
Job / Serial Num	-	13391091
Type	TYPE I	TYPE I CANOPY
Hood length	131"	131"
Hood Width	54"	54"

Test Data Exhaust		
	Design	Actual
Filter Type	-	EXTRACTOR
Filter Size 1	-	20X20
Filter Size 2	-	20X16
Filter Qty 1	-	1
Filter Qty 2	-	7
Filter AK factor size 1	-	2.00
Filters AK factor size 2	-	1.53
Filter Total AK Area	-	12.71
Filter1 FPM	-	126
Filter2 FPM	-	119
Filter3 FPM	-	136
Filter4 FPM	-	135
Filter5 FPM	-	145
Filter6 FPM	-	168
Filter7 FPM	-	154
Filter8 FPM	-	157
Filter Ave FPM(corr)	-	172
CFM	1750	1804

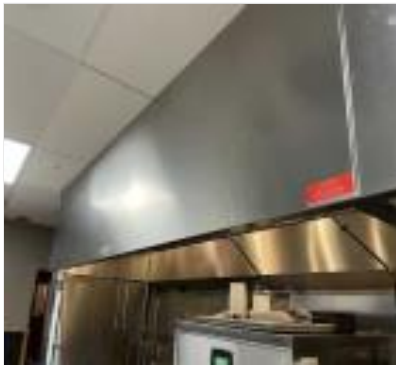
HOOD-3

Unit Data		
	Design	Actual
MFG	ACCUREX	ACCUREX
Model Num	XKEW	XKEW-131.00-S
Job / Serial Num	-	13391090
Type	TYPE I	TYPE I CANOPY
Hood length	131"	131"
Hood Width	54"	54"

Test Data Exhaust		
	Design	Actual
Filter Type	-	EXTRACTOR
Filter Size 1	-	20X20
Filter Size 2	-	20X16
Filter Qty 1	-	1
Filter Qty 2	-	7
Filter AK factor size 1	-	2.00
Filters AK factor size 2	-	1.53
Filter Total AK Area	-	12.71
Filter1 FPM	-	128
Filter2 FPM	-	155
Filter3 FPM	-	147
Filter4 FPM	-	200
Filter5 FPM	-	165
Filter6 FPM	-	159
Filter7 FPM	-	145
Filter8 FPM	-	133
Filter Ave FPM(corr)	-	151
CFM	1750	1919

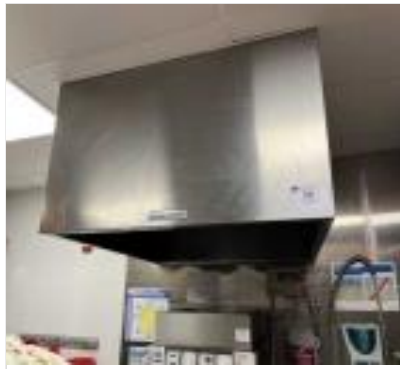
HOOD-4

Unit Data		
	Design	Actual
MFG	ACCUREX	ACCUREX
Model Num	XD1	XD1
Serial Num	-	[1]
Type	TYPE II	TYPE II CANOPY
Hood length	19"	54"
Hood Width	12"	54"

Test Data		
	Design	Actual
Exhaust CFM	800	779
