**Report: TAB REPORT
Function: Test, Adjust, & Balance
Date: 01/05/2023**

**PROJECT
01-02-23 APPLEBEES - ALTOONA, PA**

Project: 01-02-23 APPLEBEES - ALTOONA, PA

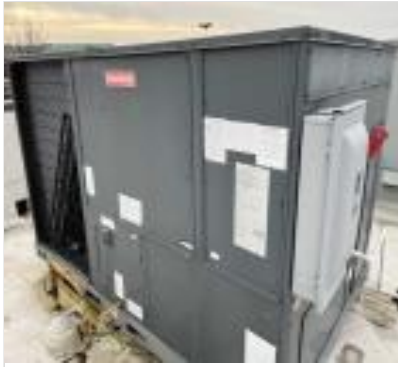
RTU-2

Unit Data		
	Design	Actual
MFG	VALENT	VALENT
Serial Num	-	6781158/20
Model Num	VPR-210-25C-40J-A-1DX	VPR-210-25C-40J-A-1DX
Type	RTU	RTU
Configuration	VERTICAL	VERTICAL
Num OA Filters 1	-	3
OA Filter Size 1	-	20X25
Num Final Filter 1	-	6
Final Filter Size 1	-	16X25X2

Motor Data		
	Design	Actual
Motor MFG	-	BALDOR
Frame	-	184T
Horsepower	5.0	5
Motor Rpm	1800	1750
Phase	3	3
Rated Voltage	208	208
Rated Amperage	-	14

Test Data		
	Design	Actual
SF CFM	5250	5315
SF RPM	-	1364
RA CFM	0	0
OA CFM	5250	5315
RL Voltage	-	208/207/207
RL Amperage	-	10.3/10.4/11.0
SF Rotation	-	CCW
RA Damper Position	-	SHUT
Min OA Damper Position	-	FULL OPEN

Performance Data		
	Design	Actual
MA Plenum SP	-	-0.56"
Fan Suction SP	-	-0.61"
Fan Discharge SP	-	0.54"
Total ESP	1.2"	1.10"
Fan Total SP	-	1.15"

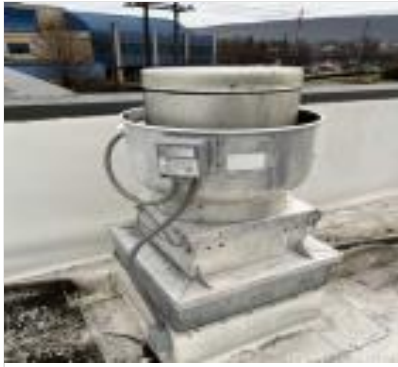
EF-3

Unit Data		
	Design	Actual
MFG	ACCUREX	ACCUREX
Model Num	XRUD-131-VG	XRUD-131-VG-7-G
Serial Num	-	13372476
Type	UPBLAST	UPBLAST
Configuration	CENTRIFUGAL	VERTICAL

Test Data		
	Design	Actual
CFM	1750	1919
Fan RPM	1597	1458
Fan Rotation	-	CCW
Motor RPM	-	1458
RL Voltage	-	115
RL Amperage	-	7.6
Total ESP	0.75	0.65"
Fan Inlet SP	-	-0.65"
Fan Discharge SP	-	ATM

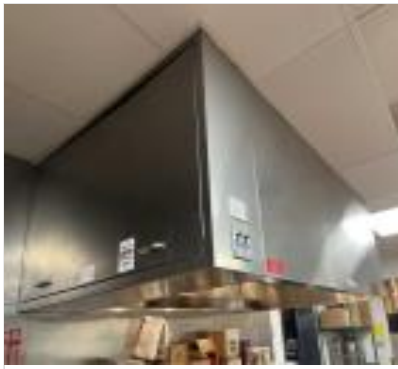
HOOD-1

Unit Data		
	Design	Actual
MFG	ACCUREX	ACCUREX
Model Num	XBEW	XBEW-86.00-S
Job / Serial Num	-	13391092
Type	TYPE I	TYPE I CANOPY
Hood length	96"	86
Hood Width	54"	54"

Test Data Exhaust		
	Design	Actual
Filter Type	-	BAFFLE
Filter Size 1	-	20X20
Filter Size 2	-	20X16
Filter Qty 1	-	1
Filter Qty 2	-	4
Filter AK factor size 1	-	2.10
Filters AK factor size 2	-	1.66
Filter Total AK Area	-	8.74
Filter1 FPM	-	154
Filter2 FPM	-	155
Filter3 FPM	-	164
Filter4 FPM	-	135
Filter5 FPM	-	131
Filter Ave FPM(corr)	-	148
CFM	1200	1293

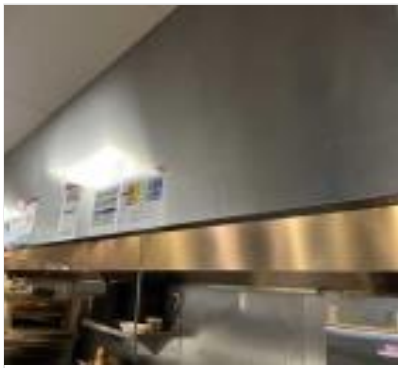
HOOD-2

Unit Data		
	Design	Actual
MFG	ACCUREX	ACCUREX
Model Num	XKEW	XKEW-131.00-S
Job / Serial Num	-	13391091
Type	TYPE I	TYPE I CANOPY
Hood length	131"	131"
Hood Width	54"	54"

Test Data Exhaust		
	Design	Actual
Filter Type	-	EXTRACTOR
Filter Size 1	-	20X20
Filter Size 2	-	20X16
Filter Qty 1	-	1
Filter Qty 2	-	7
Filter AK factor size 1	-	2.00
Filters AK factor size 2	-	1.53
Filter Total AK Area	-	12.71
Filter1 FPM	-	126
Filter2 FPM	-	119
Filter3 FPM	-	136
Filter4 FPM	-	135
Filter5 FPM	-	145
Filter6 FPM	-	168
Filter7 FPM	-	154
Filter8 FPM	-	157
Filter Ave FPM(corr)	-	172
CFM	1750	1804

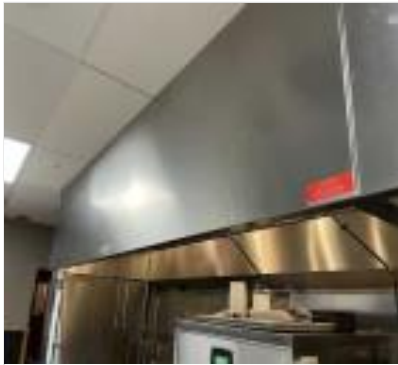
HOOD-3

Unit Data		
	Design	Actual
MFG	ACCUREX	ACCUREX
Model Num	XKEW	XKEW-131.00-S
Job / Serial Num	-	13391090
Type	TYPE I	TYPE I CANOPY
Hood length	131"	131"
Hood Width	54"	54"

Test Data Exhaust		
	Design	Actual
Filter Type	-	EXTRACTOR
Filter Size 1	-	20X20
Filter Size 2	-	20X16
Filter Qty 1	-	1
Filter Qty 2	-	7
Filter AK factor size 1	-	2.00
Filters AK factor size 2	-	1.53
Filter Total AK Area	-	12.71
Filter1 FPM	-	128
Filter2 FPM	-	155
Filter3 FPM	-	147
Filter4 FPM	-	200
Filter5 FPM	-	165
Filter6 FPM	-	159
Filter7 FPM	-	145
Filter8 FPM	-	133
Filter Ave FPM(corr)	-	151
CFM	1750	1919
