CheckList Information

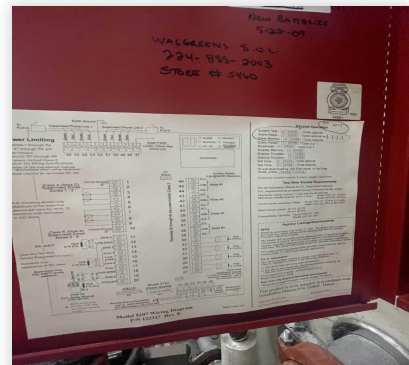
Fire panel (if exists). Take picture of front of panel. If able to open panel door easily, take a picture of inside panel. List manufacturer/model number of panel if available.

Model 5207

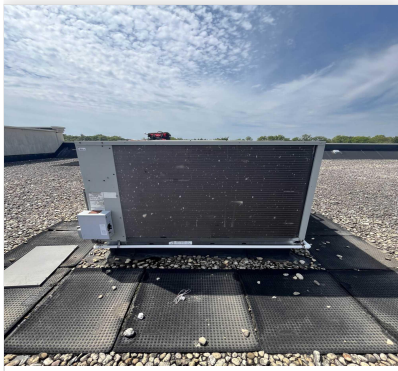
MODEL YCD121C3HAAA SERIAL P391034270 TRANE

Front side of cabinet.

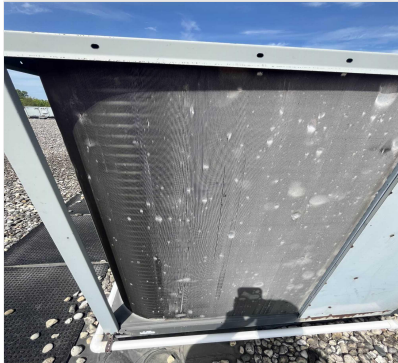
List any visual damage and take additional pictures if needed.

Condenser coil hail damage.

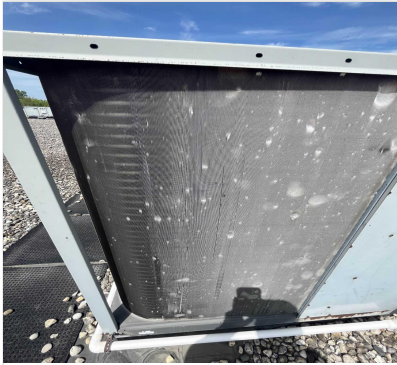
List any visual damage and take additional pictures if needed.

CONDENSOR COIL HAIL DAMAGE

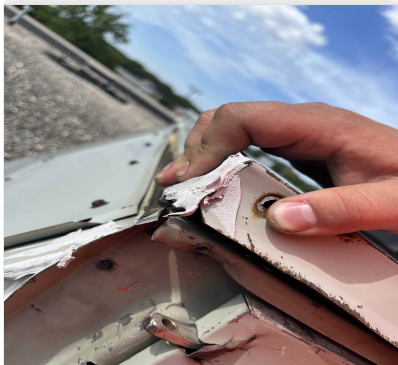
List any visual damage and take additional pictures if needed.

Evaporator coil damage, Condenser coil hail Damage Blower belt in very poor shape needs replacement. Significant Damage to MA and Electrical compartment doors as well as top cover of RTU.

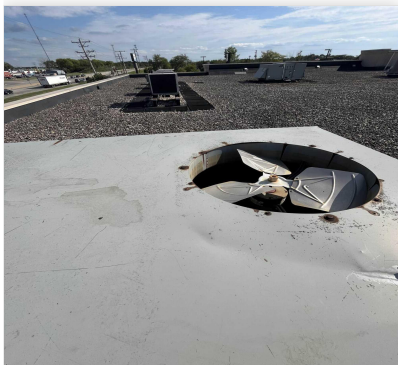
List any visual damage and take additional pictures if needed.

Extensive condenser coil damage Hole in condenser coil Outdoor fan cover missing

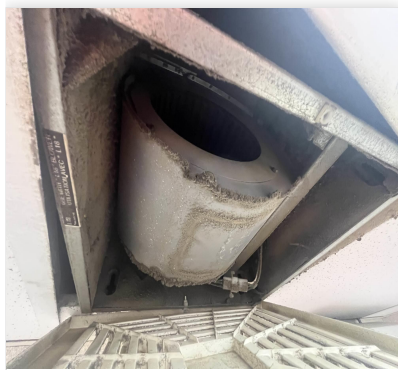
List any visual damage and take additional pictures if needed.

Fan is very dirty. Duct connector is not seated properly on ceiling cutout.
