National TAB
1329 E Kemper Rd, Ste 4210
Cincinnati, OH 45246

Report: Renew
Date: 4/20/2022

FREDDY'S HCI - SUFFOLK, VA (6802) - RENEW 2CB (3)

Project Summary

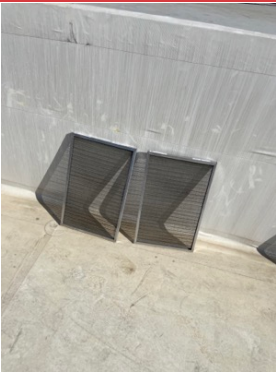
RTU-1 OA FILTER DIRTY

RTUs: There evaporator coil was rinsed off and cleaned. During warmer months a self-cleaning chemical is sprayed on the evaporator. The outside air filters were rinsed off to remove any dirty, so the unit stays at the designated outside air set point. Based on static pressures, amps, and fan rpm it shows that the total supply has not changed since the last test and balance.

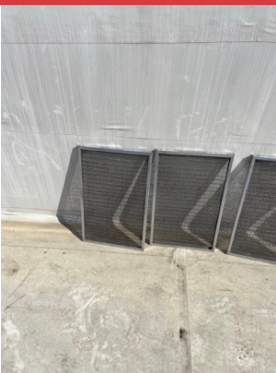
RTU-1 OA FILTER CLEAN

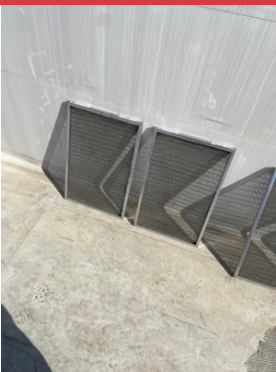
RTU-2 OA FILTER DIRTY

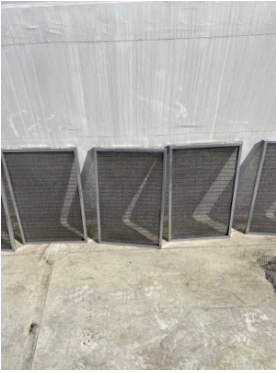
RTU-2 OA FILTER CLEAN

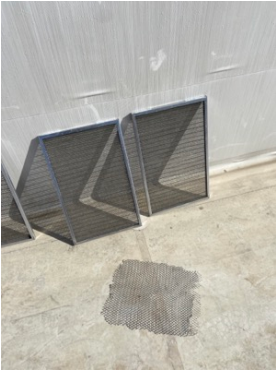
RTU-3/DOAS OA FILTERS DIRTY

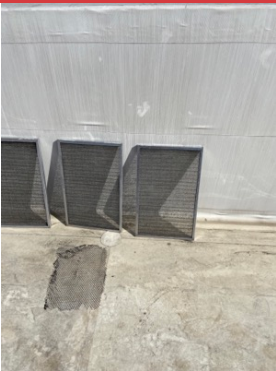
RTU-3/DOAS OA FILTERS CLEAN

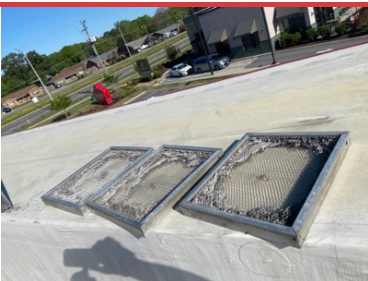
MAU OA FILTERS DIRTY

Heavy damage

MAU: The intake filters had slight dirt accumulation. They were washed.

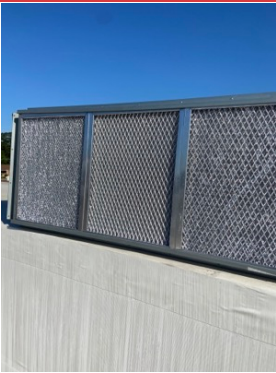
MUA OA FILTER CLEAN

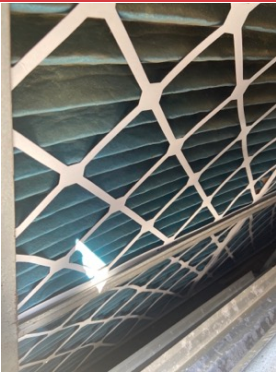
RTU-1 EVAP FILTERS DIRTY

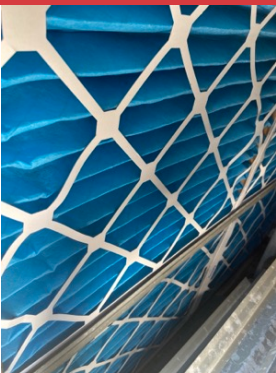
RTU-1 EVAP FILTERS CLEAN

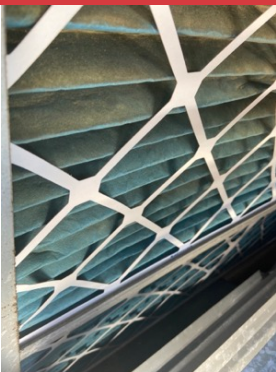
RTU-2 EVAP FILTER DIRTY

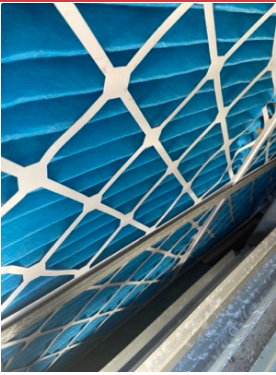
RTU-2 EVAP FILTERS CLEAN

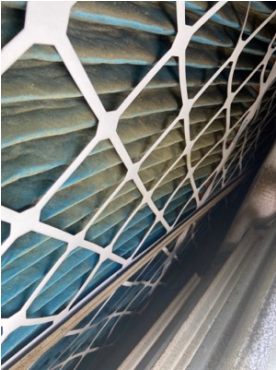
RTU-3/DOAS EVAP FILTERS DIRTY

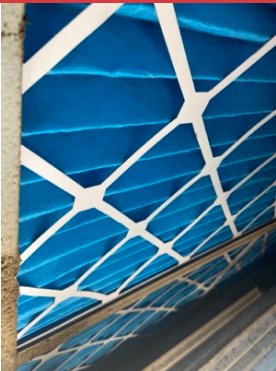
RTU-3/DOAS EVAP FILTERS CLEAN

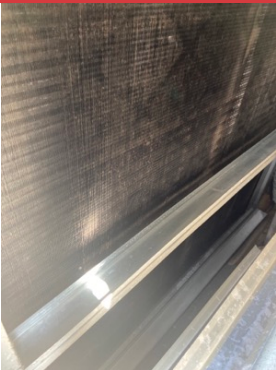
RTU-1 EVAP COIL DIRTY

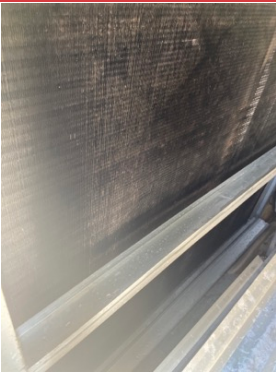
RTU-1 EVAP COIL CLEAN

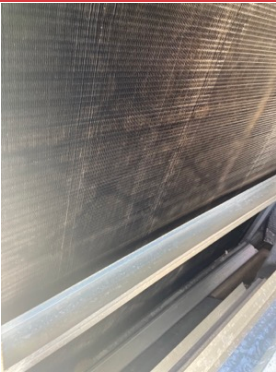
RTU-2 EVAP COIL DIRTY

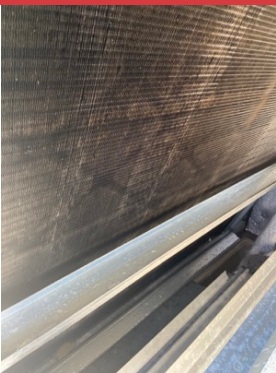
RTU-2 EVAP COIL CLEAN

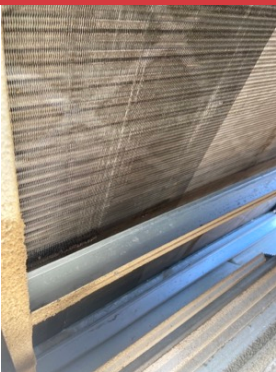
RTU-3/DOAS EVAP COIL DIRTY

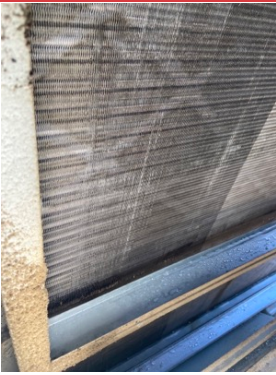
RTU-3 EVAP COIL CLEAN

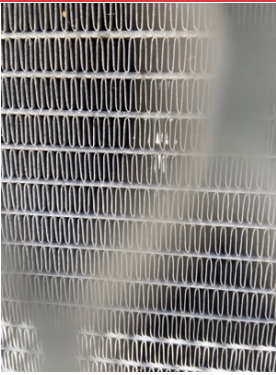
RTU-1 CONDENSER COIL DIRTY

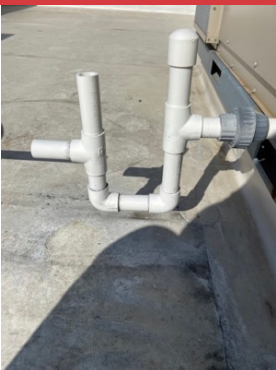
RTU-1 CONDENSATION DRAIN

Unit does not show signs of building up with water. Leave drains as is. NT prefers it slightly oversized to account for issues that can occur.

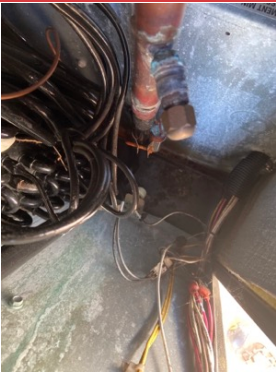
RTU-1 DRAIN PAN CLEAN

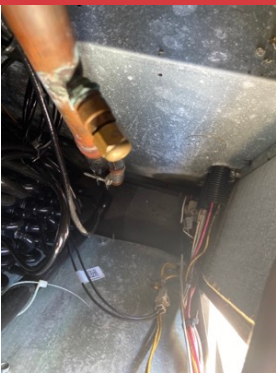
RTU-2 DRAIN PAN CLEAN

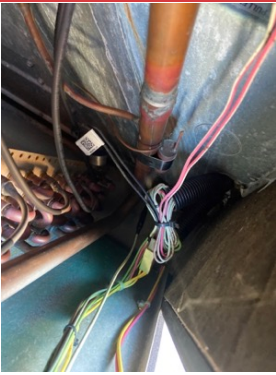
RTU-3/DOAS DRAIN PAN CLEAN
