**Report: PUNCH**

**Function: Test, Adjust, & Balance**

**01-05-26 Whataburger #1598 - Wake Forest,  
NC**

Project: 01-05-26 Whataburger #1598 - Wake Forest, NC

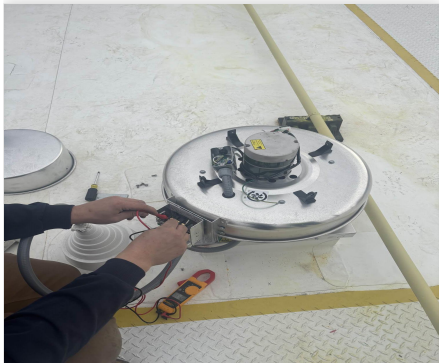
**Issue Name :** EF1: Motor not functioning  
**Description :** Restroom exhaust fan is powered from the roof but the motor is unresponsive.  
**Created By :** National TAB                      **Assigned To :** National TAB - Dan Hertenstein  
**Status :** Open  
**Priority :** Urgent                                      **Asset Tag :**  
**Originated Date :** 01/15/2026 - Cody Mauro - National TAB

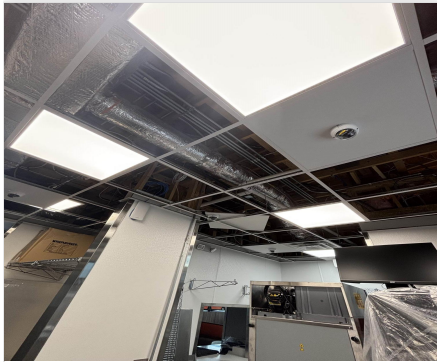
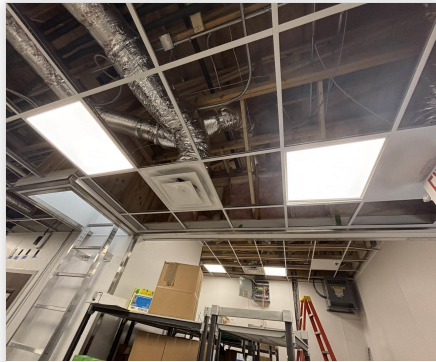
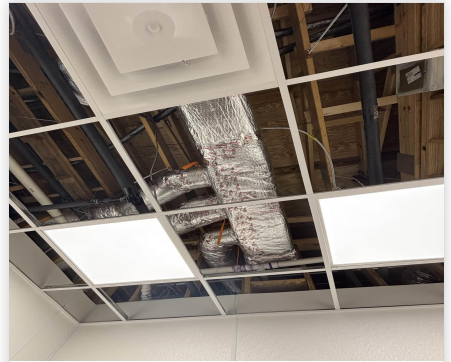
**Issue Name :** RTU1: SGRD 1,10,12  
**Description :** Noticeably low supplying diffusers. Could be due to sharp turns from main branch, length/size of duct, change in height across distance.  
**Created By :** National TAB                      **Assigned To :** National TAB - Dan Hertenstein  
**Status :** Open  
**Priority :** Medium                                      **Asset Tag :**  
**Originated Date :** 01/15/2026 - Cody Mauro - National TAB
