**Report: PRELIM**

**Function: Test, Adjust, & Balance**

## 03-27-23 FOOD LION #2834 - CHESNEE, SC

TRS-SESCO LLC

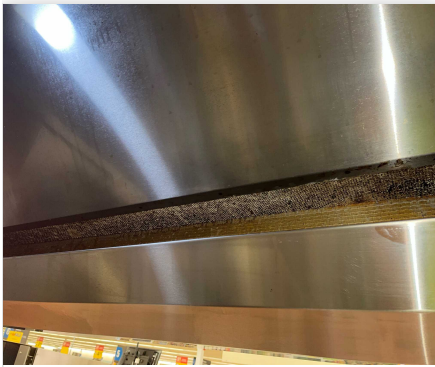
MUA-1.jpeg

**Issue Name :** MUA-1

**Description :** UNIT IS AT FLA AND 0 TURNS OPEN. ACTUAL CFM IS 363 CFM AND DESIGN CFM IS 1050 CFM. SUPPLY PLENUM NEEDS TO BE CLEANED

Notes: CONDUCTED A TRAVERSE AND OBTAINED 318 CFM SUPPLY PLENUM NEEDS TO BE CLEANED

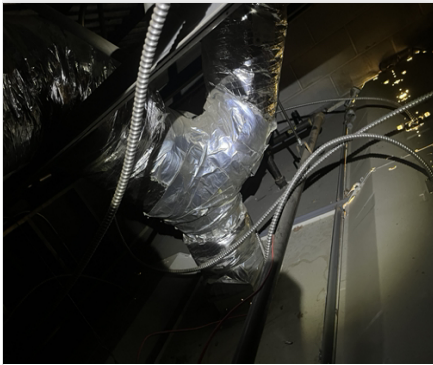
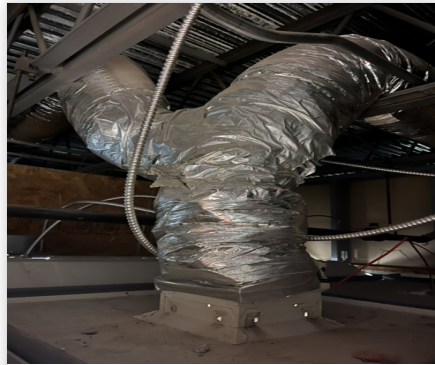
3-3.jpeg

**Issue Name :** NO DAMPER INSTALLED 3-3 & 3-4

**Description :** NO DAMPER INSTALLED 3-3 & 3-4.

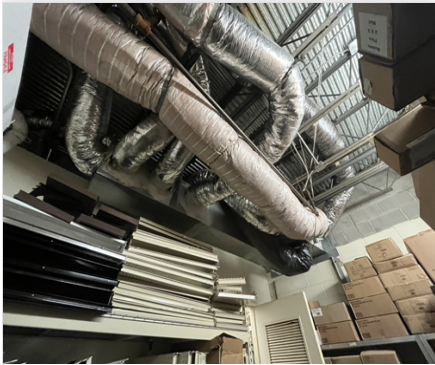
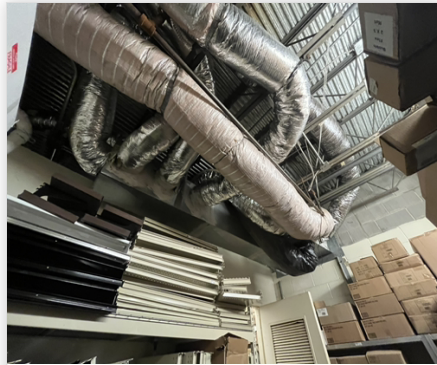
RTU-3.jpeg

**Issue Name :** RTU-3 NO DAMPERS INSTALLED

**Description :** NO DAMPERS INSTALLED FOR ANY GRILLS

Notes: NO DAMPERS INSTALLED

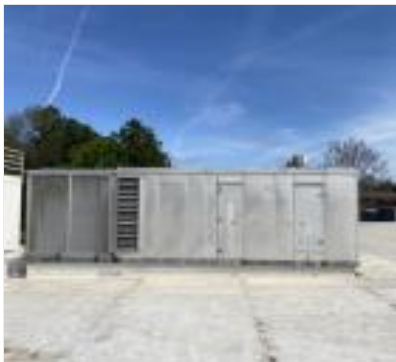
RTU-1.jpeg

Notes: MOTOR SHEAVE NEEDS REPLACEMENT. CFM IS AT 77% OF DESIGN. FILTER PD: 0.45" COIL PD: 0.47" EVAP COIL PD: 0.66"

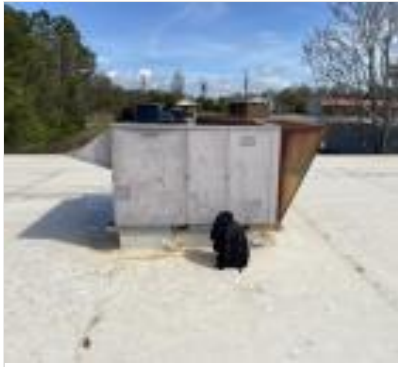
**RTU-2.jpeg**

**Description :** UNIT IS NOT OPERATIONAL

Notes: UNABLE TO ADJUST MOTOR. CFM IS AT 39% OF DESIGN. UNABLE TO OPEN OA VENT. OA FILTERS NEED REPLACED.

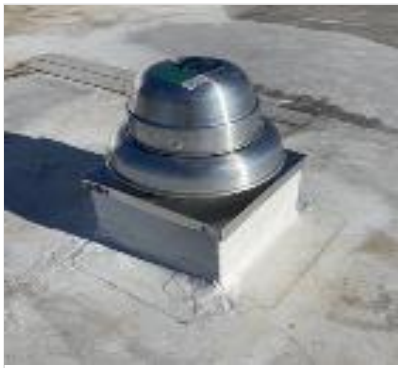
EF-3.jpeg

**Issue Name :** EF-3  
**Description :** UNIT IS NOT OPERATIONAL  
**Created By :** National TAB                      **Assigned To :** National TAB - Will Turnbough  
**Status :** Open  
**Originated Date :** 03/27/2023 - Antonio Flores-De La Cruz - National TAB

Notes: UNIT IS NOT OPERATIONAL

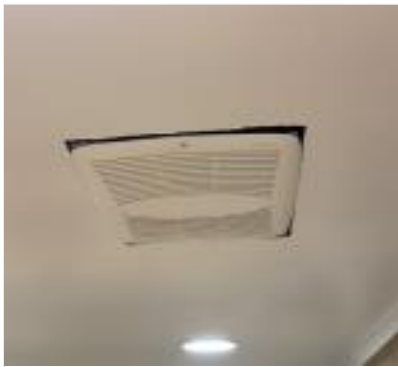
EF-4.jpeg

**Issue Name :** EF-4  
**Description :** UNIT IS NOT OPERATIONAL  
**Created By :** National TAB                      **Assigned To :** National TAB - Will Turnbough  
**Status :** Open  
**Originated Date :** 03/28/2023 - Antonio Flores-De La Cruz - National TAB

Notes: UNIT IS NOT OPERATIONAL

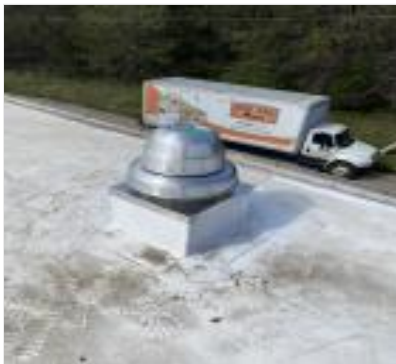
EF-7.jpeg

**Issue Name :** EF-7  
**Description :** UNIT IS NOT OPERATIONAL  
**Created By :** National TAB                      **Assigned To :** National TAB - Will Turnbough  
**Status :** Open  
**Originated Date :** 03/27/2023 - Antonio Flores-De La Cruz - National TAB
