**Report: TAB Report**  
**Function: Test, Adjust, & Balance**  
**Date: 01/29/2026**  
**Completed By: National TAB**

**01-26-26 WHATABURGER #1653 - HICKORY,  
NC**

2411 N CENTER ST

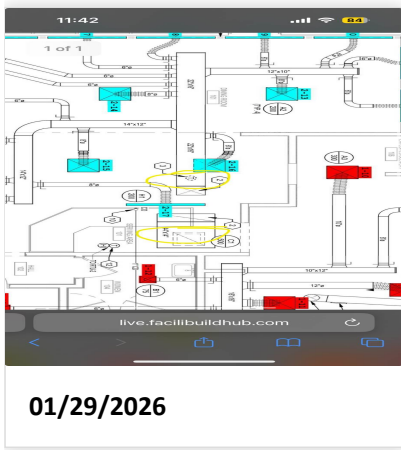
Screenshot of the GRD marked up with supply and return traverse locations for RTU-2 (Add picture here)

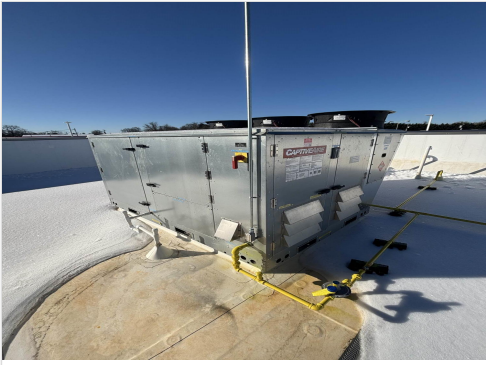
## Unit Data - PHOTO LOG

Asset: RTU-1

Unit Data	
	Actual
MFG	CAPTIVEAIRE
Serial Num	7658584
Model Num	CAS-HVAC3-I.300-20-20T
Num OA Filters 1	1
OA Filter Size 1	46X32
Num OA Filters 2	4
OA Filter Size 2	24X16
Num Final Filter 1	6
Final Filter Size 1	20X25X2

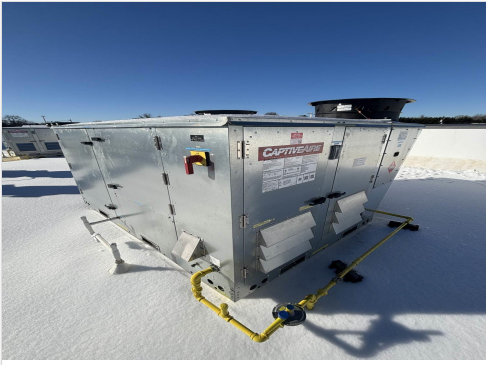
## Unit Data - PHOTO LOG

Asset: RTU-2

Unit Data	
	Actual
MFG	CAPTIVEAIRE
Serial Num	7658584
Model Num	CAS-HVAC3-I.200-15-15T
Num OA Filters 1	1
OA Filter Size 1	46X32
Num OA Filters 2	4
OA Filter Size 2	24X16
Num Final Filter 1	8
Final Filter Size 1	20X25X2

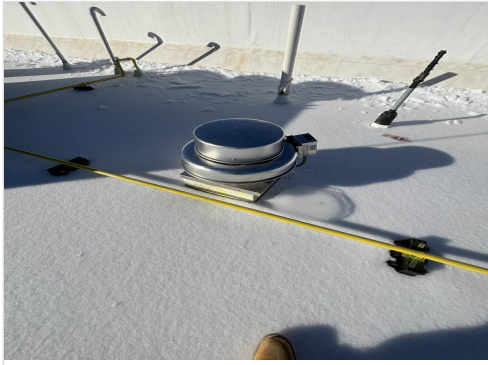
## Unit Data - PHOTO LOG

Asset: EF-1

Unit Data		
	Design	Actual
<b>MFG</b>	GREENHECK	GREENHECK
<b>Model Num</b>	G-080-VG	G-080-VG-1-17-X
<b>Serial Num</b>	-	27813549
<b>Type</b>	DOWNBLAST	DOWNBLAST
<b>Configuration</b>	VERTICAL	VERTICAL

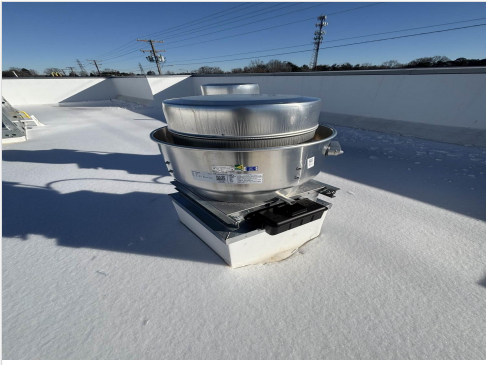
## Unit Data - PHOTO LOG

Asset: KEF-1

Unit Data		
	Design	Actual
MFG	GREENHECK	GREENHECK
Model Num	CUE-140-VG	CUE-140-7-VG-1-22-G
Serial Num	-	27813550
Type	UPBLAST	UPBLAST
Configuration	VERTICAL	VERTICAL

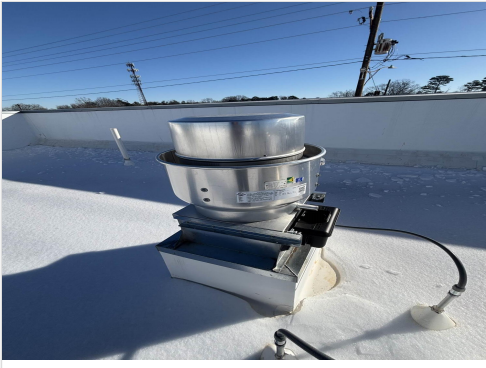
## Unit Data - PHOTO LOG

Asset: KEF-2

Unit Data		
	Design	Actual
MFG	GREENHECK	GREENHECK
Model Num	CUE-120-VG	CUE-120-5-VG-1-19-G
Serial Num	-	27813551
Type	UPBLAST	UPBLAST
Configuration	VERTICAL	VERTICAL

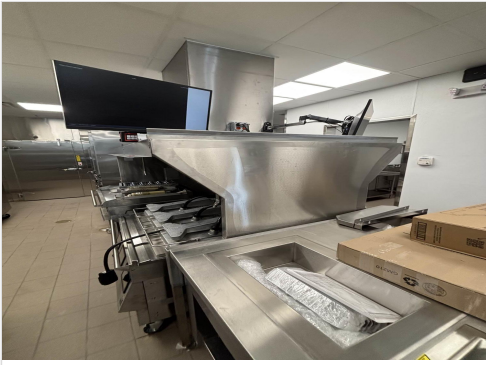
## Unit Data - PHOTO LOG

Asset: HD-1

Unit Data		
	Design	Actual
MFG	H&K	H&K
Model Num	HKD027	HKD027
Job / Serial Num	-	8184330-001
Type	TYPE I CANOPY	TYPE I CANOPY
Hood length	87"	87"
Hood Width	55"	55"

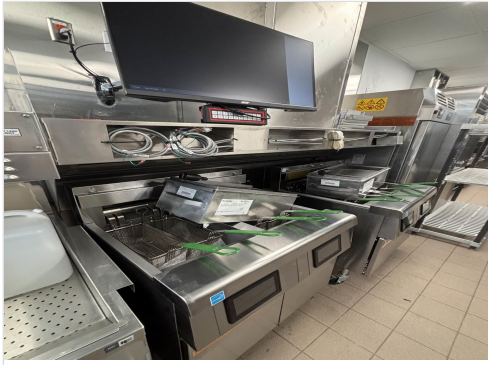
## Unit Data - PHOTO LOG

Asset: HD-2

Unit Data		
	Design	Actual
MFG	H&K	H&K
Model Num	HKD023	HKD023
Job / Serial Num	-	8189823-001
Type	TYPE I CANOPY	TYPE I CANOPY
Hood length	73"	73"
Hood Width	22"	22"
