Report: TAB Report
Function: Test, Adjust, & Balance
Date: 03/09/2026
Completed By: National TAB

PROJECT
03-09-26 QT #0472 PEORIA, AZ

Project: 03-09-26 QT #0472 PEORIA, AZ

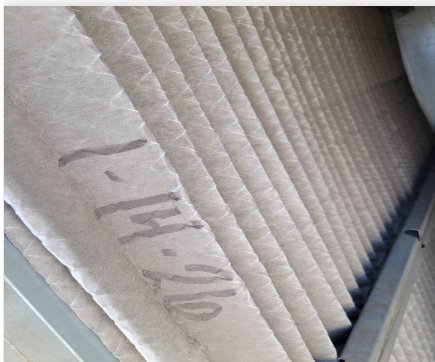
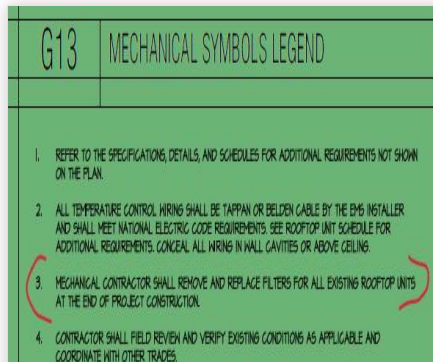
Issue Name : DIRTY FINAL FILTERS
Description : MSET states mechanical contractor should replace filters at project's culmination. Filters don't appear to have been changed and are extremely dirty.
Created By : National TAB **Assigned To :** National TAB - Dan Hertenstein
Status : Open
Priority : Low **Asset Tag :**
Originated Date : 03/10/2026 - Christine Weale - National TAB

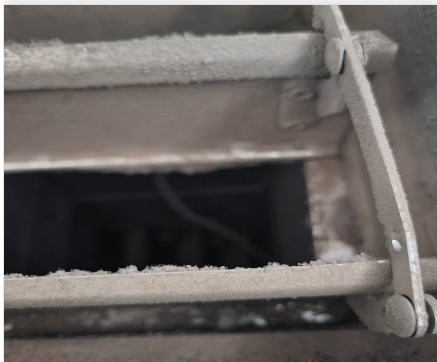
Issue Name : EF1 BACKDRAFT DAMPER STUCK OPEN
Description : Backdraft damper does not close.
Created By : National TAB **Assigned To :** National TAB - Dan Hertenstein
Status : Open
Priority : Low **Asset Tag :** EF1
Originated Date : 03/10/2026 - Christine Weale - National TAB

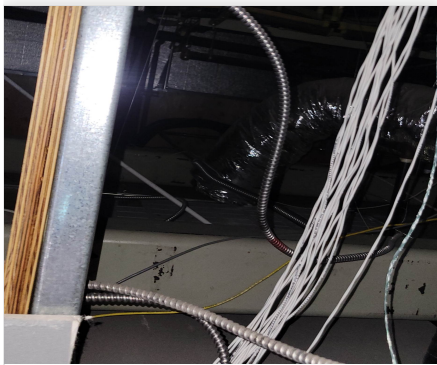
Issue Name : NO SUPPLY TO HUMID AREA
Description : The grille has been completely removed from the ceiling and the duct is laying atop it. This area has a lot of drainage and running machines, it should have constant air supply.
Created By : National TAB **Assigned To :** National TAB - Dan Hertenstein
Status : Open
Priority : Medium **Asset Tag :** SGRD10
Originated Date : 03/10/2026 - Christine Weale - National TAB

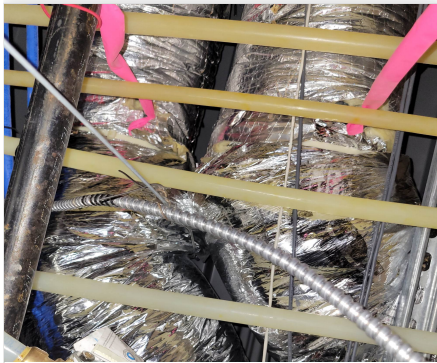
Issue Name : SGRD3-5 DAMPER NONFUNCTIONAL
Description : Most of the air flow is going to SGRD3-5 and moving the damper from side to side does nothing at all. Pulled as much air as possible by opening other dampers but staying in design for all others. Recommend checking air flow is almost nonexistent when set to close.
Created By : National TAB **Assigned To :** National TAB - Dan Hertenstein
Status : Open
Priority : High **Asset Tag :** SGRD5
Originated Date : 03/09/2026 - Christine Weale - National TAB

Asset	Notes	Date	Written By
SGRD5	DAMPER NONFUNCTIONAL, SEE 'REMARKS'.	03/09/2026	Christine Weale

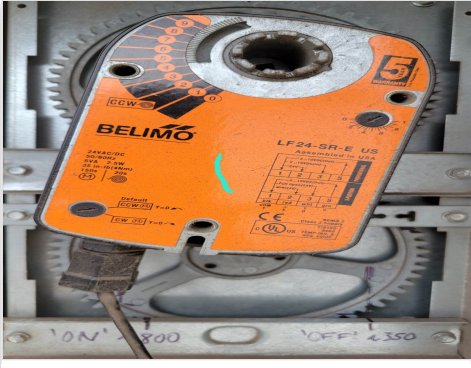
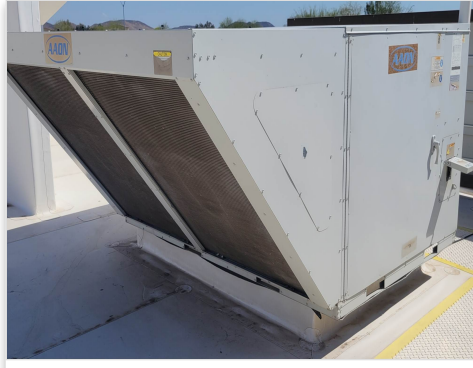
Asset: RT-1

General	
	Actual
Fan Rotation Correct	YES
Unit Filters Clean	NO
Condensate Drain Installed	YES

Notes:
ELECTRICAL RM GRILLE INACCESSIBLE, CLOSED DAMPER FOR MEASURE, THEN REOPENED.

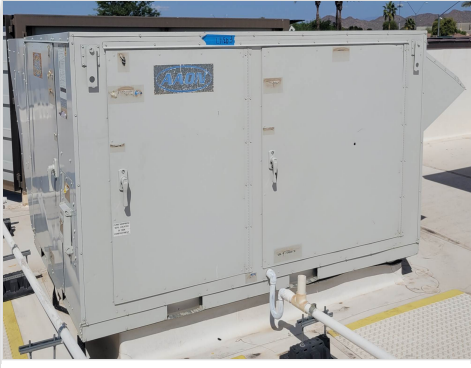
Asset: RT-2

General	
	Actual
Fan Rotation Correct	YES
Unit Filters Clean	NO
Condensate Drain Installed	YES

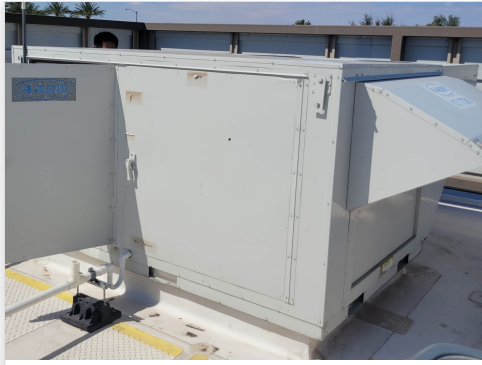
Asset: RT-3

General	
	Actual
Fan Rotation Correct	YES
Unit Filters Clean	NO
Condensate Drain Installed	YES

Issue Name : RTU3 POSSIBLE ACTUATOR ISSUE
Description : Econ damper didn't seem to be functioning properly or responding appropriately to settings. Even on 15.0 Emerson setting, damper wouldn't open as the others did. Had to set the Belimo actuator to 0.3". At first, it wouldn't fully open to 46.0 as the others did, either. Manually set to balance.
Created By : National TAB **Assigned To :** National TAB - Dan Hertenstein
Status : Open
Priority : InfoOnly **Asset Tag :** RT-3
Originated Date : 03/10/2026 - Christine Weale - National TAB
