Report: TAB

Function: Test, Adjust, & Balance

**05-26-25 SWEETGREEN LAGUNA NIGUEL,
CA (TAB, IAQ)**

Project: 05-26-25 SWEETGREEN LAGUNA NIGUEL, CA (TAB, IAQ)

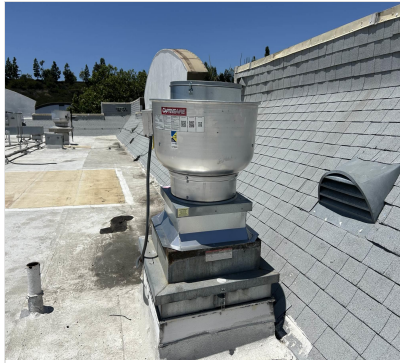
Identify where the exhaust air is discharged and take pictures

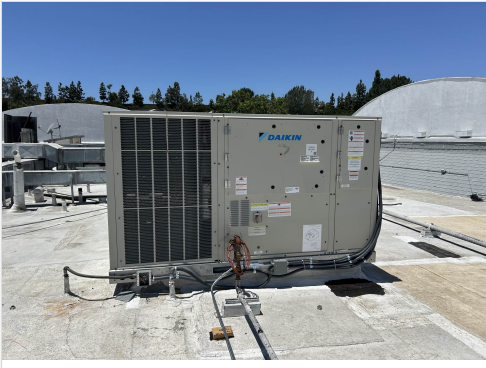
Unit Data - PHOTO LOG

Asset: RTU1

AREA:KITCHEN

Unit Data		
	Design	Actual
MFG	TRANE	DAIKIN
Serial Num	-	2412364584
Model Num	YSJ-120	DRG1203LH00137CAB
Type	RTU	RTU
Configuration	VERTICAL	VERTICAL
Num OA Filters 1	-	1
OA Filter Size 1	-	41X23"
Num Final Filter 1	-	2
Final Filter Size 1	-	25X25X2
Num Final Filter 2	-	2
Final Filter Size 2	-	20X25X2

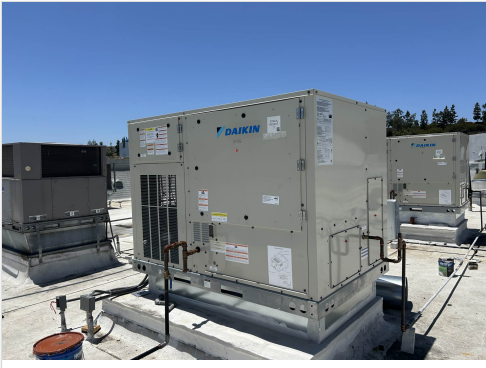
Unit Data - PHOTO LOG

Asset: RTU3

AREA: DINING

Unit Data		
	Design	Actual
MFG	TRANE	DAIKIN
Serial Num	-	2412337092
Model Num	YSJ-072	DRG0723DM00055CAB
Type	RTU	RTU
Configuration	VERTICAL	VERTICAL
Num OA Filters 1	-	1
OA Filter Size 1	-	29X17.5
Num Final Filter 1	-	4
Final Filter Size 1	-	20X20X2

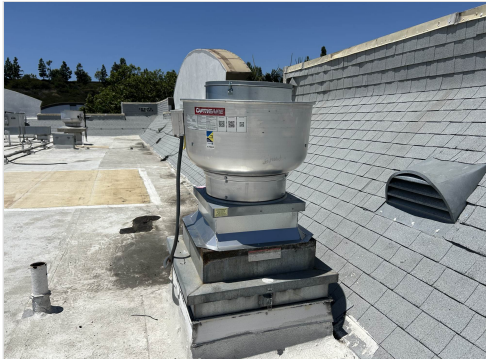
Unit Data - PHOTO LOG

Asset: EF1

Unit Data		
	Design	Actual
MFG	CAPTIVE AIRE	CAPTIVE AIRE
Model Num	NA	DU50HFA
Serial Num	-	7354715
Type	-	UPBLAST
Configuration	-	VERTICAL

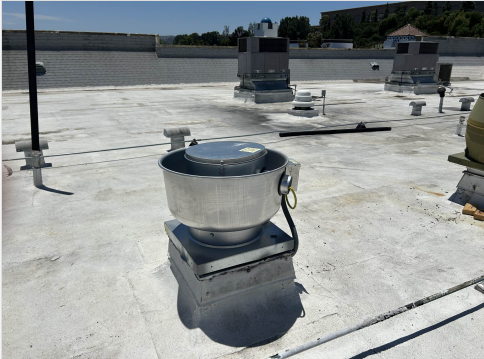
Unit Data - PHOTO LOG

Asset: EF2

AREA:RESTROOMS

Unit Data		
	Design	Actual
MFG	CAPTIVAIRE	CAPTIVAIRE
Model Num	DR12HFA	DU12HFA
Serial Num	-	7249490
Type	DOWNBLAST	UPBLAST
Configuration	VERTICAL	VERTICAL

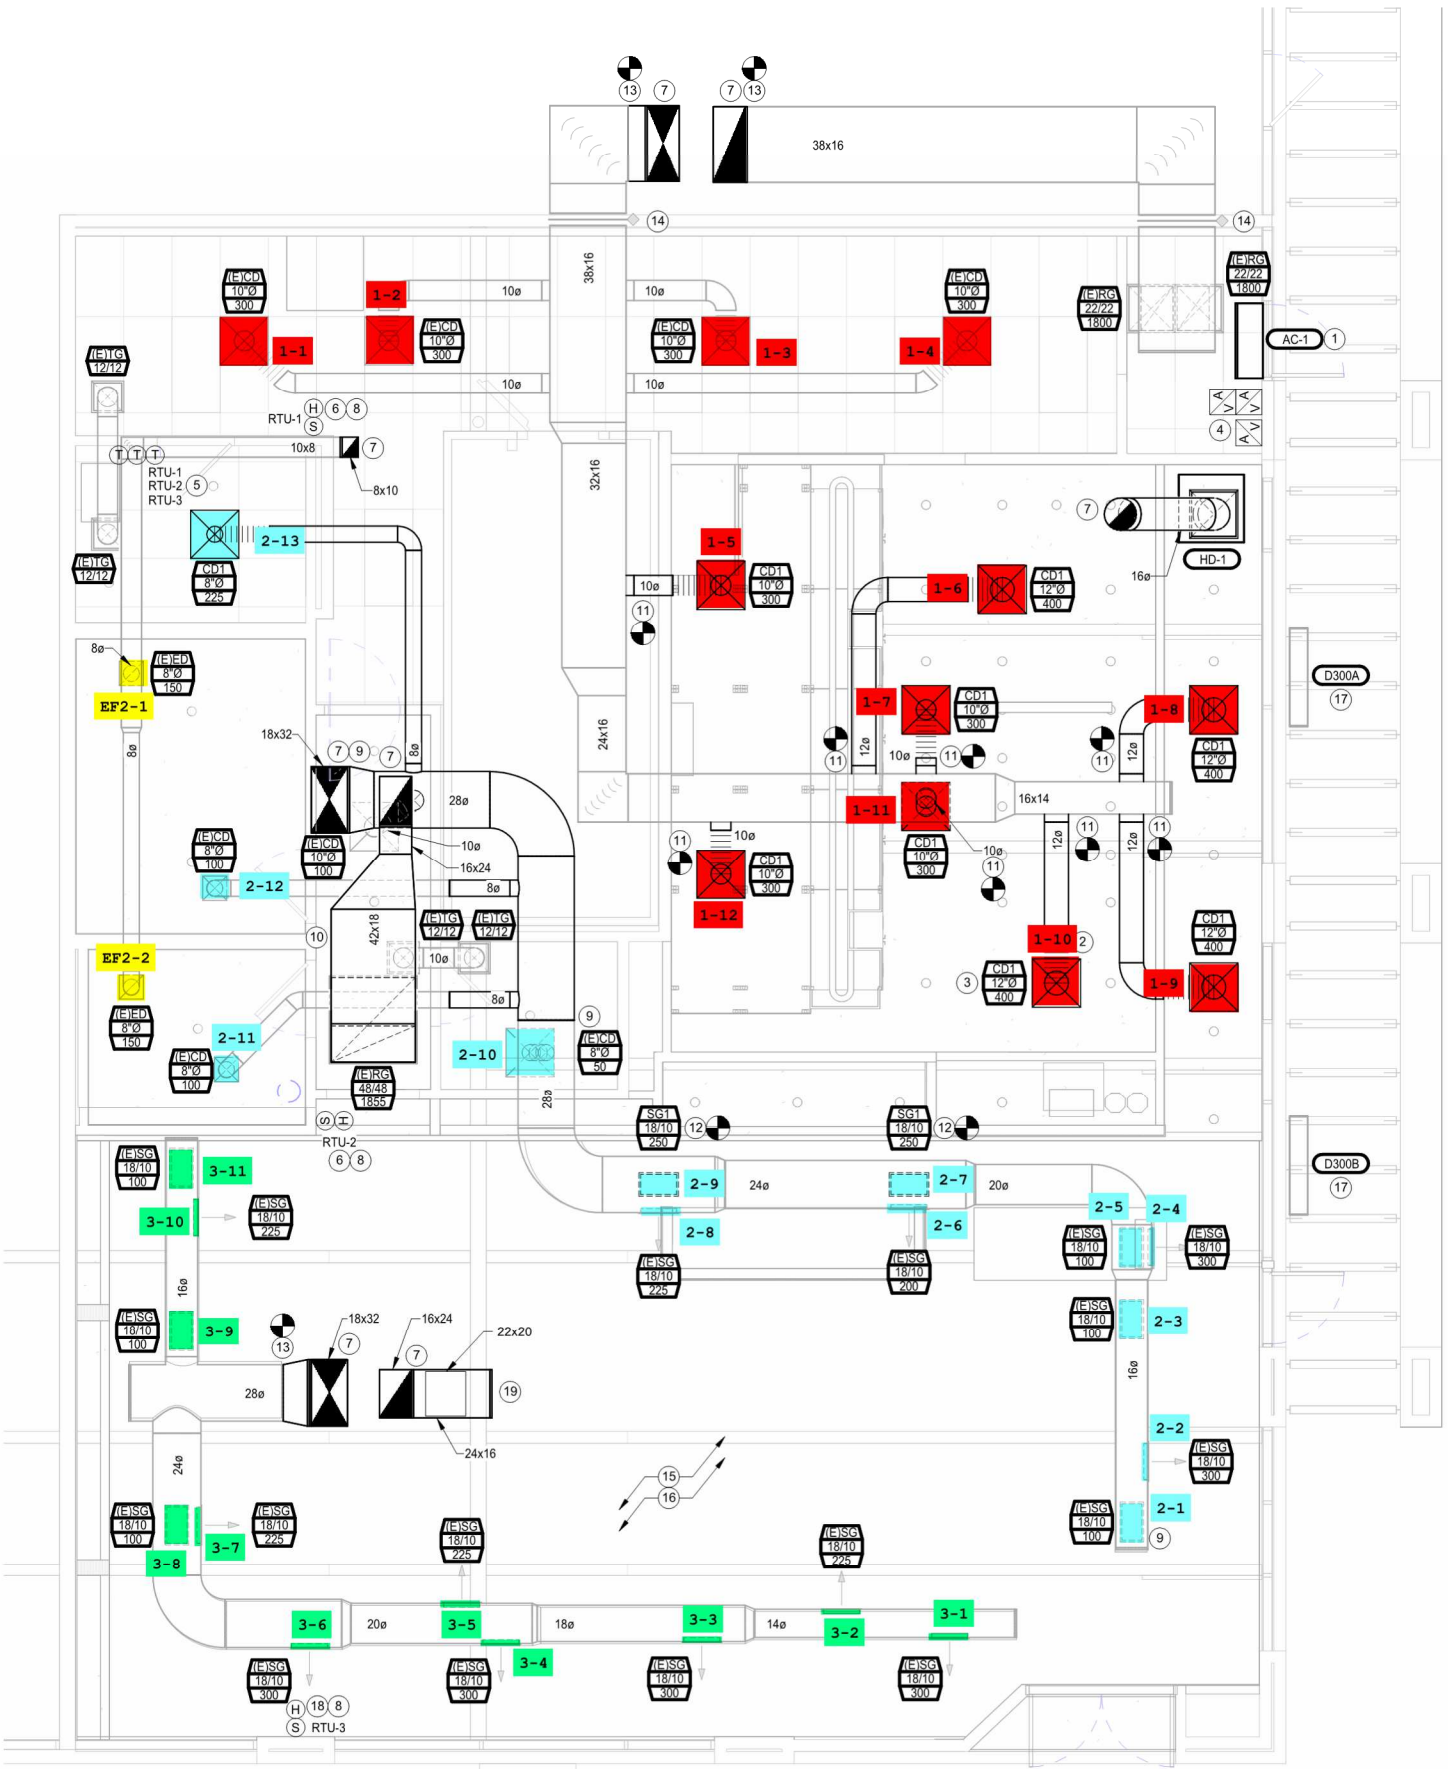
HVAC PLAN
 1/4" = 1'-0"

- D300C (17)
- D300D (17)
- D300E (17)
- D300F (17)
- D300B (17)
- D300G (17)
