Report: TAB

Function: Test, Adjust, & Balance

Date: 06/17/2025

**06-16-25 CHIPOTLE #5486 SACRAMENTO,
CA (FULTON & MARCONI)**

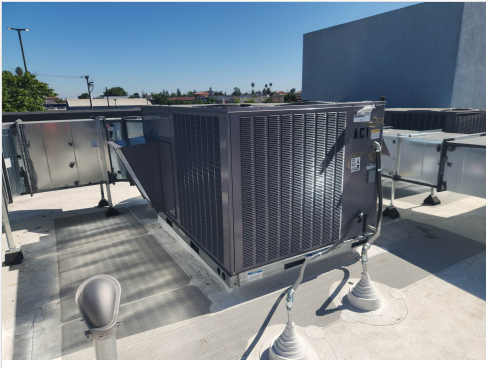
Unit Data - PHOTO LOG

Unit Data		
	Design	Actual
MFG	CARRIER	CARRIER
Serial Num	-	2623P64526
Model Num	48FEFN12D3M5	48FCDN12A3P5A6F4C0
Type	RTU	RTU
Configuration	VERTICAL	VERTICAL
Num OA Filters 1	-	1
OA Filter Size 1	-	29.5X20.5
Num Final Filter 1	-	4
Final Filter Size 1	-	20X20X2

Test Data		
	Design	Actual
SF CFM	3400	3519
SF RPM	-	1897
RA CFM	2600	2708
OA CFM	800	811
RL Voltage	-	211/211/212
RL Amperage	-	4.8/4.8/4.81
SF Rotation	-	CCW
SF System SetPt	-	6.4VDC
RA Damper Position	-	75%
Min OA Damper Position	-	25%
Min OA Damper Type	-	MOTORIZED
OA Enthalpy Setpt	-	ES5

General	
	Actual
Fan Rotation Correct	YES
Unit Filters Clean	YES, CONSTRUCTION FILTERS
Condensate Drain Installed	YES

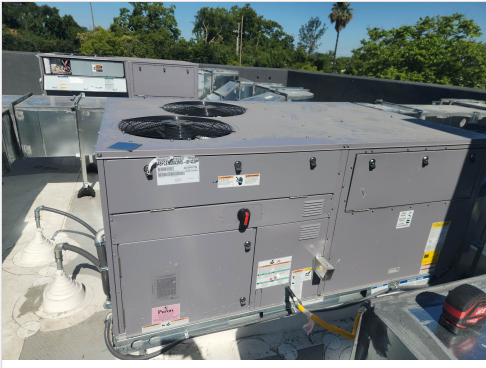
Unit Data - PHOTO LOG

Unit Data		
	Design	Actual
MFG	CARRIER	CARRIER
Serial Num	-	2223P61793
Model Num	48FEEN08A3M5	48FCEN08A3M5A6F4C0
Type	RTU	RTU
Configuration	VERTICAL	VERTICAL
Num OA Filters 1	-	1
OA Filter Size 1	-	29.5X20.5
Num Final Filter 1	-	4
Final Filter Size 1	-	20X20X2

Test Data		
	Design	Actual
SF CFM	3000	2980
SF RPM	-	1812
RA CFM	2300	2261
OA CFM	700	719
RL Voltage	-	211/211/211
RL Amperage	-	4.5/4.5/4.5
SF Rotation	-	CCW
SF System SetPt	-	6.1VDC
RA Damper Position	-	76%
Min OA Damper Position	-	24%
Min OA Damper Type	-	MOTORIZED
OA Enthalpy Setpt	-	ES5

General	
	Actual
Fan Rotation Correct	YES
Unit Filters Clean	YES, CONSTRUCTION FILTERS
Condensate Drain Installed	YES

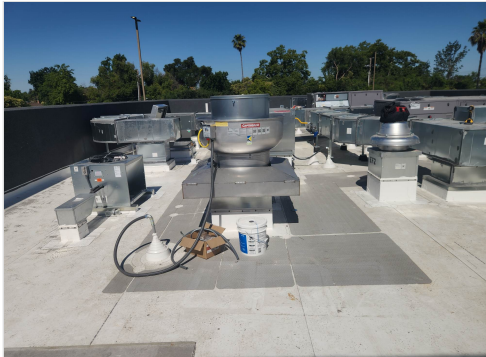
Unit Data - PHOTO LOG

Unit Data		
	Design	Actual
MFG	CAPTIVEAIRE	CAPTIVEAIRE
Model Num	DU180HFA	DU180HFA
Serial Num	-	7051339
Type	UPBLAST/CEILING	UPBLAST
Configuration	VERTICAL	VERTICAL

Test Data		
	Design	Actual
CFM	2550	2566
Fan RPM	-	946
Fan Rotation	-	CCW
Motor RPM	-	946
System SetPt	-	48.7HZ
RL Voltage	-	155/155/155
RL Amperage	-	4.58/4.58/4.58
Total ESP	1.450"	1.11"
Fan Inlet SP	-	-1.11"
Fan Discharge SP	-	ATM

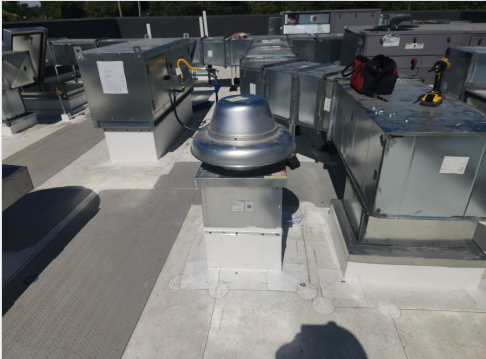
Unit Data - PHOTO LOG

Unit Data		
	Design	Actual
MFG	CAPTIVEAIRE	CAPTIVEAIRE
Model Num	DR12HFA	DR12HFA
Serial Num	-	7051339
Type	DOWNBLAST	DOWNBLAST
Configuration	VERTICAL	VERTICAL

Test Data		
	Design	Actual
CFM	150	158
Fan RPM	-	912
Fan Rotation	-	CCW
Motor RPM	-	912
System SetPt	-	50%
RL Voltage	-	NA
RL Amperage	-	NA
Total ESP	.60"	0.43"
Fan Inlet SP	-	-0.43"
Fan Discharge SP	-	ATM

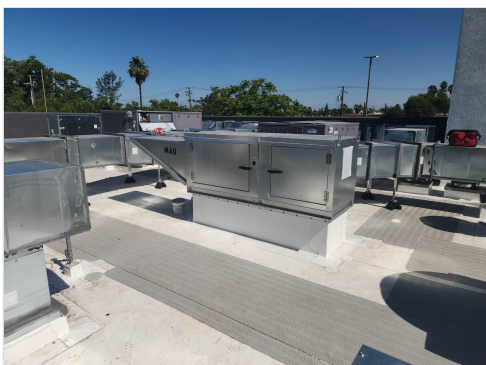
Unit Data - PHOTO LOG

Unit Data		
	Design	Actual
MFG	CAPTIVEAIRE	CAPTIVEAIRE
Model Num	A1.D.250-15D	A1.D.250-15D
Serial Num	-	7051339
Type	MUA	MUA
Configuration	VERTICAL	VERTICAL

Gas Heat		
	Design	Actual
Heater Operates (y/n)	-	YES
Flame Status (pass/fail)	-	PASS
Inlet Air Temp SetPt	-	55
Discharge Air Temp SetPt	-	60
Air Flow Switch SP Actual	-	0.44"

Test Data		
	Design	Actual
CFM	1300	1353
SF RPM	-	1740
Motor RPM	-	1740
SF System SetPt	-	60HZ
RL Voltage	-	211/211/211
RL Amperage	-	2.87/2.87/2.87
Total ESP	-	NA
Fan Discharge SP	-	NA

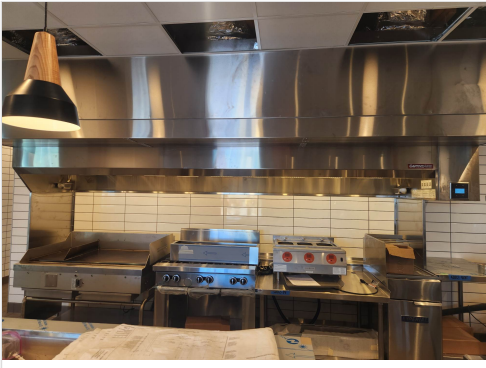
Unit Data - PHOTO LOG

Unit Data		
	Design	Actual
MFG	CAPTIVEAIRE	CAPTIVEAIRE
Model Num	3650-BD-2-ACSP	3650 BD-2
Job / Serial Num	-	7051339
Type	TYPE I - LOW PROXIMITY -	TYPE I CANOPY
Hood length	165"	165"
Hood Width	36"	36"
Supply Plenum Type	-	PERFORATED
Supply Plenum Width	9"	9"
Supply Plenum Length	165"	165"

Test Data Exhaust		
	Design	Actual
Filter Type	CAPRATE SOLO FILTER	CAPRATE SOLO
Filter Size 1	16X16	16X16
Filter Qty 1	9	9
Filter AK factor size 1	1.62	1.62
Filter Total AK Area	14.58	14.58
Filter1 FPM	-	185
Filter2 FPM	-	161
Filter3 FPM	-	174
Filter4 FPM	-	189
Filter5 FPM	-	186
Filter6 FPM	-	186
Filter7 FPM	-	176
Filter8 FPM	-	172
Filter9 FPM	-	157
Filter Ave FPM(corr)	-	176
CFM	2550	2566

Test Data Supply		
	Design	Actual
Total Area	10.31	10.31
Kv factor (Vel)	.81	0.81
Num of Readings	-	12
Reading1 FPM	-	166
Reading2 FPM	-	167
Reading3 FPM	-	179
Reading4 FPM	-	185
Reading5 FPM	-	147
Reading6 FPM	-	172
Reading7 FPM	-	141
Reading8 FPM	-	176
Reading9 FPM	-	175
Reading10 FPM	-	158
Reading11 FPM	-	141
Reading12 FPM	-	143
Ave FPM(corr)	-	162
CFM	1300	1353
