National TAB

Project: 10-20-25 QT #0847 GAINESVILLE, GA

Project: 10-20-25 QT #0847 GAINESVILLE, GA
Function: Test, Adjust, & Balance

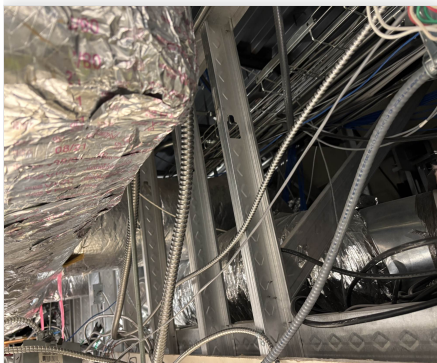
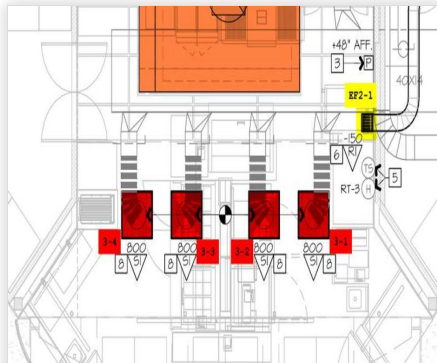
Issue Name : RTU-3: Kitchen Supply Diffuser Ductwork Incorrect
Description : RTU-3 Diffusers 3-1 and 3-4 in the kitchen are not connected to the supply duct. They are still connected to the return duct. This will need to be corrected. RTU 3 is balanced to total design airflow.
Created By : National TAB **Assigned To :** National TAB - Dan Hertenstein
Status : Closed
Priority : Urgent **Asset Tag :**
Originated Date : 10/23/2025 - Sagar Patel - National TAB
