PlanGrid Task Report - Jul 19, 2024

Prepared by Stephen Tassinaro

Jul 19, 2024

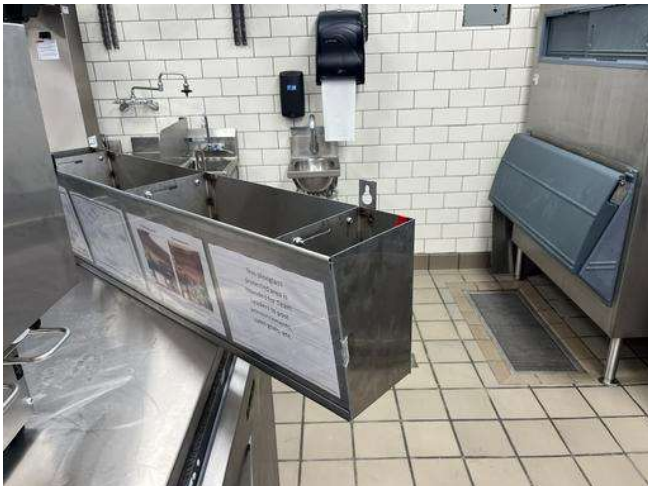
IMG_3457

#24 [CURT 502] [NEW] Air curtain diverter box.

Air curtain diverter box is not installed. should be bolted to wall, slid forward, and flush with door header.

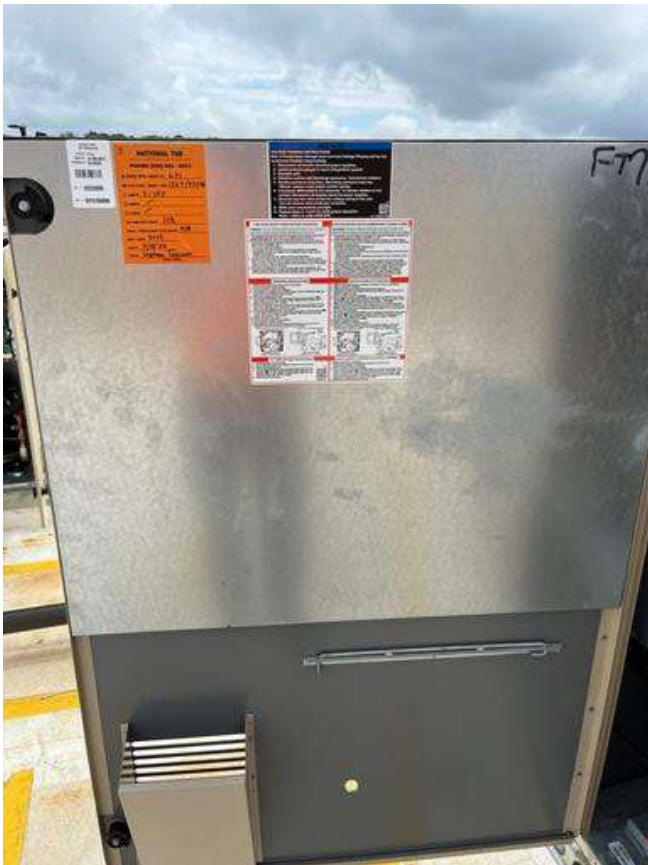
IMG_3467

#22 [UNIT 501] [NEW] Equipment low voltage diagrams

Equipment missing
laminated copy of controls
detail low voltage wiring
diagrams.

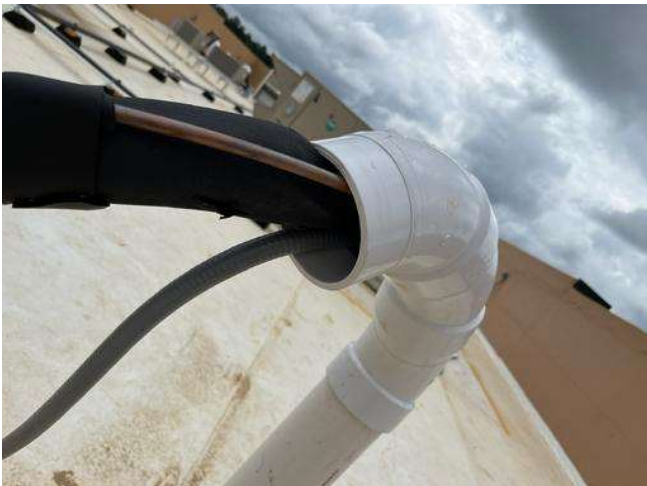
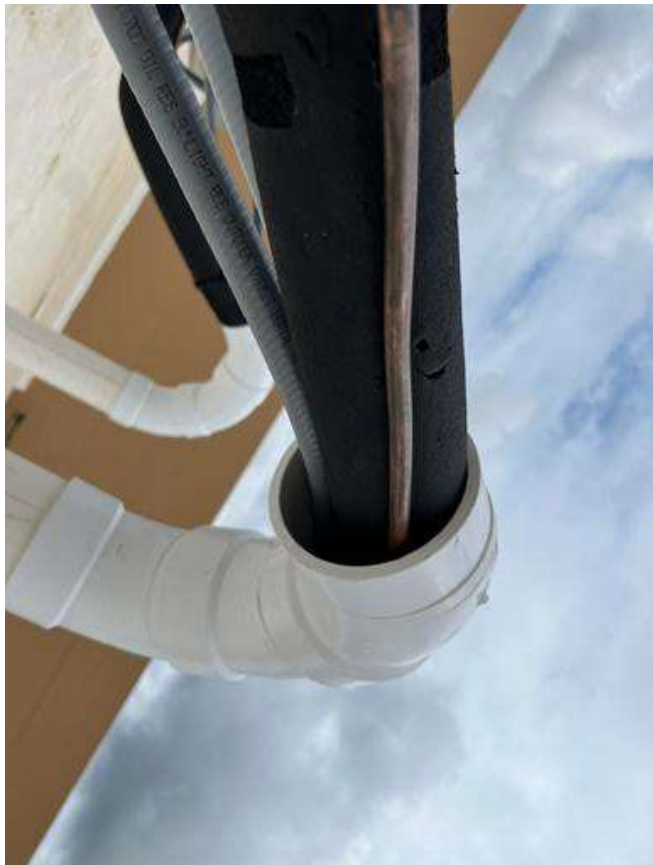
IMG_3493

#20 [REFG 999] [NEW] Spray Foam In Goosenecks

WIC/WIF spray foam not installed to seal goosenecks on rooftop. PVC not glued together.

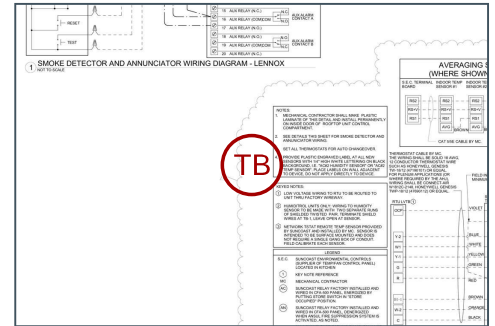
IMG_3415

#15 [CNTL 508] [NEW] Controls labeling.

Description
Label all sensors, humidistats, thermostats, smoke annunciators and remote space mounted OADs, MODs, VFD's for which piece of equipment they serve.

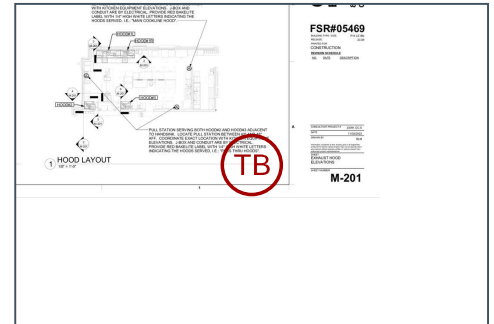
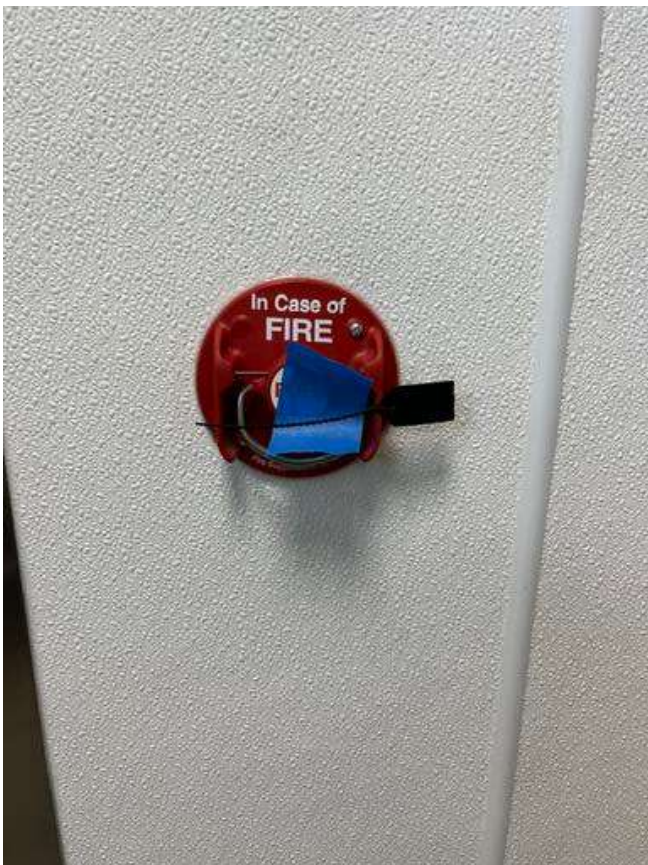
IMG_3399

#14 [CNTL 509] [NEW] Ansul pull labeling.

Label all ansul pull stations for which hoods they serve.

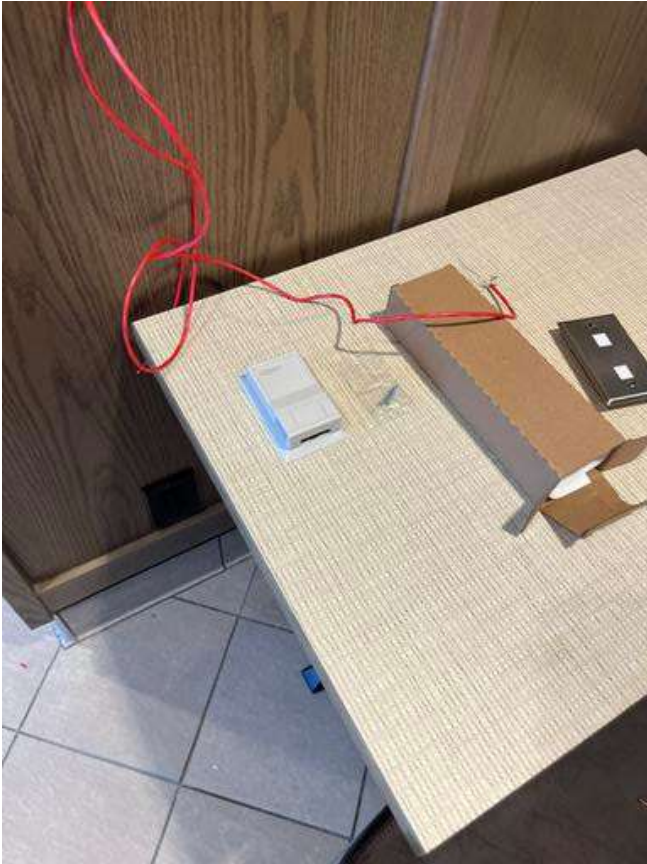
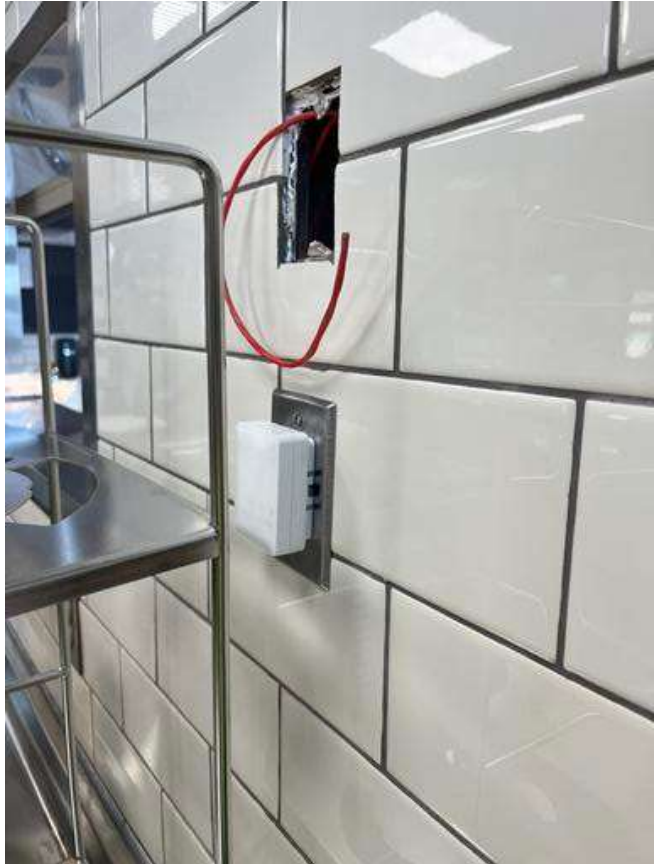
IMG_3456
Stephen Tassinaro
Jul 19, 2024 2:38 PM

#13 [CNTL 999] [NEW] Humidity Sensors

Description
Humidity sensors have not yet been installed.

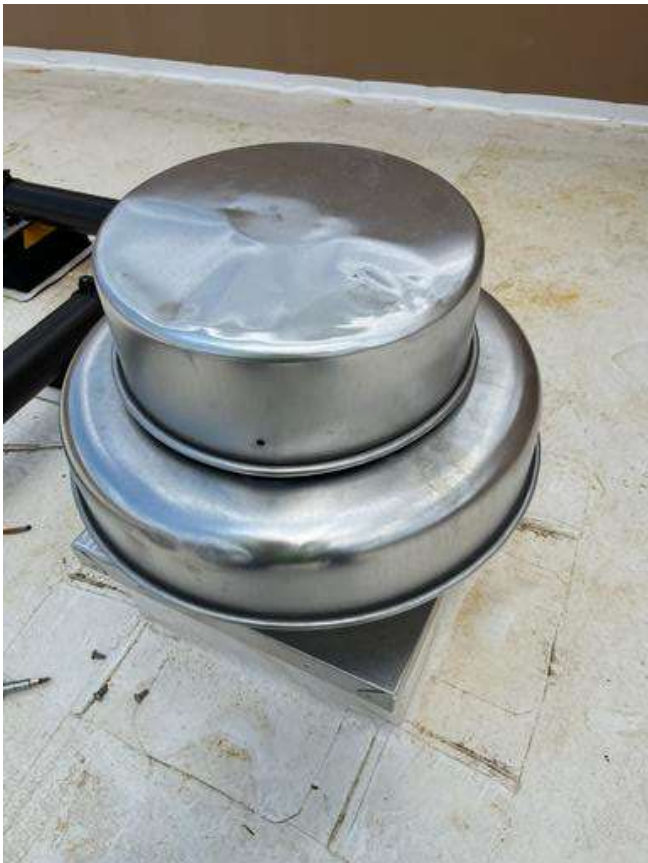
IMG_3402

#11 [EXHA 501] [NEW] Restroom fan is not secured.

Restroom fan is to be secured with screws at all corners of curb.

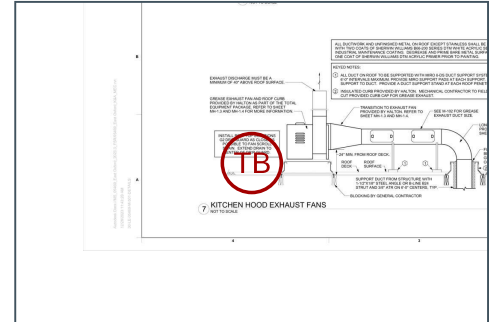
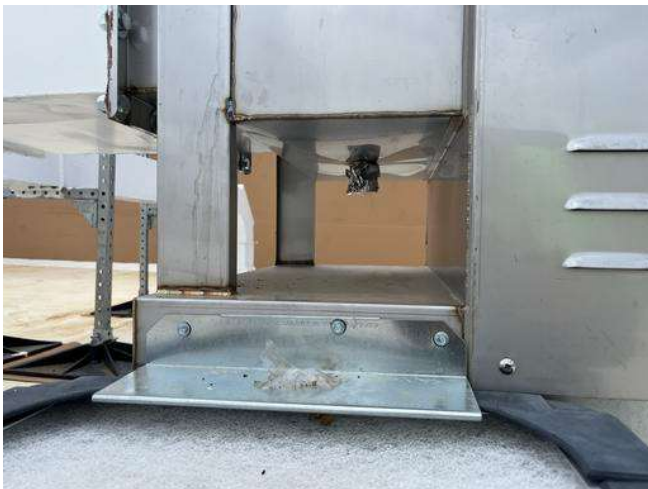
IMG_3401

#10 [EXHA 507] [NEW] Exhaust fan drain line.

Description
Exhaust fan drain is not properly installed, pitched, or routed to center of drip guard per detail. If gas piping is used, will need to be painted for rust protection.

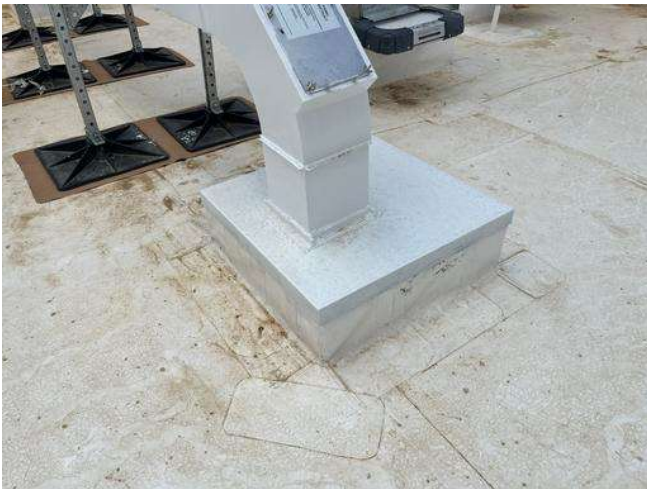
IMG_3400

#9 [EXHA 511] [NEW] Grease exhaust duct curb cap.

Grease duct curb cap is to be screwed at all corners along with a full perimeter weld between curb cap and duct.

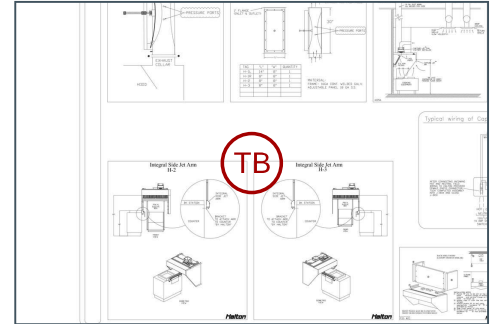
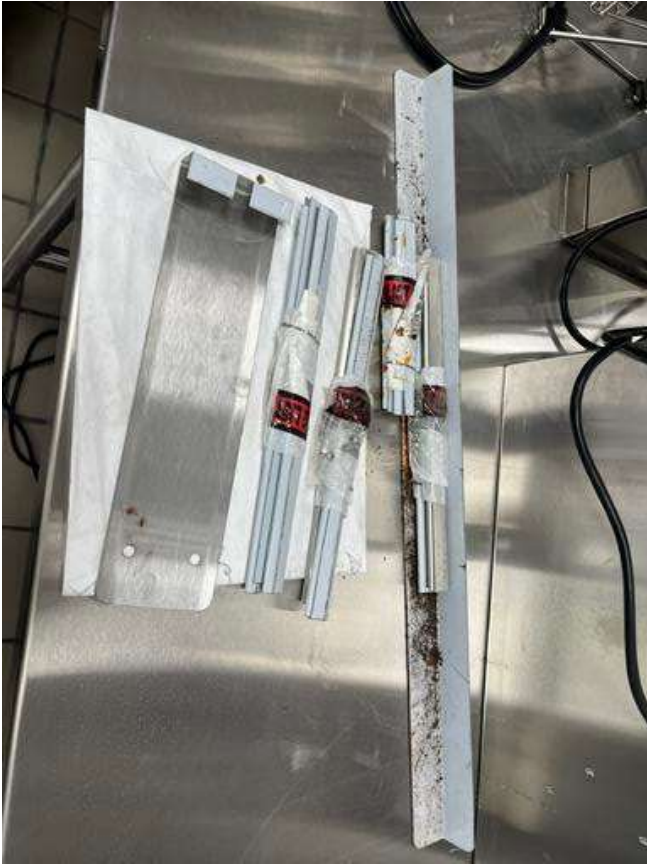
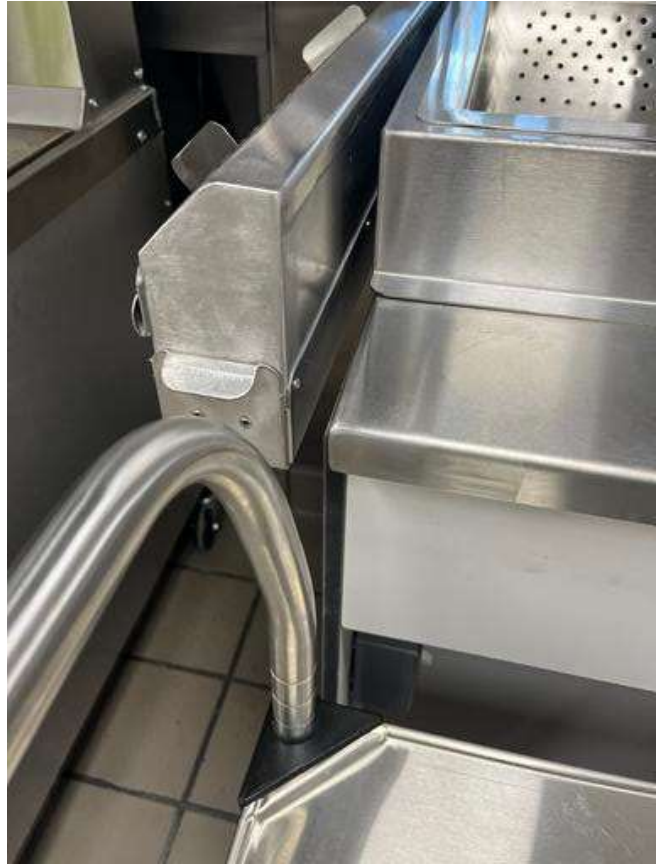
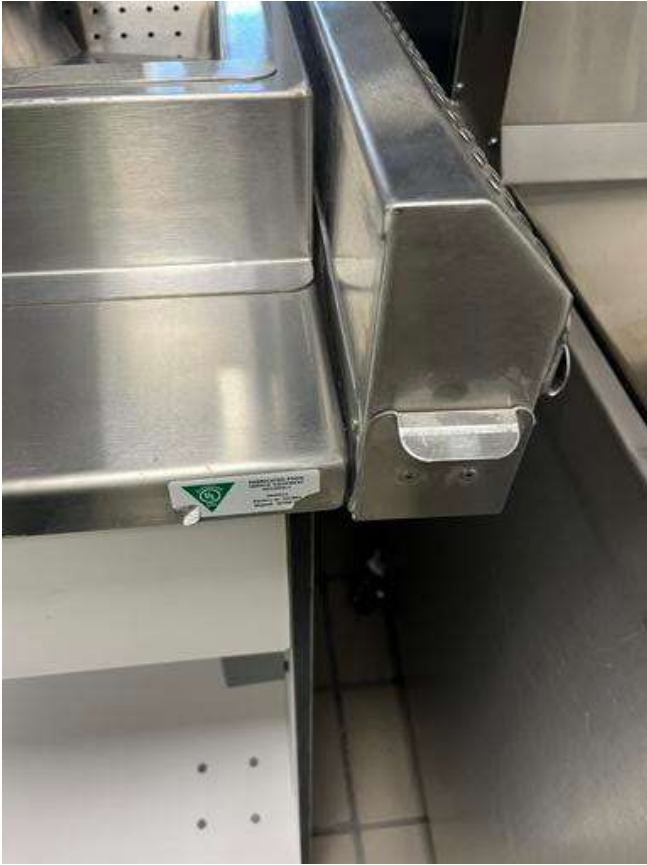
IMG_3396

#6 [HOOD 508] [NEW] Sidejet arm angle bracket. Hoods 2 & 3

The Halton supplied angle bracket that connects the integral sidejet arm to the counter is missing or not installed correctly. Secure bracket to arm and bracket to counter underneath removeable fry dump via stainless steel rivets. Hoods 2 & 3.

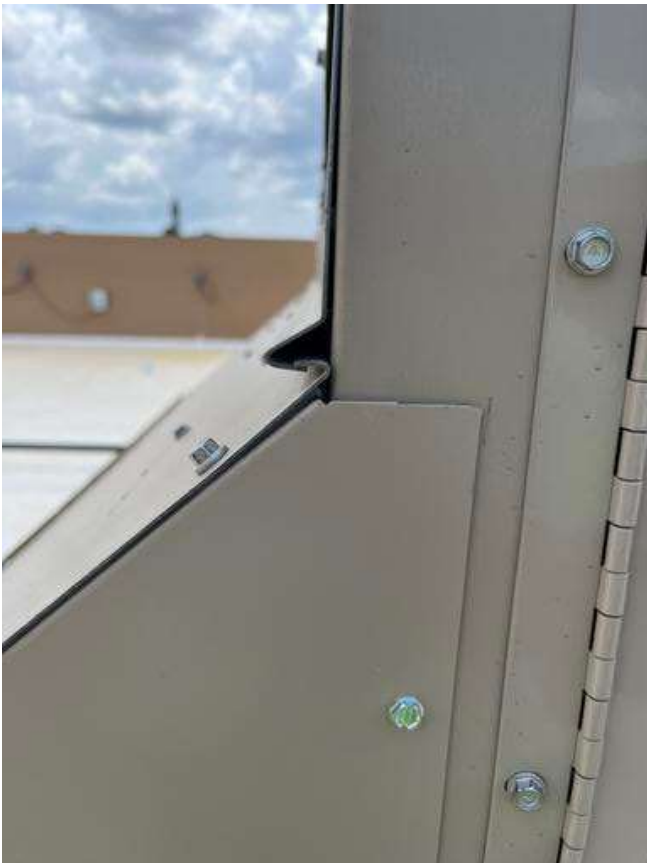
IMG_3411

#5 [UNIT 508] [NEW] Outdoor air intakes.

OAs must be caulked/
gasketed to prevent water
infiltration.

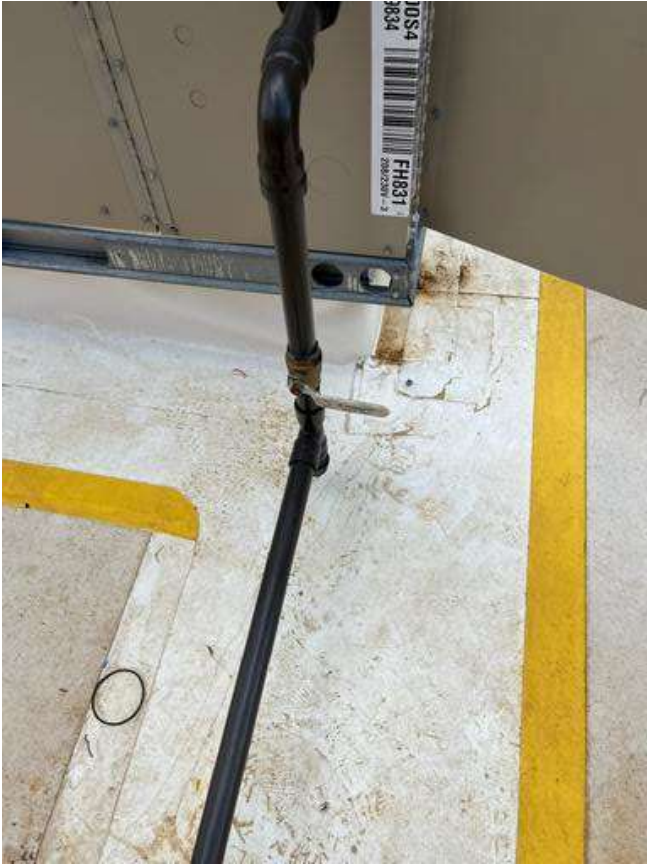
IMG_3408

#4 [UNIT 514] [NEW] Equipment gas piping.

Equipment missing gas grommet, gas startups incomplete, or gas piping is not constructed/supported per normal CFA specifications (incorrect drip leg/missing inverted trap/flex piping connections). Gas valves off at this time.
