**Report: TAB REPORT**  
**Function: Test, Adjust, & Balance**  
**Date: 07/20/2023**

**PROJECT**  
**07-10-23 FREDDY'S - NORTH PLATTE, NE**

1100 S Dewey

NORTH PLATTE, NE 69101

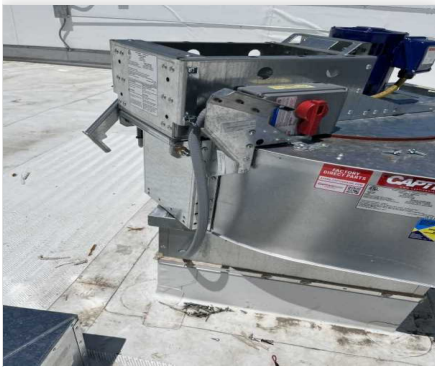
**FLEX\_CONDUIT**  
**07/20/2023**

**Issue Name :** KEF1 Conduit Too Short  
**Description :** The flex conduit on KEF-1 is too short and does not allow the fan to hinge back. This prevented NTi from taking a static pressure measurement on this fan and will inhibit proper cleaning of the grease duct.  
**Created By :** National TAB                      **Assigned To :** National TAB - Will Turnbough  
**Status :** Open  
**Originated Date :** 07/19/2023 - Stephen Tassinaro - National TAB

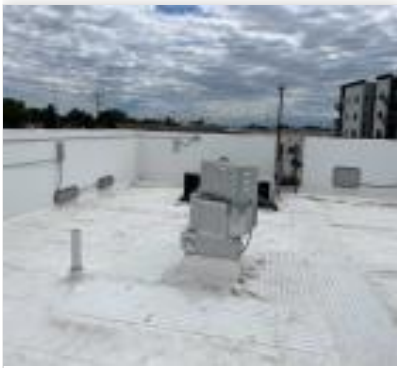
**KEF1**  
**07/20/2023**

KEF-1 FLEX CONDUIT IS NOT LONG ENOUGH. KEF-2 IS ACCEPTABLE.

Notes:  
CONDUIT TOO SHORT TO TILT FAN BACK FOR STATIC PRESSURE MEASUREMENT.
