PlanGrid Task Report - Nov 7, 2024

00792 Falls Village FSU // Raleigh, NC // ...

Raleigh, North Carolina

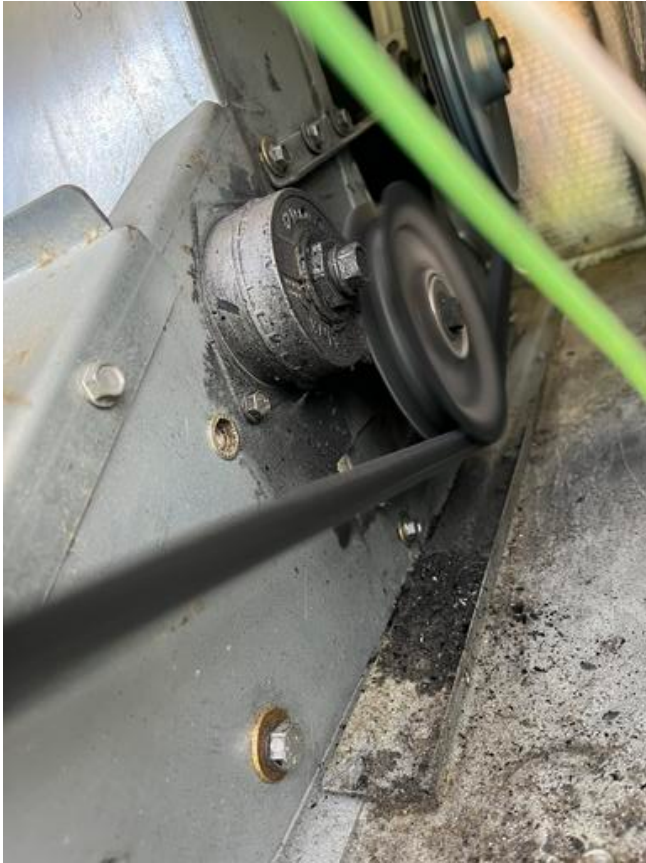
IMG_6124

#62 [UNIT 999] [EXIST] (MISC) [Belt Tensioners]

AC1 & AC4 are existing units, belt tensioner bearings sound as if they are failing. Recommend belt tensioners be replaced or removed.

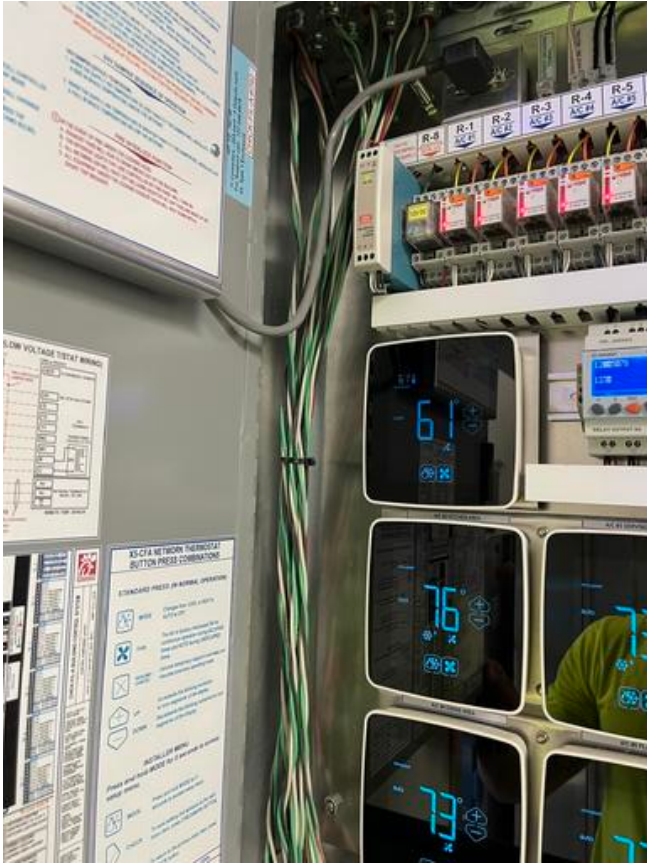
IMG_6095

#61 [CNTL 512] [NEW] SEC Line voltage cover.

SunCoast panel high voltage wiring cover needs to be installed.

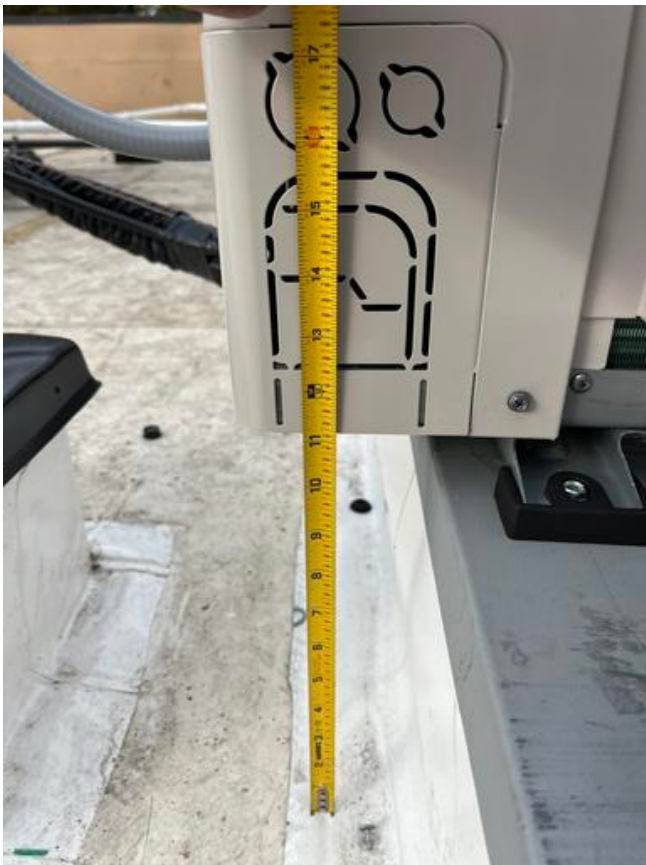
IMG_6111

#60 [UNIT 999] [NEW] (MISC) [MINI SPLIT CLEARANCE]

18" of clearance is required from bottom of support rack structural member to top of roof assembly. Currently there is 16" of clearance.
