Report: TAB Report
Function: Test, Adjust, & Balance
Date: 10/22/2025
Completed By: National TAB

PROJECT
10-20-25 QT #1427 MESA, AZ

Project: 10-20-25 QT #1427 MESA, AZ

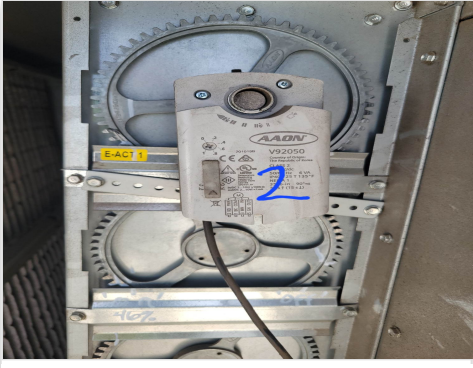
Test Data - PHOTO LOG

Test Data		
	Design	Actual
SF CFM	4200	4171
SF RPM	-	45 HZ
OA CFM (Hoods On)	800	839
OA CFM (Hoods Off)	350	330
RL Voltage	-	151.0
RL Amperage	-	7.4
VFD Max SetPt	-	75
VFD Min SetPt	-	24
OA Damper Position (Hoods On)	-	46.0
OA Damper Position (Hoods Off)	-	0.0
