Report: TAB Report
Function: Test, Adjust, & Balance
Date: 10/22/2025
Completed By: National TAB

PROJECT
10-20-25 QT #1427 MESA, AZ

Project: 10-20-25 QT #1427 MESA, AZ

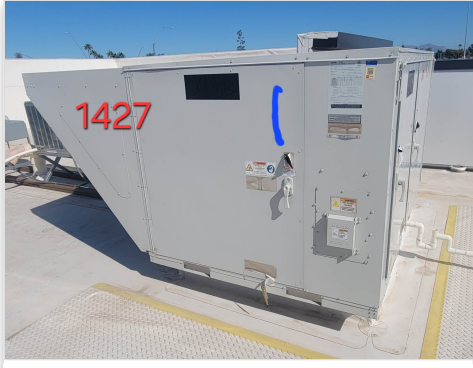
Unit Data - PHOTO LOG

Unit Data	
	Actual
MFG	AAON
Serial Num	202105-ANEK22146
Model Num	RN-013-8-0-EA0A-152
Num OA Filters 1	1
OA Filter Size 1	45X22
Num Final Filter 1	2
Final Filter Size 1	46X19.5X2

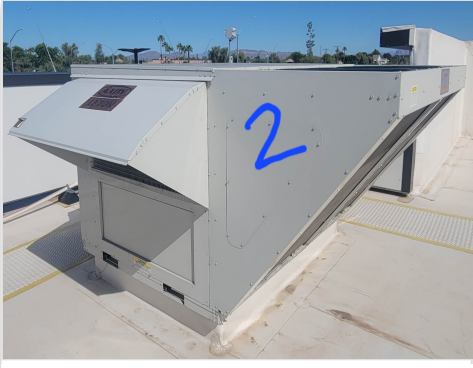
Unit Data - PHOTO LOG

Unit Data	
	Actual
MFG	AAON
Serial Num	202105-ANEK22147
Model Num	RN-013-8-2-EA0A-152
Num OA Filters 1	1
OA Filter Size 1	45X22
Num Final Filter 1	2
Final Filter Size 1	46X19.5X2

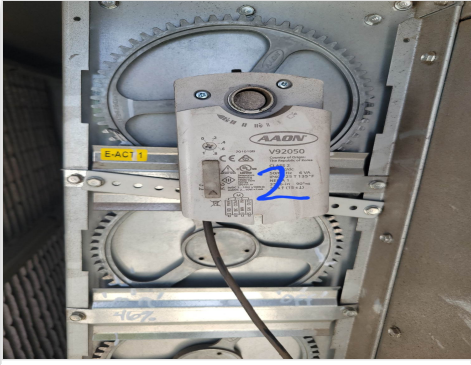
Test Data - PHOTO LOG

Test Data		
	Design	Actual
SF CFM	4200	4171
SF RPM	-	45 HZ
OA CFM (Hoods On)	800	839
OA CFM (Hoods Off)	350	330
RL Voltage	-	151.0
RL Amperage	-	7.4
VFD Max SetPt	-	75
VFD Min SetPt	-	24
OA Damper Position (Hoods On)	-	46.0
OA Damper Position (Hoods Off)	-	0.0

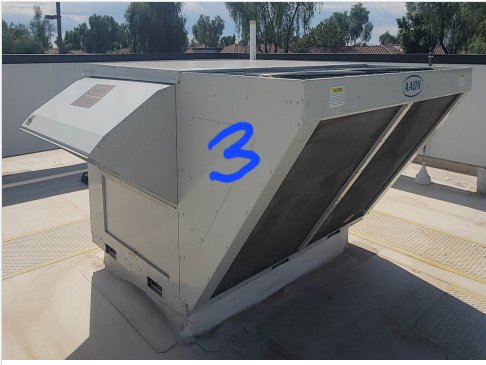
Unit Data - PHOTO LOG

Unit Data	
	Actual
MFG	AAON
Serial Num	202105-ANEK22148
Model Num	RN-013-8-0-EA0A-152
Num OA Filters 1	1
OA Filter Size 1	45X22
Num Final Filter 1	2
Final Filter Size 1	46X19.5X2

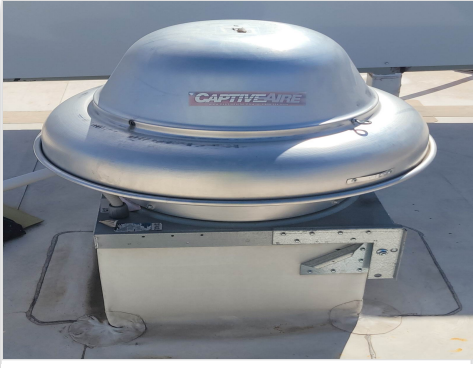
Unit Data - PHOTO LOG

Issue Name : EF1 RUNNING TOO HIGH
Description : EF1 (small exhaust) is running too high. Even on lowest setting, running about twice as high as it should. Current draw measured at 8.02A, which is almost FLA. Should not be that high on low. Recommend checking speed controller wiring.
Created By : National TAB **Assigned To :** National TAB - Dan Hertenstein
Status : Closed
Priority : Low **Asset Tag :** EF1
Originated Date : 10/25/2025 - Christine Weale - National TAB

Test Data		
	Design	Actual
CFM	750	1613 [1]
Fan RPM	-	DD
Fan Rotation	-	CCW
Motor RPM	-	DD
System SetPt	-	LOW
RL Voltage	-	N/A
RL Amperage	-	8.02
Total ESP	-	0.44"
Fan Inlet SP	-	-0.44"
Fan Discharge SP	-	ATMS

Notes:
 [1] SPEED CONTROLLER MINIMIZED, SEE ISSUE; UNABLE TO RESUCE AIRFLOW.

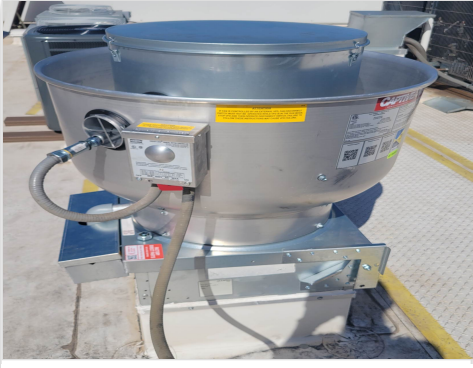
Unit Data - PHOTO LOG

Unit Data		
	Design	Actual
MFG	NA	CAPTIVEAIRE
Model Num	NA	DU50HFA
Serial Num	-	7632211
Type	UPBLAST	UPBLAST
Configuration	VERTICAL	VERTICAL
