Report: TAB

Function: Test, Adjust, & Balance

Date: 08/06/2025

**08-04-25 CHIPOTLE #5495 GLOUCESTER,
MA**

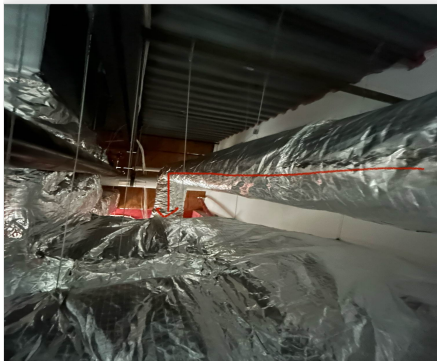
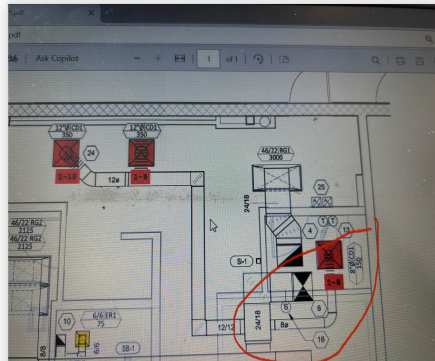
Issue Name : Miss damper in office
Description : Missing damper on manager office. (SGRD 1-8) Currently at 231% of design 150 CFM., which is stealing air from the last 2 diffusers. Unit is at total flow.
Created By : National TAB **Assigned To :** National TAB - Dan Hertenstein
Status : Open
Priority : Medium **Asset Tag :** SGRD8
Originated Date : 08/06/2025 - Jearod Ferrette - National TAB

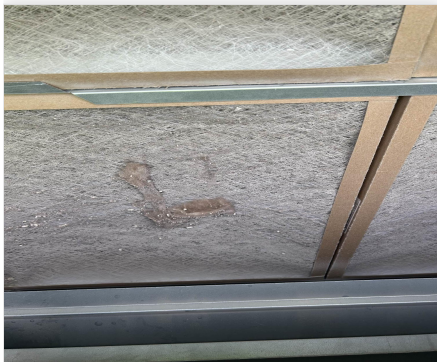
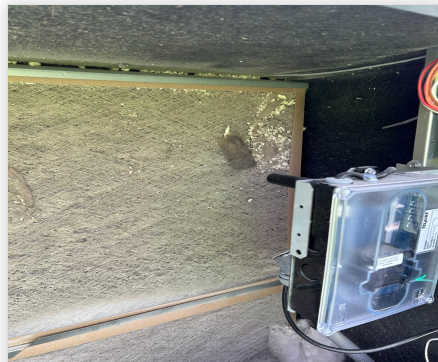
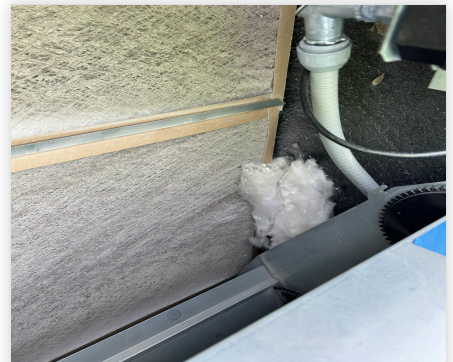
Issue Name : RTU 1 dirty final filters
Description : Dirty final filters
Created By : National TAB **Assigned To :** National TAB - Dan Hertenstein
Status : Open
Priority : Low **Asset Tag :** RTU1
Originated Date : 08/06/2025 - Jearod Ferrette - National TAB

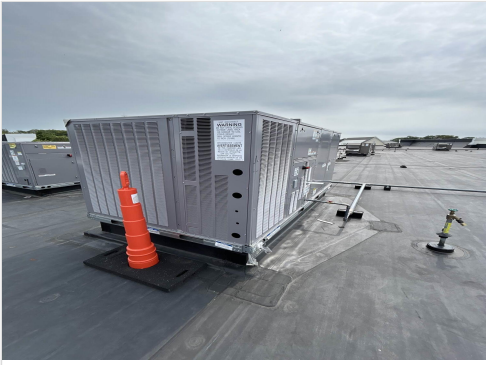
Unit Data - PHOTO LOG

Asset: RTU2

Unit Data		
	Design	Actual
MFG	CARRIER	CARRIER
Serial Num	-	0425P02365
Model Num	48FE_M09	48FE_M09
Type	RTU	RTU
Configuration	VERTICAL	VERTICAL
Num OA Filters 1	-	2
OA Filter Size 1	-	22.5X25.5
Num Final Filter 1	-	6
Final Filter Size 1	-	18X24X2

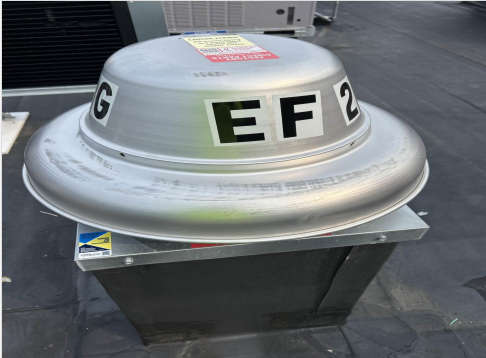
Unit Data - PHOTO LOG

Asset: EF2

Unit Data		
	Design	Actual
MFG	CAPTIVEAIRE	CAPTIVEAIRE
Model Num	DR12HFA	DR12HFA
Serial Num	-	7310033
Type	DOWNBLAST	DOWNBLAST
Configuration	VERTICAL	VERTICAL

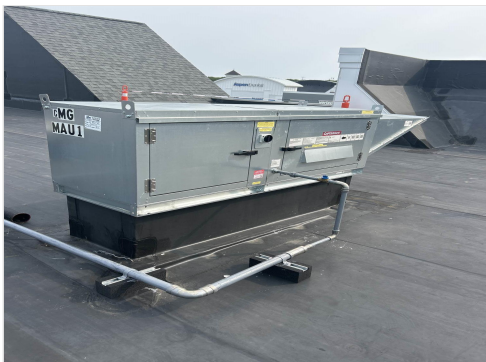
Unit Data - PHOTO LOG

Asset: MUA1

Unit Data		
	Design	Actual
MFG	CAPTIVEAIRE	CAPTIVEAIRE
Model Num	A1--D250-15D	A1--D250-15D
Serial Num	-	7310033
Type	MUA	MUA
Configuration	VERTICAL	VERTICAL

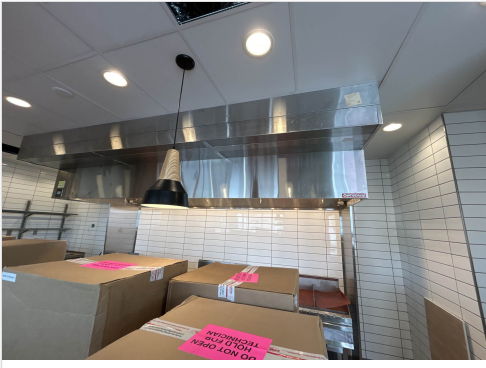
Unit Data - PHOTO LOG

Asset: HD1

Unit Data		
	Design	Actual
MFG	CAPTIVEAIRE	CAPTIVEAIRE
Model Num	5424 ND-2-ACPSP-F	5424 ND-2-ACPSP-F
Job / Serial Num	-	7310033
Type	TYPE I - CANOPY	TYPE I - CANOPY
Hood length	165"	165"
Hood Width	54"	54"
Supply Plenum Type	-	ACPSP
Supply Plenum Width	9"	9"
Supply Plenum Length	165"	165"
