**Report: TAB**

**Function: Test, Adjust, & Balance**

**08-04-25 CHIPOTLE #5495 GLOUCESTER,  
MA**

Chipotle Mexican Grill  
610 Newport Center Drive, Suite 1100  
Newport Beach, CA 92660

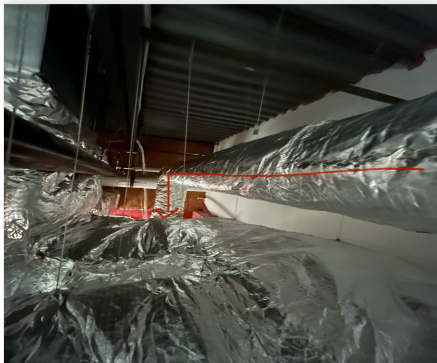
**Issue Name :** Office diffuser damper not installed  
**Description :** Total airflow is at design for the kitchen unit but the damper for the office diffuser is missing so airflow is high to that diffuser as a result (SGRD 1-8). Damper needs to be installed and closed about halfway.  
**Created By :** National TAB                      **Assigned To :** National TAB - Dan Hertenstein  
**Status :** Open  
**Priority :** Medium                                      **Asset Tag :** SGRD8  
**Originated Date :** 08/06/2025 - Jearod Ferrette - National TAB

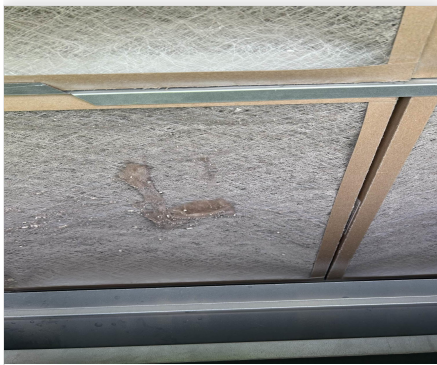
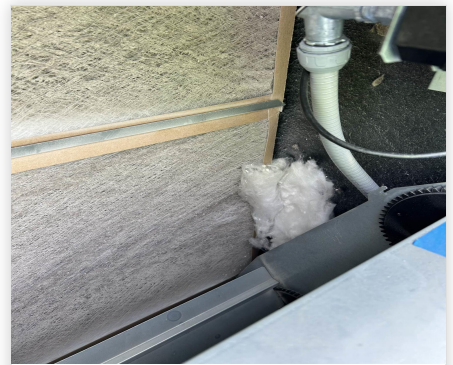
**Issue Name :** RTU 1 dirty final filters  
**Description :** Temporary construction filters are installed and are dirty. Final pleated filters need to be installed.  
**Created By :** National TAB                      **Assigned To :** National TAB - Dan Hertenstein  
**Status :** Open  
**Priority :** Low                                      **Asset Tag :** RTU1  
**Originated Date :** 08/06/2025 - Jearod Ferrette - National TAB

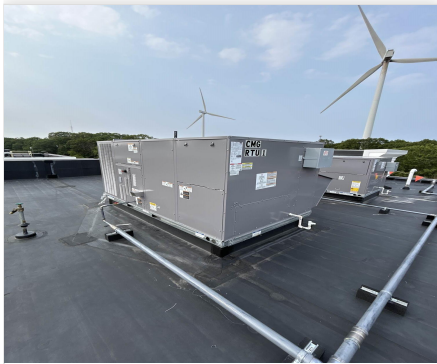
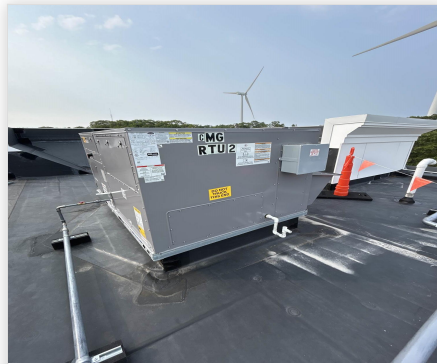
**Issue Name :** RTU labeled incorrectly  
**Description :** RTUs are labeled incorrectly, RTU 1 and RTU 2 numbers need to switch.  
**Created By :** National TAB                      **Assigned To :** National TAB - Dan Hertenstein  
**Status :** Open  
**Priority :** InfoOnly                                      **Asset Tag :**  
**Originated Date :** 08/06/2025 - Jearod Ferrette - National TAB

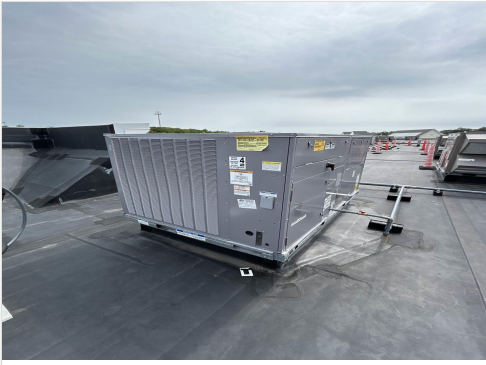
## Unit Data - PHOTO LOG

Asset: RTU1

Unit Data		
	Design	Actual
MFG	CARRIER	CARRIER
Serial Num	-	0225P70263
Model Num	48FE_M12	48FE_M12
Type	RTU	RTU
Configuration	VERTICAL	VERTICAL
Num OA Filters 1	-	1
OA Filter Size 1	-	35X19.5
Num Final Filter 1	-	4
Final Filter Size 1	-	20X20X2

General		Actual
Fan Rotation Correct		YES
Unit Filters Clean		NO
Condensate Drain Installed		YES

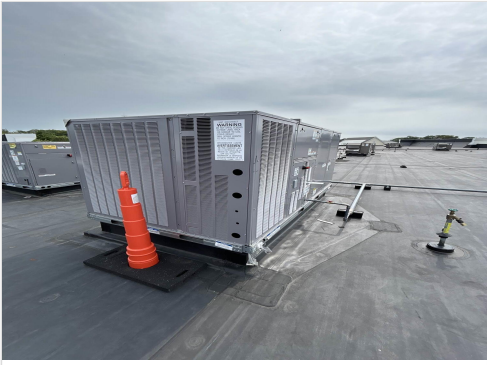
## Unit Data - PHOTO LOG

Asset: RTU2

Unit Data		
	Design	Actual
MFG	CARRIER	CARRIER
Serial Num	-	0425P02365
Model Num	48FE_M09	48FE_M09
Type	RTU	RTU
Configuration	VERTICAL	VERTICAL
Num OA Filters 1	-	2
OA Filter Size 1	-	22.5X25.5
Num Final Filter 1	-	6
Final Filter Size 1	-	18X24X2

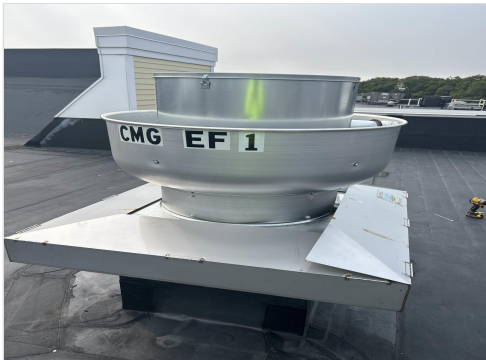
### Unit Data - PHOTO LOG

Asset: EF1

Unit Data		
	Design	Actual
MFG	CAPTIVEAIRE	CAPTIVEAIRE
Model Num	DU180HFA	DU180HFA
Serial Num	-	731003
Type	UPBLAST/CEILING	UPBLAST/CEILING
Configuration	VERTICAL	VERTICAL

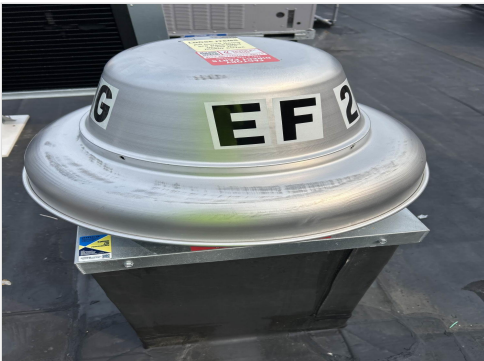
## Unit Data - PHOTO LOG

Asset: EF2

Unit Data		
	Design	Actual
MFG	CAPTIVEAIRE	CAPTIVEAIRE
Model Num	DR12HFA	DR12HFA
Serial Num	-	7310033
Type	DOWNBLAST	DOWNBLAST
Configuration	VERTICAL	VERTICAL

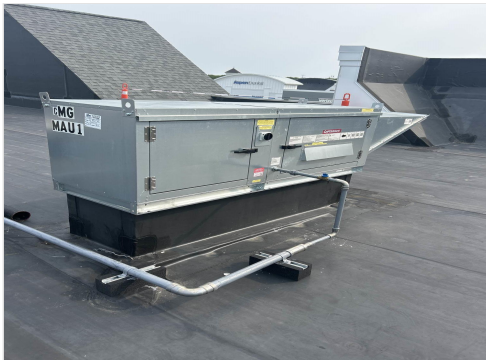
### Unit Data - PHOTO LOG

Asset: MUA1

Unit Data		
	Design	Actual
MFG	CAPTIVEAIRE	CAPTIVEAIRE
Model Num	A1--D250-15D	A1--D250-15D
Serial Num	-	7310033
Type	MUA	MUA
Configuration	VERTICAL	VERTICAL

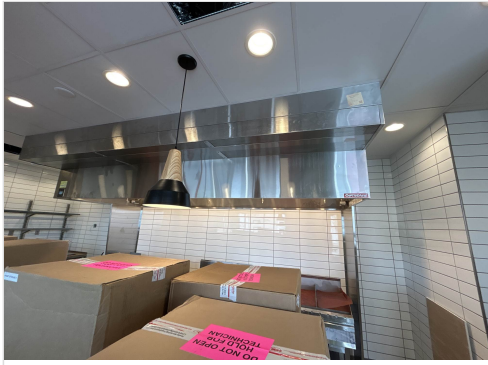
## Unit Data - PHOTO LOG

Asset: HD1

Unit Data		
	Design	Actual
MFG	CAPTIVEAIRE	CAPTIVEAIRE
Model Num	5424 ND-2-ACPSP-F	5424 ND-2-ACPSP-F
Job / Serial Num	-	7310033
Type	TYPE I - CANOPY	TYPE I - CANOPY
Hood length	165"	165"
Hood Width	54"	54"
Supply Plenum Type	-	ACPSP
Supply Plenum Width	9"	9"
Supply Plenum Length	165"	165"
