Report: TAB REPORT
Function: Test, Adjust, & Balance
Date: 01/19/2026
Completed By: National TAB

**01-19-26 WHATABURGER #1553 FRANKLIN,
TN**

Project: 01-19-26 WHATABURGER #1553 FRANKLIN, TN

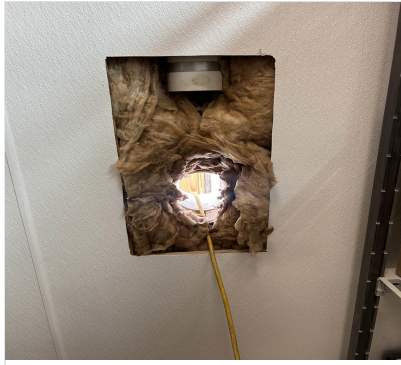
Is the building pressure at least +0.02"? If not, do you see any obvious areas of external building that aren't sealed?

THERE IS A HOLE IN THE WALL IN THE BACK OF THE BUILDING.

VARIABLES THAT EFFECTED BUILDING PRESSURE: HOLE IN THE WALL (PICTURE UPLOADED), 50% MISSING TILES, OPEN ROOFTOP FOR ROOFING CREW.

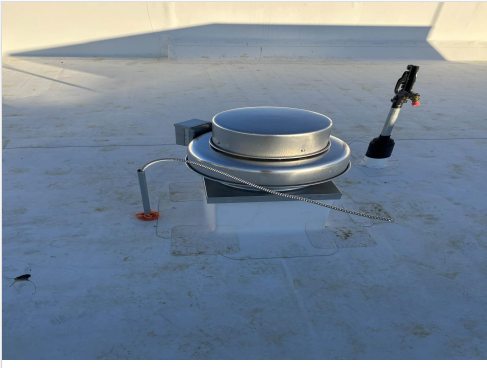
Unit Data - PHOTO LOG

Asset: EF1

Unit Data		
	Design	Actual
MFG	GREENHECK	GREENHECK
Model Num	G-080-VG	G-080-VG
Serial Num	-	k00250004
Type	DOWNBLAST	DOWNBLAST
Configuration	VERTICAL	VERTICAL
