Report: TAB REPORT
Function: Test, Adjust, & Balance
Date: 01/19/2026
Completed By: National TAB

**01-19-26 WHATABURGER #1553 FRANKLIN,
TN**

3075 MALLORY LANE

FRANKLIN, TN 37067

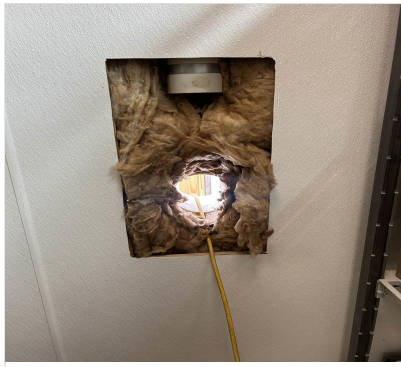
VARIABLES THAT EFFECTED BUILDING PRESSURE: HOLE IN THE WALL (PICTURE UPLOADED), 50% MISSING TILES, OPEN ROOFTOP FOR ROOFING CREW.

Is the building pressure at least +0.02"? If not, do you see any obvious areas of external building that aren't sealed?

Fail

THERE IS A HOLE IN THE WALL IN THE BACK OF THE BUILDING.

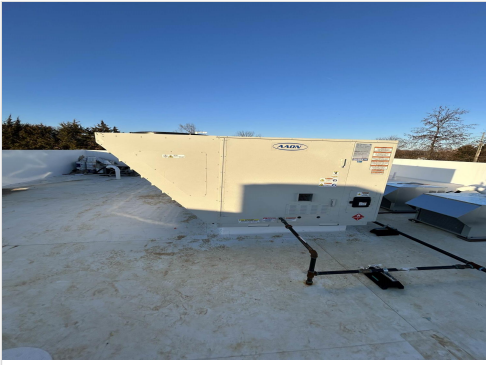
Unit Data - PHOTO LOG

Asset: RTU1

AREA: KITCHEN

Unit Data	
	Actual
MFG	AAON
Serial Num	202509-BNGP125438
Model Num	RNA-020-C-A-8-FAB04-CB1K0
Num OA Filters 1	18.5X24
OA Filter Size 1	3
Num Final Filter 1	6
Final Filter Size 1	20X25X2

Test Data		
	Design	Actual
SF CFM (Traverse)	-	3626
SF CFM	3850	3927
RA CFM (Traverse)	-	1497
RA CFM	1390	1433
OA CFM	2460	2494
RL Voltage	-	208
RL Amperage	-	5.5 / 6.6
SF System SetPt	-	46.9HZ
RA Damper Position	-	MANUAL ADJUSTMENT
Min OA Damper Position	-	MANUAL ADJUSTMEN
Min OA Damper Type	-	ECON

General	
	Actual
Unit free of Damage	YES
Fan Rotation Correct	YES
Unit Filters Clean	YES
Condensate Drain Installed	YES

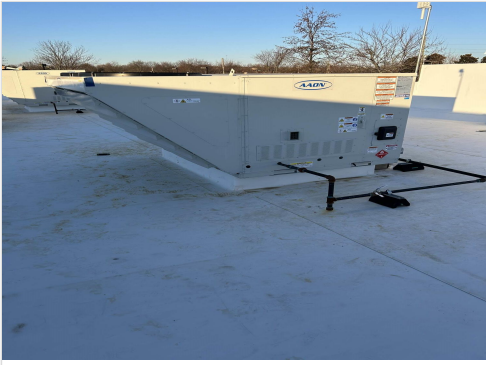
Unit Data - PHOTO LOG

Asset: RTU2

AREA:DINING

Unit Data	
	Actual
MFG	AAON
Serial Num	202509-ANGK125421
Model Num	RNA-013-B-A-8-FAB04-CB1K0
Num OA Filters 1	3
OA Filter Size 1	20X24.5
Num Final Filter 1	6
Final Filter Size 1	20X25X2

Test Data		
	Design	Actual
SF CFM (Traverse)	-	1942
SF CFM	2050	2052
RA CFM (Traverse)	-	526
RA CFM	500	549
OA CFM	1550	1503
RL Voltage	-	208
RL Amperage	-	2.6 / 2.2
SF System SetPt	-	44 HZ
RA Damper Position	-	MANUAL ADJUSTMENT
Min OA Damper Position	-	MANUAL ADJUSTMENT
Min OA Damper Type	-	ECON

General	
	Actual
Unit free of Damage	YES
Fan Rotation Correct	YES
Unit Filters Clean	YES
Condensate Drain Installed	YES

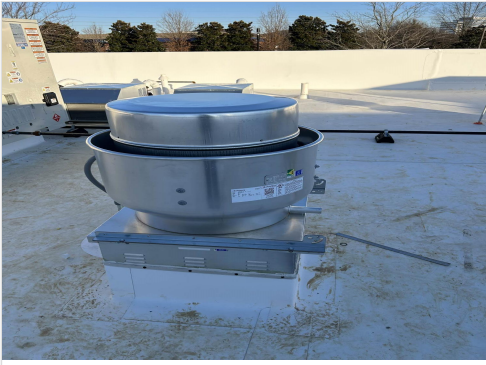
Unit Data - PHOTO LOG

Asset: KEF1

AREA:KITCHEN HD

Unit Data		
	Design	Actual
MFG	GREENHECK	GREENHECK
Model Num	CUE-140-VG	CUE-140-VG
Serial Num	-	27719716251
Type	UPBLAST	UPBLAST
Configuration	VERTICAL	VERTICAL

Test Data		
	Design	Actual
CFM	1994	2088
Fan Rotation	-	CCW
System SetPt	-	67%
RL Voltage	-	6.9
RL Amperage	-	5.25
Total ESP	1.00"	0.63"
Fan Inlet SP	-	-0.63"
Fan Discharge SP	-	ATM

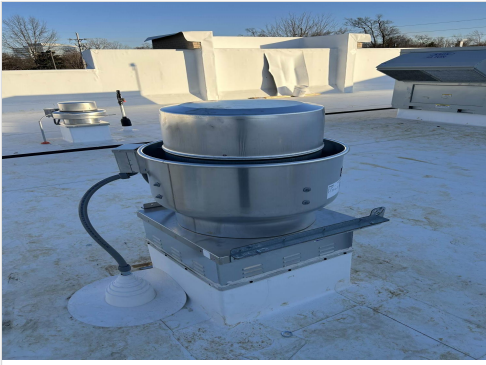
Unit Data - PHOTO LOG

Asset: KEF2

AREA:KITCHEN HD

Unit Data		
	Design	Actual
MFG	GREENHECK	GREENHECK
Model Num	CUE-120-VG	CUE-120-VG
Serial Num	-	27719717
Type	UPBLAST	UPBLAST
Configuration	VERTICAL	VERTICAL

Test Data		
	Design	Actual
CFM	1216	1110
Fan Rotation	-	CCW
System SetPt	-	67%
RL Voltage	-	7.5
RL Amperage	-	2.2
Total ESP	0.75"	0.34"
Fan Inlet SP	-	-0.34"
Fan Discharge SP	-	ATM

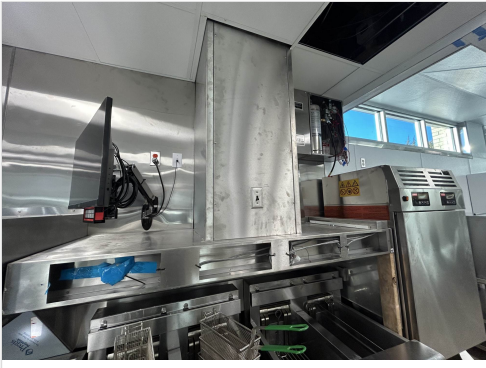
Unit Data - PHOTO LOG

Asset: HD1

AREA:KITCHEN

Unit Data		
	Design	Actual
MFG	H&K DALLAS INC	H&K DALLAS INC
Model Num	HKD0	HKD027
Job / Serial Num	-	8177783-001
Type	TYPE 1 CANOPY	TYPE 1 CANOPY
Hood length	86.78"	87"
Hood Width	55.63"	55"

Test Data Exhaust		
	Design	Actual
Filter Type	FLAMGUARD	FLAMGUARD
Filter Size 1	12X20	12X20
Filter Qty 1	8	8
Filter AK factor size 1	1.5	1.7
Filter Total AK Area	12.0	13.3
Filter1 FPM	-	138
Filter2 FPM	-	147
Filter3 FPM	-	152
Filter4 FPM	-	166
Filter5 FPM	-	171
Filter6 FPM	-	182
Filter7 FPM	-	141
Filter8 FPM	-	158
Filter Ave FPM(corr)	-	157
CFM	1994	2088

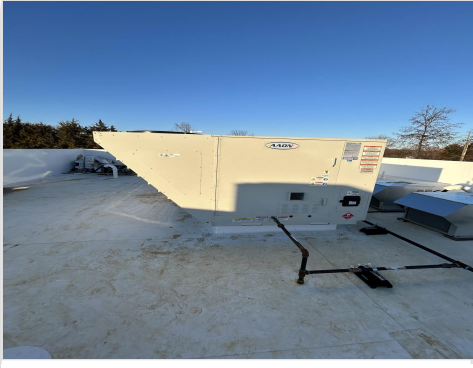
Unit Data - PHOTO LOG

Asset: RTU1

AREA:KITCHEN

Unit Data	
	Actual
MFG	AAON
Serial Num	202509-BNGP125438
Model Num	RNA-020-C-A-8-FAB04-CB1K0
Num OA Filters 1	18.5X24
OA Filter Size 1	3
Num Final Filter 1	6
Final Filter Size 1	20X25X2

Test Data		
	Design	Actual
SF CFM (Traverse)	-	3626
SF CFM	3850	3927
RA CFM (Traverse)	-	1497
RA CFM	1390	1433
OA CFM	2460	2494
RL Voltage	-	208
RL Amperage	-	5.5 / 6.6
SF System SetPt	-	46.9HZ
RA Damper Position	-	MANUAL ADJUSTMENT
Min OA Damper Position	-	MANUAL ADJUSTMEN
Min OA Damper Type	-	ECON

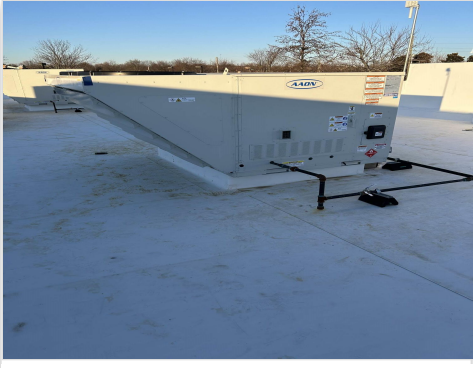
Unit Data - PHOTO LOG

Asset: RTU2

AREA: DINING

Unit Data	
	Actual
MFG	AAON
Serial Num	202509-ANGK125421
Model Num	RNA-013-B-A-8-FAB04-CB1K0
Num OA Filters 1	3
OA Filter Size 1	20X24.5
Num Final Filter 1	6
Final Filter Size 1	20X25X2

Test Data		
	Design	Actual
SF CFM (Traverse)	-	1942
SF CFM	2050	2052
RA CFM (Traverse)	-	526
RA CFM	500	549
OA CFM	1550	1503
RL Voltage	-	208
RL Amperage	-	2.6 / 2.2
SF System SetPt	-	44 HZ
RA Damper Position	-	MANUAL ADJUSTMENT
Min OA Damper Position	-	MANUAL ADJUSTMENT
Min OA Damper Type	-	ECON

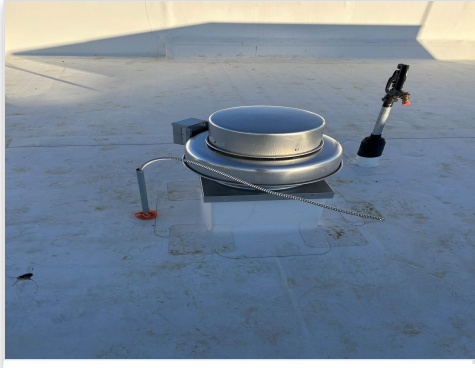
Unit Data - PHOTO LOG

Asset: EF1

AREA:RESTROOM

Unit Data		
	Design	Actual
MFG	GREENHECK	GREENHECK
Model Num	G-080-VG	G-080-VG
Serial Num	-	k00250004
Type	DOWNBLAST	DOWNBLAST
Configuration	VERTICAL	VERTICAL

Test Data		
	Design	Actual
CFM	300	325
Fan RPM	1680	
Fan Rotation	-	CCW
System SetPt	-	60%
RL Voltage	-	9
RL Amperage	-	0,78
Total ESP	0.50"	0.17"
Fan Inlet SP	-	-0.17"
Fan Discharge SP	-	ATM

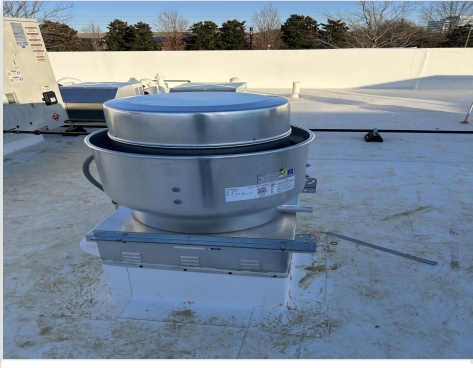
Unit Data - PHOTO LOG

Asset: KEF1

AREA: KITCHEN HD

Unit Data		
	Design	Actual
MFG	GREENHECK	GREENHECK
Model Num	CUE-140-VG	CUE-140-VG
Serial Num	-	27719716251
Type	UPBLAST	UPBLAST
Configuration	VERTICAL	VERTICAL

Test Data		
	Design	Actual
CFM	1994	2088
Fan Rotation	-	CCW
System SetPt	-	67%
RL Voltage	-	6.9
RL Amperage	-	5.25
Total ESP	1.00"	0.63"
Fan Inlet SP	-	-0.63"
Fan Discharge SP	-	ATM
