Pre-Evaluation Report Prior to PreDesign Phase

KROGER #435

808 N. 12TH ST.

MURRAY, KY 42071

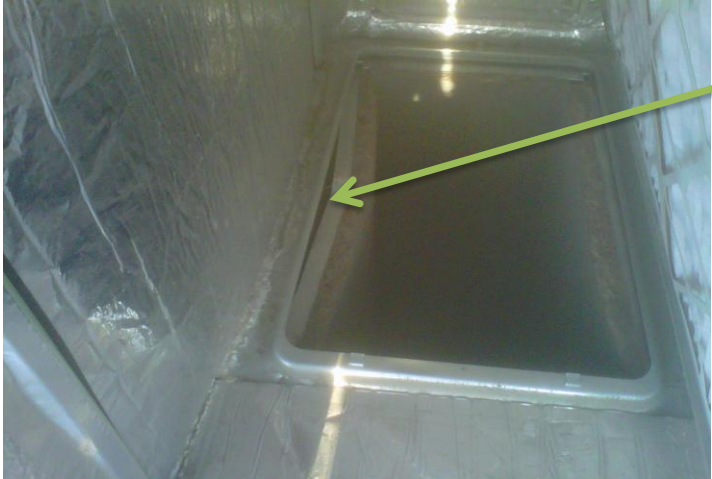
435 rtu-4 return pulled away from unit. rrecommend getting this fixed during remodel

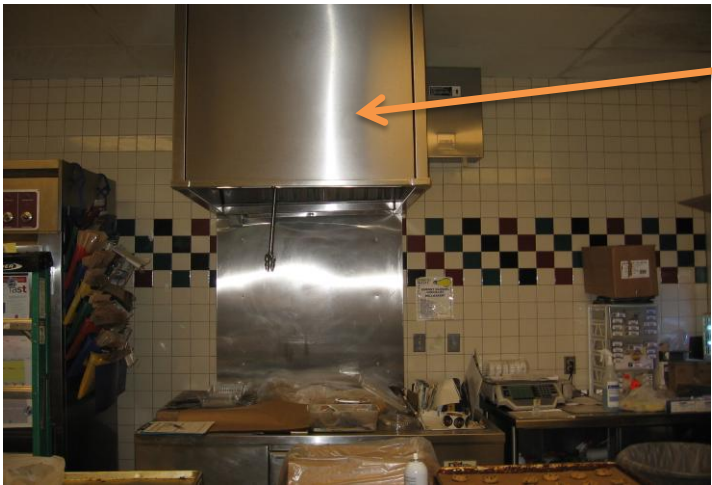
bakery area non operational hood - EMPLOYEES DO NO USE IT - could be eliminated if KROGER has no need for it.

HOOD # 3	FIELD NOTES
SIZE OF HOOD (L x W)	42" x 48"
LOCATION OF HOOD (IE- FRONT CHARBROILER DISPLAY HD)	BY BAKERY OVEN, HOOD NOT BEING USED. DUCT TAPE OVER LIGHT SOCKET.
IS HOOD EXHAUST ONLY OR EXHAUST WITH MU-AIR?	NO MUA
IF HOOD HAS MUA AIR - IS AIR COMING OUT OF PLENUM OR IS IT CLOGGED WITH DIRT?	N/A
ANY MISSING FILTERS (QTY/SIZE):	2 - 24" x 16"
ANY EVIDENCE OF GREASE ACCUMILATION IN OR AROUND HOOD?

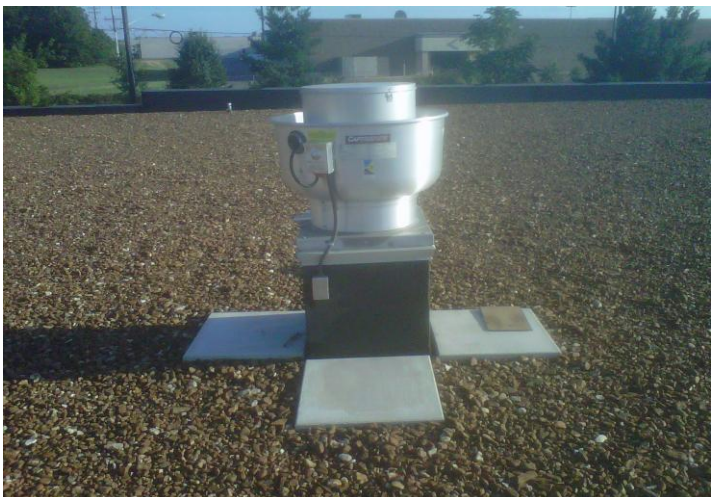
Bakery oven hood

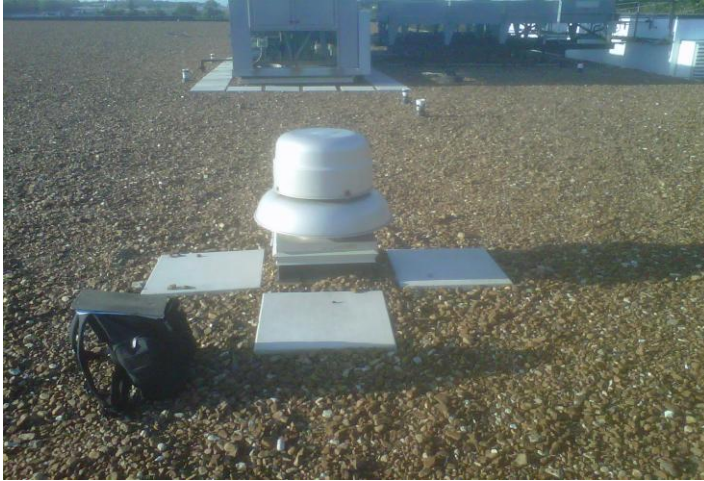
fan not in use over by bakery -
Could be Capped if not used.

ADDITIONAL NOTES (OVERALL DEFFICIENCY OR CONDITION OF FAN-DESCRIBE):
FAN NOT RUNNING

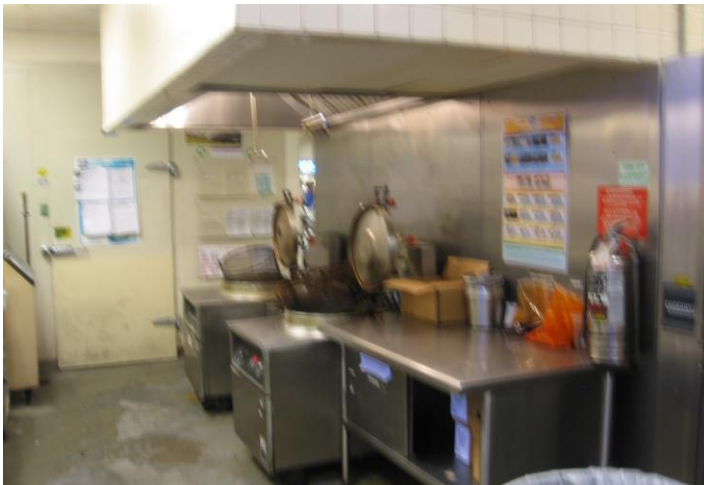
Fryer hood

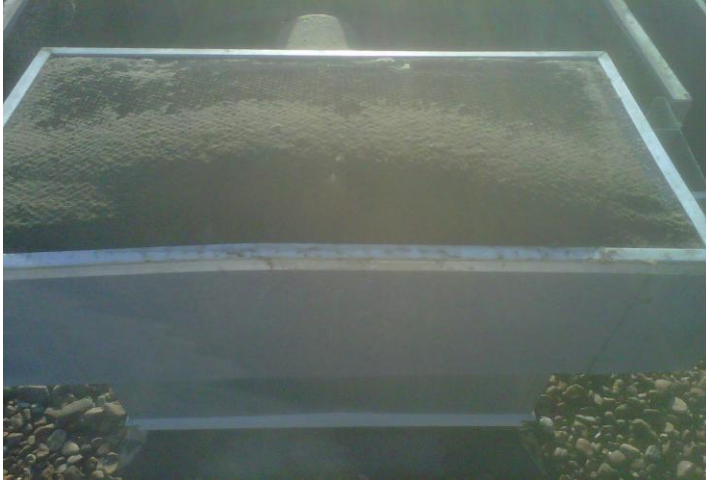
mua filters dirty

MUA Unit Heated OR Non-Heated?	NON-HEATED
Size & # of filters in Unit?	4 - 28X16
Are the filters clean?	FILTHY
Is the electrical Whip frayed?	NO
Any excessive noise?	MUA NOT RUNNING
Fan belt in good condition?	FAIR BELT SIZE A-45

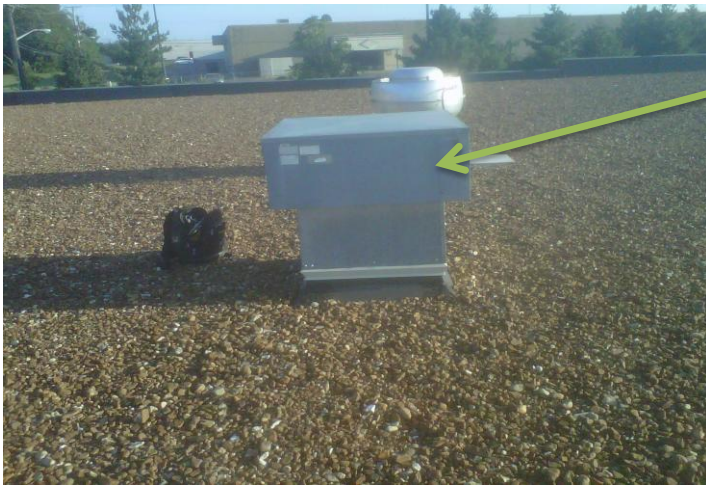
**mua suppls fryers and stove
oven unit not running - fix if
plan on using existing system.**

ADDITIONAL NOTES/COMMENTS: UNIT TURNED ON AT ROOF BUT NOT RUNNING, NO POWER AT ROOF, 1 FUSE BLOWN. IF GOING TO BE REUSED AFTER REMODEL, SUGGEST TO HAVE HVAC CONTRACTOR FIX DURING RENOVATION PHASE

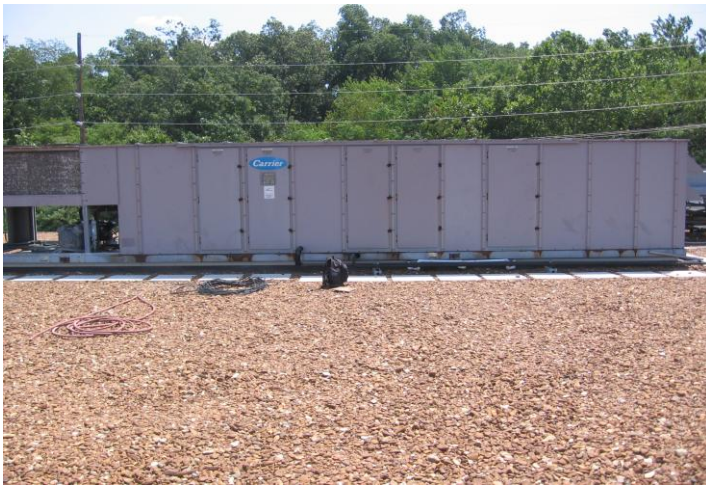
rtu-1 and rtu-2

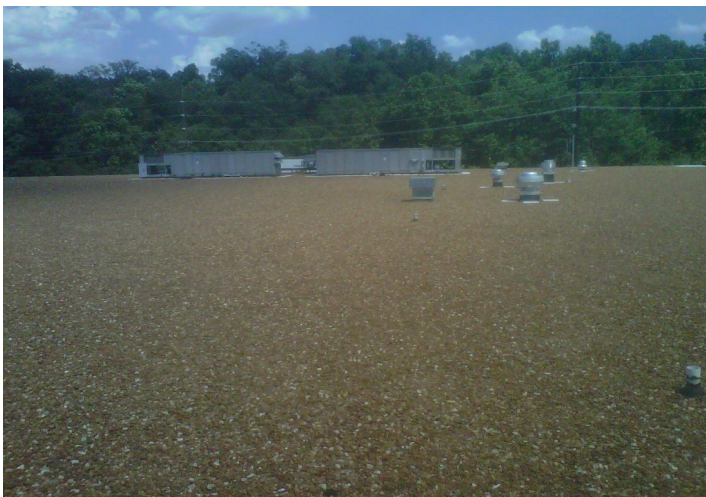
rtu-1 on left, rtu-2 on right

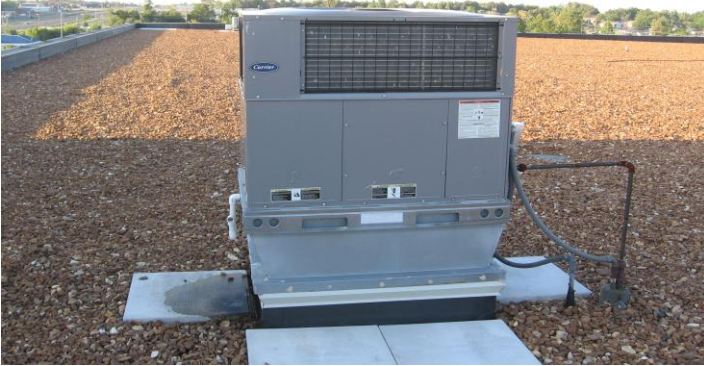
rtu-3 customer service

No outside air intake or hood. If requires outside air for remodel; it will require unit to have HVAC contractor to install a manual intake hood with manual outside air slide damper. See Pictures in summary

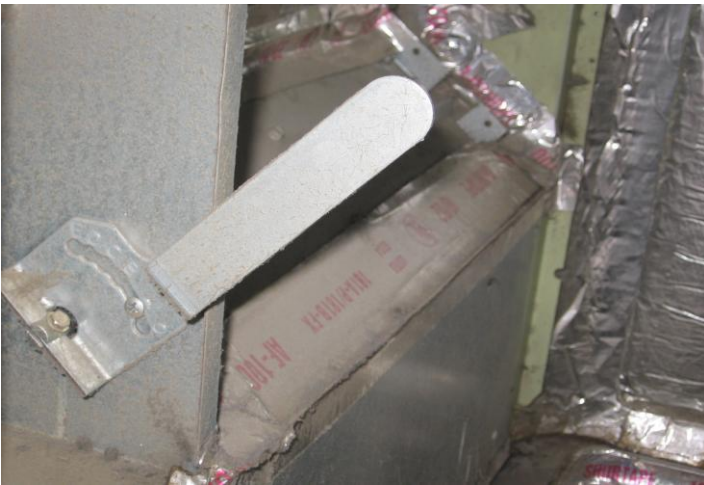
rtu-5 pharmacy outside air

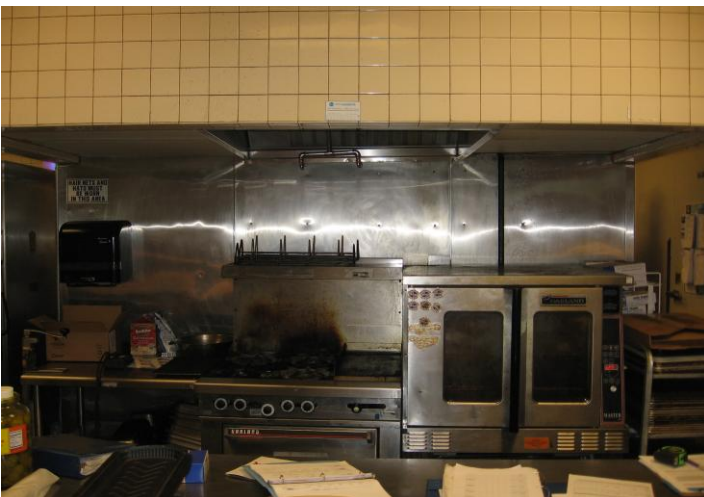
stove and oven hood

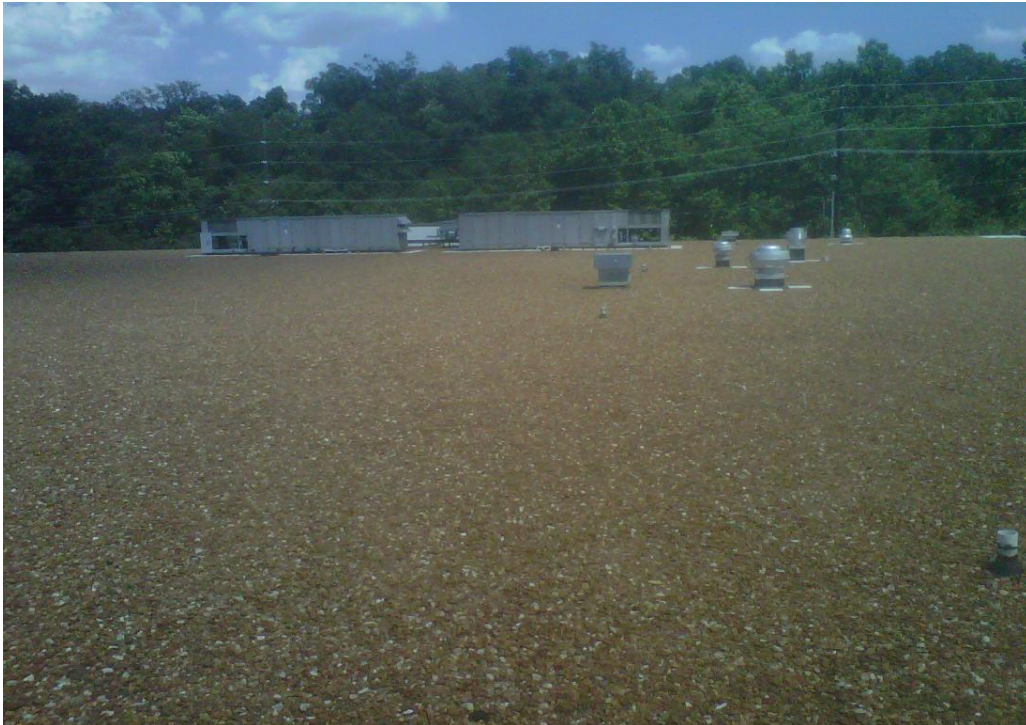
Looked real good, coils had some dirt but overall not bad.

2) Draw an elevation diagram of unit arrangement below showing main system components on diagram, main duct size coming off unit, where outside air is supplied and size.

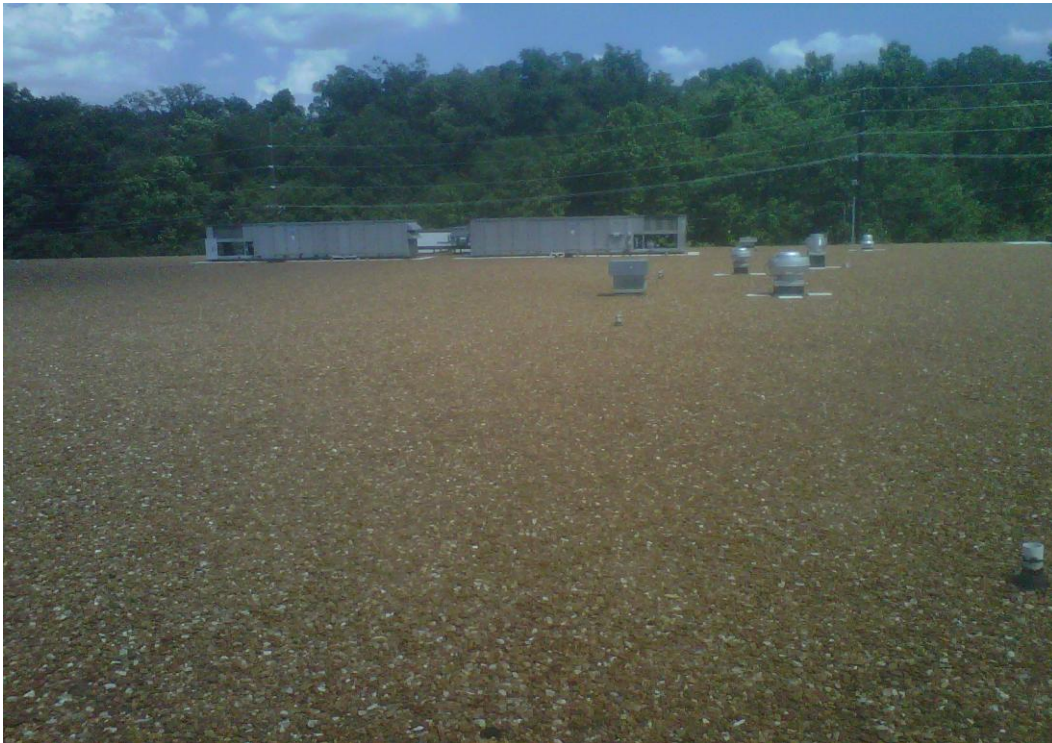
No issues, everything was running great. Bearings greased, filters new, motor running under full load.

2) Draw an elevation diagram of unit arrangement below showing main system components on diagram, main duct size coming off unit, where outside air is supplied and size.
