Report: TAB REPORT
Function: Test, Adjust, & Balance
Date: 09/10/2025
Completed By: National TAB

PROJECT
09-08-25 WAWA #6110 WILSON, NC

1600 FOREST HILLS ROAD

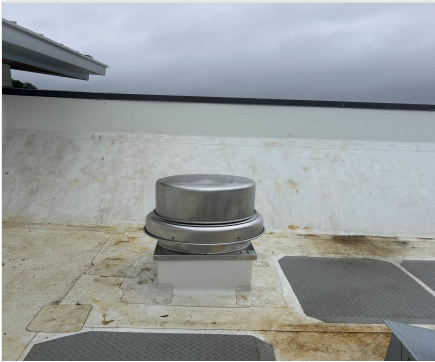
Issue Name : EF 1 low flow
Description : EF 1 currently at 88% of design, pulley at max turns in.
Created By : National TAB **Assigned To :** National TAB - Brianna Biggs
Status : Open
Priority : Low **Asset Tag :** EF1
Originated Date : 09/10/2025 - Jearod Ferrette - National TAB

EF1 currently at 88% of design pulled at max turns in.

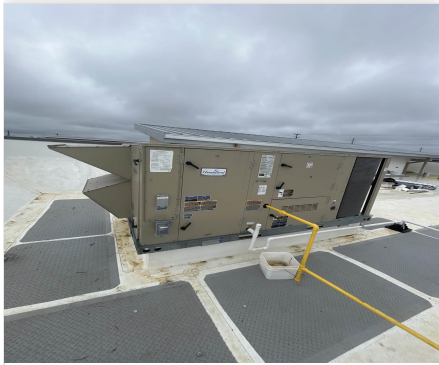
Issue Name : Heating mode not operational
Description : Heating mode not operational unable to perform test
Created By : National TAB **Assigned To :** National TAB - Brianna Biggs
Status : Open
Priority : Low **Asset Tag :** RTU2
Originated Date : 09/10/2025 - Jearod Ferrette - National TAB

RTU2- NOT OPERATIONAL RTU3- EAT: 92 LAT: 69

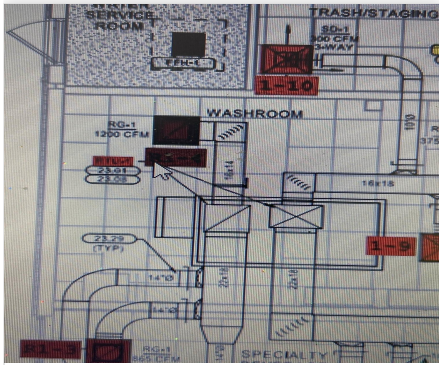
Issue Name : Vibrating noise on return
Description : RTU1 KITCHEN RETURN #4 HAS A VIBRATING NOISE
Created By : National TAB **Assigned To :** National TAB - Brianna Biggs
Status : Open
Priority : Low **Asset Tag :** RTU1
Originated Date : 09/10/2025 - Jearod Ferrette - National TAB

RTU1 KITCHEN RETURN #4 HAS A VIBRATING NOISE

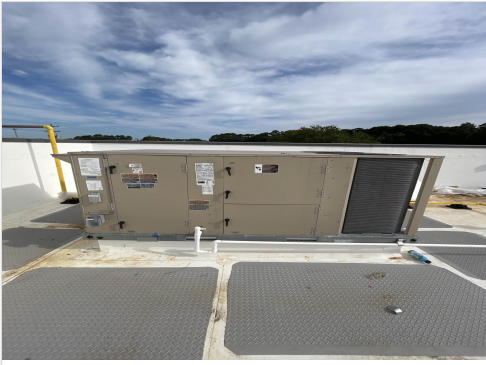
Asset: RTU1

Unit Data		
	Design	Actual
MFG	LENNOX	LENNOX
Serial Num	-	5625D02814
Model Num	LCT150H5E	LCT150H5E
Type	RTU	RTU
Configuration	VERTICAL	VERTICAL
Num OA Filters 1	-	2
OA Filter Size 1	-	14X24
Num Final Filter 1	-	4
Final Filter Size 1	-	20X25X2

Test Data		
	Design	Actual
SF CFM	4500	4624
SF RPM	-	DD/ 80%
MOTOR RPM	-	DD/ 80%
RA CFM	3800	3930
OA CFM	700	694
RL Voltage	-	210/209/209
RL Amperage	-	5.2/5.4/5.3
SF System SetPt	-	80%
RA Damper Position	-	74%
OA Damper Position	-	26%
OA Damper Type	-	ECON

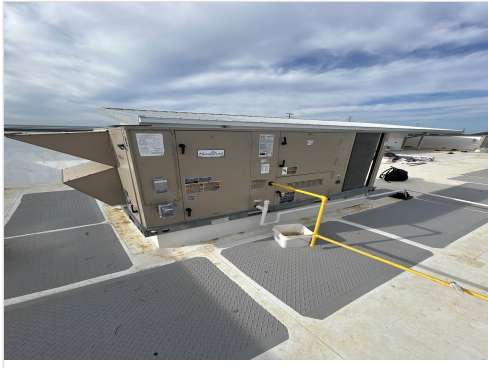
Asset: RTU2

Unit Data		
	Design	Actual
MFG	LENNOX	LENNOX
Serial Num	-	5625D02331
Model Num	LGT102H5E	LGT102H5E
Type	RTU	RTU
Configuration	VERTICAL	VERTICAL
Num OA Filters 1	-	2
OA Filter Size 1	-	14X24
Num Final Filter 1	-	4
Final Filter Size 1	-	20X25X2

Test Data		
	Design	Actual
SF CFM	3400	3413
SF RPM	-	DD/ 58%
MOTOR RPM	-	DD/ 58%
RA CFM	3020	3022
OA CFM	380	391
RL Voltage	-	209/210/210
RL Amperage	-	4.9/5/4.9
SF System SetPt	-	58%
RA Damper Position	-	73%
OA Damper Position	-	27%
OA Damper Type	-	ECON

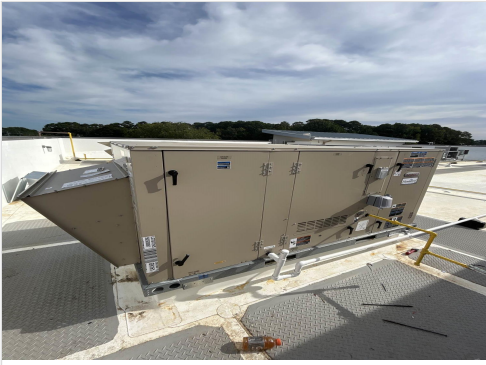
Asset: RTU3

Unit Data		
	Design	Actual
MFG	LENNOX	LENNOX
Serial Num	-	5625E00867
Model Num	LGT072H5E	LGT072H5E
Type	RTU	RTU
Configuration	VERTICAL	VERTICAL
Num OA Filters 1	-	1
OA Filter Size 1	-	14X28
Num Final Filter 1	-	4
Final Filter Size 1	-	20X20X2

Test Data		
	Design	Actual
SF CFM	2400	2575
SF RPM	-	DD/ 83%
MOTOR RPM	-	DD/ 83%
RA CFM	2200	2372
OA CFM	200	203
RL Voltage	-	210/210/209
RL Amperage	-	5.3/5.1/5.3
SF System SetPt	-	83%
RA Damper Position	-	74%
OA Damper Position	-	26%
OA Damper Type	-	ECON

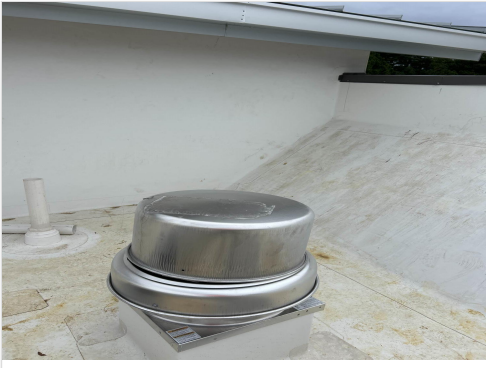
Asset: EF1

Unit Data		
	Design	Actual
MFG	GREENHECK	GREENHECK
Model Num	GB-098-6	GB-098-6
Serial Num	-	27071967
Type	DOWNBLAST	DOWNBLAST
Configuration	VERTICAL	VERTICAL

Test Data		
	Design	Actual
CFM	375	333
Fan RPM	-	1425
Fan Rotation	-	CW
Motor RPM	-	1709
System SetPt	-	MAX TURNS IN
RL Voltage	-	120
Total ESP	0.38"	0.33"
Fan Inlet SP	-	0.33"
Fan Discharge SP	-	ATMO

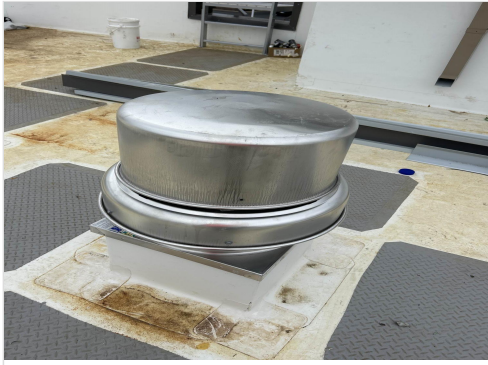
Asset: EF2

Unit Data		
	Design	Actual
MFG	GREENHECK	GREENHECK
Model Num	GB-098-6	GB-098-6
Serial Num	-	27071968
Type	DOWNBLAST	DOWNBLAST
Configuration	VERTICAL	VERTICAL

Test Data		
	Design	Actual
CFM	400	417
Fan RPM	-	1117
Fan Rotation	-	CW
Motor RPM	-	1762
System SetPt	-	3 TURNS OUT
RL Voltage	-	119
Total ESP	0.38"	0.18"
Fan Inlet SP	-	0.18"
Fan Discharge SP	-	ATMO

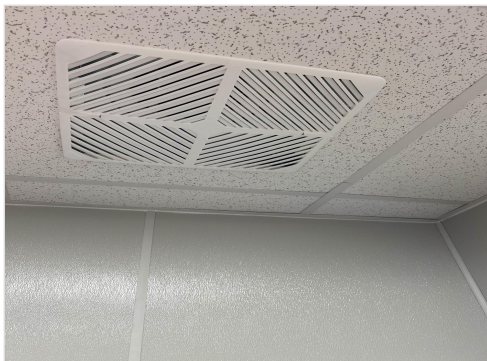
Asset: EF3

Unit Data		
	Design	Actual
MFG	GREENHECK	GREENHECK
Model Num	SP-B200	SP-B200
Serial Num	-	197302958-0052
Type	CEILING	CEILING
Configuration	VERTICAL	VERTICAL

Test Data		
	Design	Actual
CFM	200	215
Fan RPM	-	DD
System SetPt	-	HIGH
RL Voltage	-	119
Total ESP	0.50"	0.42"
Fan Inlet SP	-	0.42"
Fan Discharge SP	-	ATMO
