Report: Test and Balance
Date: 10/7/2020

PROJECT
FREDDY'S - SAPPINGTON (ST LOUIS, MO)

5479 SOUTHFIELD CENTER
ST. LOUIS, MO

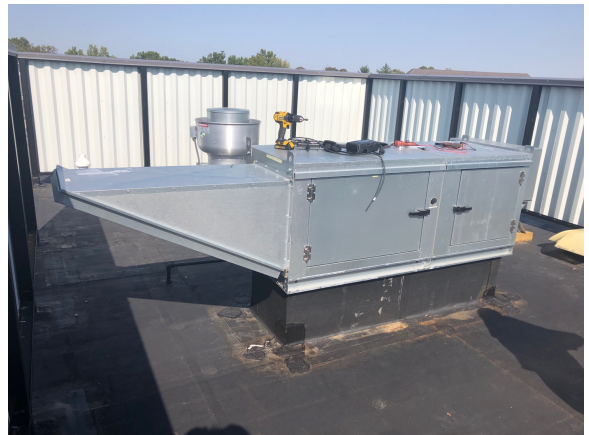
MAU

Rotation is correct?	NO - ELECTRICAL FIXED
Gas piping is installed and valves are in on position?	YES
Heater tested and is functional?	YES
Internal motorized damper is fully opening?	YES
Motor is operating below the FLA rating?	YES
Unit free of noticeable noise and vibration?	YES
HOODS	
Kitchen equipment installed in proper places?	YES
Can kitchen equipment be turned on for final smoke test?	NO, COOKING EQUIPMENT HAS NOT BEEN STARTED
Griddle is completely centered underneath hood?	YES
PSPs	
Are the dampers tightened down? (Round collars with a wingnut, not the rectangular dampers with the allen adjustment.)	YES
DOCUMENTATION	
Have trades/general contractor been notified about any issues and are they created on FaciliBuild?	YES
PICTURES TAKEN OF:	
All Issues	YES
Each Piece of equipment	YES
Each Hood	YES
Front of Store	YES

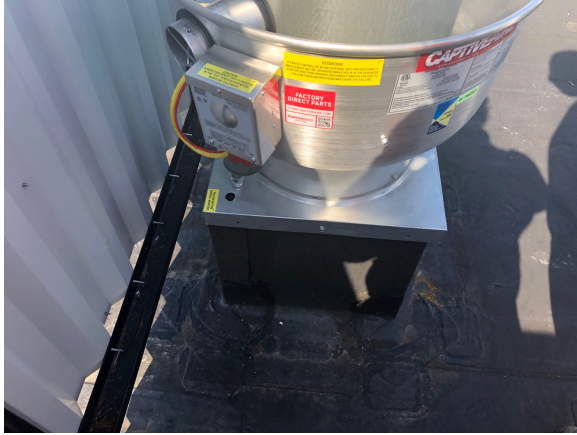
KEF3 Hole In Curb

PRIORITY (HIGH/LOW/INFO ONLY)	
HIGH	RTU1, RTU2, RTU3 do not have a wire run from thermostats to OCP terminal at units. Installed a temporary jumper so that balancing of the OA could be completed. But this wire needs to be run in order to ensure that the OA dampers close while the restaurant is unoccupied and open during occupied hours.
HIGH	KEF3 has a small hole at base of the fan that goes into unit curb. This penetration needs to be sealed to prevent water or debris from entering duct. See pictures

Notes: [1] Unit has hole that goes into unit curb, see pictures

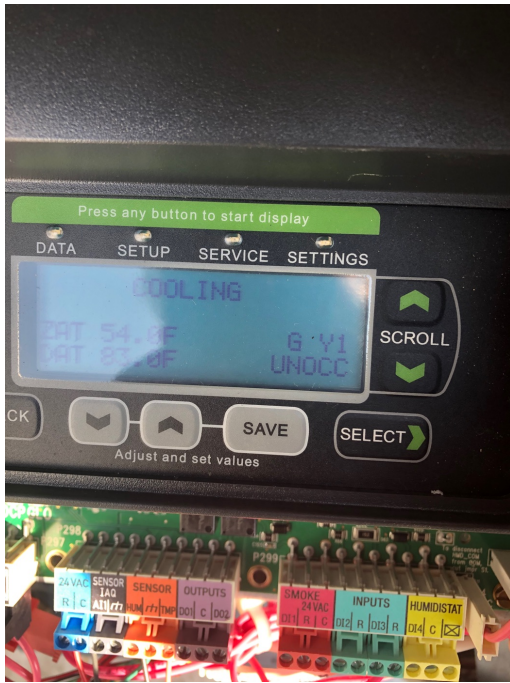
Typ. RTU OCP

- Notes: [1] Motor sticker not accessible, motor data taken from unit sticker.
 [2] Motor set to 72% speed
 [3] OCP not connected. Installed temporary jumper to balance the OA.

Notes: [1] OCP not connected, bypassed OA dampers open to ensure balance.
 [2] OCP not connected. Installed temporary jumper to balance the OA.

Notes: [1] OCP not connected. Installed temporary jumper to balance the OA.
