**Report: TAB Report**  
**Function: Test, Adjust, & Balance**  
**Date: 02/24/2026**  
**Completed By: National TAB**

**02-23-26 QT #0460 TEMPE, AZ**

QUIKTRIP  
4705 SOUTH 129TH EAST AVENUE  
TULSA, OK 74134

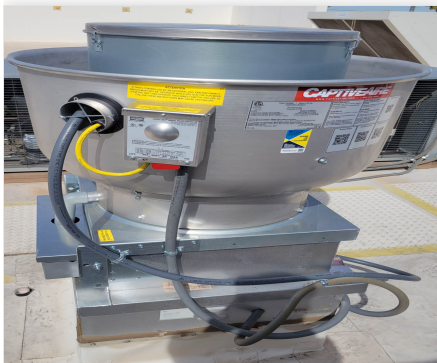
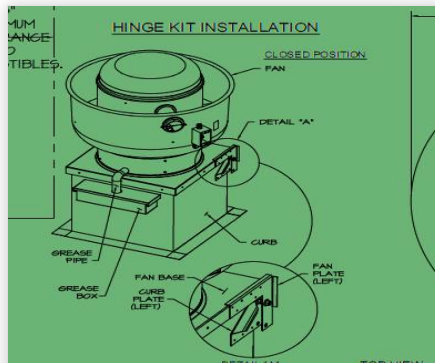
**Issue Name :** EF3 HINGE/GREASE CUP NOT PROPERLY INSTALLED  
**Description :** HINGE SHOULD BE INSTALLED OPPOSITE THE GREASE CONDUIT/CUP.  
**Created By :** National TAB **Assigned To :** National TAB - Dan Hertenstein  
**Status :** Open  
**Priority :** Low **Asset Tag :** EF3  
**Originated Date :** 02/24/2026 - Christine Weale - National TAB

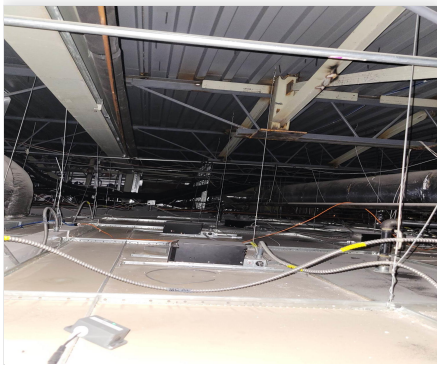
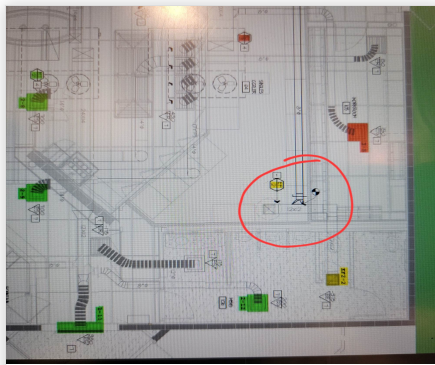
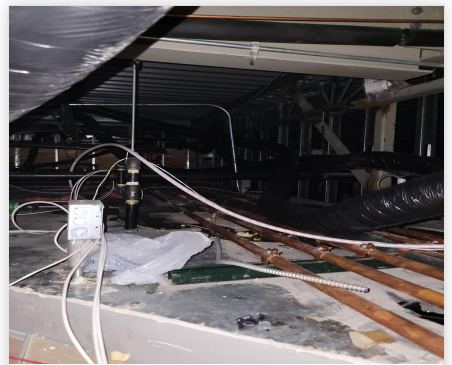
**Issue Name :** INACCESSIBLE DAMPER  
**Description :** Damper not installed in MSET location. Tried to trace, dampers inaccessible. Pic shows where Dampers should be located. Most of these QTs have OBDs installed in grille, those are recommended to guarantee accessibility.  
**Created By :** National TAB                      **Assigned To :** National TAB - Dan Hertenstein  
**Status :** Open  
**Priority :** High                                      **Asset Tag :** EF2  
**Originated Date :** 02/24/2026 - Christine Weale - National TAB

TOTAL FLOW BALANCED, SEE 'REMARKS'. ONCE DAMPER IS LOCATED AND ADJUSTED TO ALLOW FLOW FROM COMBI-OVEN, NO FURTHER CHANGES SHOULD BE NECESSARY.

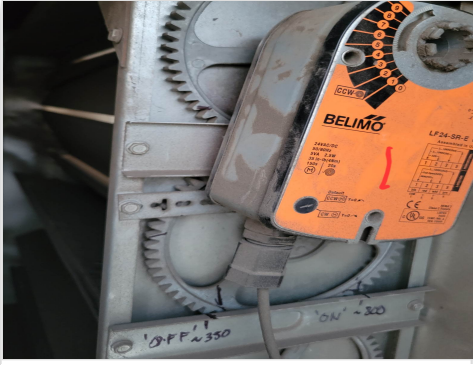
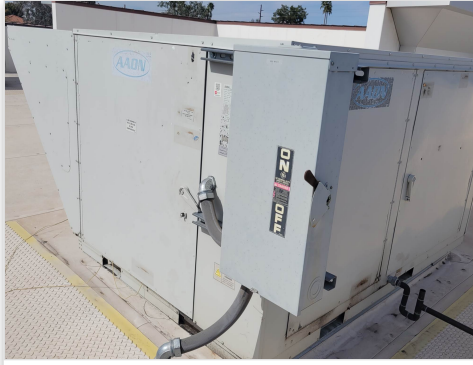
**Unit Data - PHOTO LOG**

Unit Data	
	Actual
MFG	AAON
Serial Num	201111-ANEL060068
Model Num	RN-015-8-0-EA0A-152
Num OA Filters 1	1
OA Filter Size 1	45X22
Num Final Filter 1	1
Final Filter Size 1	46X19.5

Test Data		
	Design	Actual
SF CFM	4200	4608
SF RPM	-	32 HZ
OA CFM (Hoods On)	800	839
OA CFM (Hoods Off)	350	344
RL Voltage	-	66.2
RL Amperage	-	7.65
VFD Max SetPt	-	53.3
VFD Min SetPt	-	24.0
OA Damper Position (Hoods On)	-	0.5"
OA Damper Position (Hoods Off)	-	0 - SMALL OPENING AT BOTTOM OF DAMPER

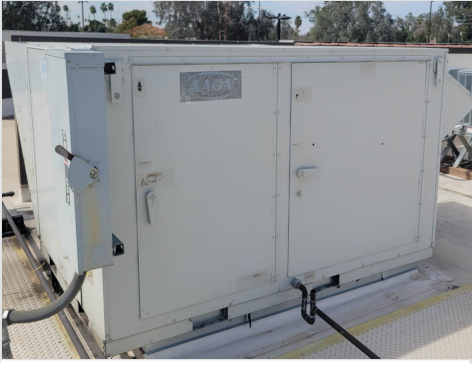
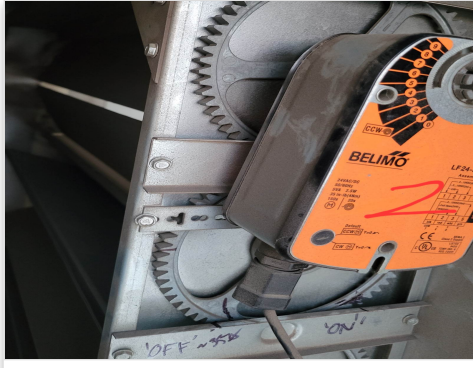
## Unit Data - PHOTO LOG

Unit Data	
	Actual
MFG	AAON
Serial Num	201111-ANEL06067
Model Num	RN-015-8-0-EA0A-152
Num OA Filters 1	1
OA Filter Size 1	45X22
Num Final Filter 1	2
Final Filter Size 1	46X19.5

Test Data		
	Design	Actual
SF CFM	4200	4604
SF RPM	-	32 HZ
OA CFM (Hoods On)	800	832
OA CFM (Hoods Off)	350	378
RL Voltage	-	66.6
RL Amperage	-	7.7
VFD Max SetPt	-	53.3
VFD Min SetPt	-	24.0
OA Damper Position (Hoods On)	-	0.5"
OA Damper Position (Hoods Off)	-	0 - SMALL CRACK AT BOTTOM OF DAMPER

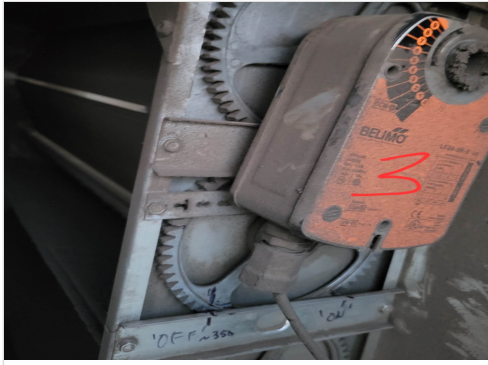
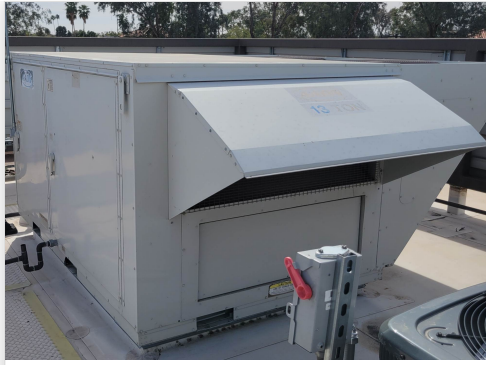
**Unit Data - PHOTO LOG**

Unit Data	
	Actual
MFG	AAON
Serial Num	201111-ANEK06069
Model Num	RN-013-8-0-EA0A-152
Num OA Filters 1	1
OA Filter Size 1	45X22
Num Final Filter 1	2
Final Filter Size 1	46X19.5

Test Data		
	Design	Actual
SF CFM	4200	4327
SF RPM	-	42 HZ
OA CFM (Hoods On)	800	866
OA CFM (Hoods Off)	350	385
RL Voltage	-	136.0
RL Amperage	-	8.7
VFD Max SetPt	-	70.0
VFD Min SetPt	-	24.0
OA Damper Position (Hoods On)	-	3/8"
OA Damper Position (Hoods Off)	-	0 - SMALL CRACK AT BOTTOM OF DAMPER

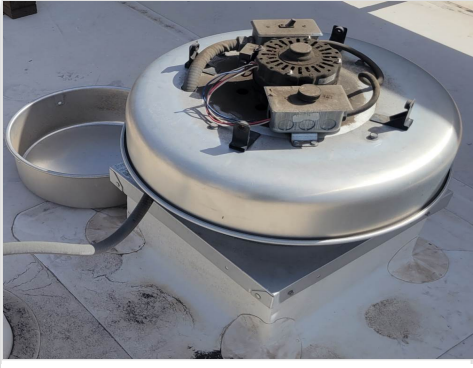
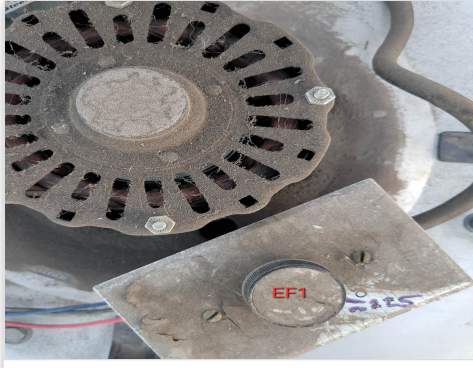
**Unit Data - PHOTO LOG**

Unit Data		
	Design	Actual
MFG	NA	GREENHECK
Model Num	NA	G-090-D-X
Serial Num	-	12644854
Type	-	DOWNBLAST
Configuration	-	VERTICAL

Test Data		
	Design	Actual
CFM	225	229
Fan RPM	-	N/A
Fan Rotation	-	CCW
Motor RPM	-	N/A
System SetPt	-	MED-LOW
RL Voltage	-	N/A
RL Amperage	-	1.23
Total ESP	-	0.16"
Fan Inlet SP	-	-0.16"
Fan Discharge SP	-	ATMS

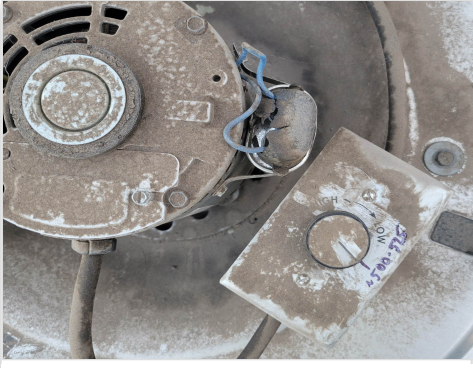
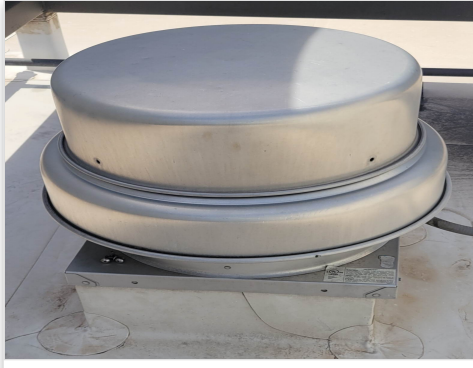
**Unit Data - PHOTO LOG**

Unit Data		
	Design	Actual
MFG	NA	GREENHECK
Model Num	NA	G-123-B-X
Serial Num	-	12644855
Type	-	DOWNBLAST
Configuration	-	VERTICAL

Test Data		
	Design	Actual
CFM	525	563
Fan RPM	-	N/A
Fan Rotation	-	CCW
Motor RPM	-	N/A
System SetPt	-	LOW
RL Voltage	-	N/A
RL Amperage	-	N/A
Total ESP	-	0.11"
Fan Inlet SP	-	0.11"
Fan Discharge SP	-	ATMS

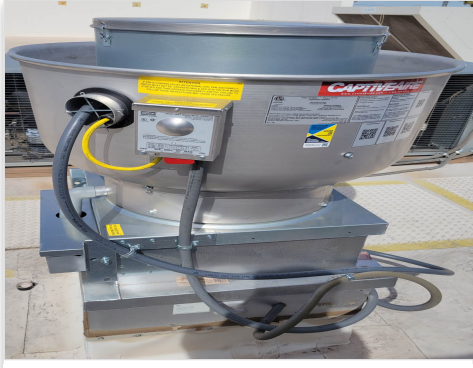
## Unit Data - PHOTO LOG

Unit Data		
	Design	Actual
MFG	NA	CAPTIVEAIRE
Model Num	NA	DU50HFA
Serial Num	-	8196378
Type	UPBLAST	UPBLAST
Configuration	VERTICAL	VERTICAL

Test Data		
	Design	Actual
CFM	1350	1348
Fan RPM	-	1225
Fan Rotation	-	CCW
Motor RPM	-	1225
System SetPt	-	53.8 HZ
RL Voltage	-	215.0
RL Amperage	-	2.0
Total ESP	0.75"	0.55"
Fan Inlet SP	-	-0.55"
Fan Discharge SP	-

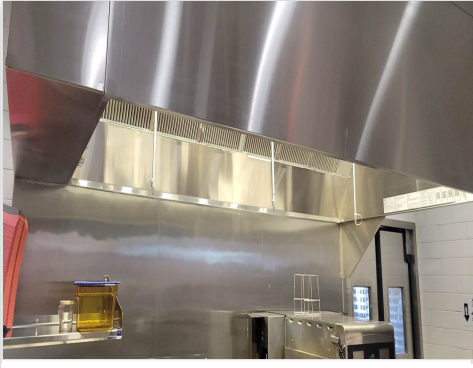
**Unit Data - PHOTO LOG**

Unit Data		
	Design	Actual
MFG	CAPTIVEAIRE	CAPTIVEAIRE
Model Num	6030ND-2-F	6030ND-2-F
Job / Serial Num	-	8196378
Type	TYPE I CANOPY	TYPE I CANOPY
Hood length	108"	108"
Hood Width	60"	60"

Test Data Exhaust		
	Design	Actual
Filter Type	CAPTRATE SOLO FILTER	CAPTRATE SOLO
Filter Size 1	20X16	16X20
Filter Qty 1	6	6
Filter AK factor size 1	2.08	2.08
Filter Total AK Area	12.48	12.48
Filter1 FPM	-	102
Filter2 FPM	-	117
Filter3 FPM	-	110
Filter4 FPM	-	104
Filter5 FPM	-	110
Filter6 FPM	-	105
Filter Ave FPM(corr)	-	108
CFM	1350	1348
