Report: TAB Report
Function: Test, Adjust, & Balance
Date: 02/24/2026
Completed By: National TAB

PROJECT
02-23-26 QT #0460 TEMPE, AZ

Project: 02-23-26 QT #0460 TEMPE, AZ

Table Of Contents

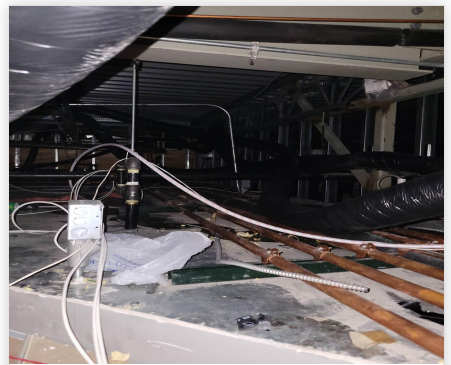
Issue Name : INACCESSIBLE DAMPER
Description : Damper not installed in MSET location. Tried to trace, dampers inaccessible. Pic shows where Dampers should be located. Most of these QTs have OBDs installed in grille, those are recommended to guarantee accessibility.
Created By : National TAB **Assigned To :** National TAB - Dan Hertenstein
Status : Open
Priority : High **Asset Tag :** EF2
Originated Date : 02/24/2026 - Christine Weale - National TAB

DAMPER INACCESSIBLE, NOT WHERE DENOTED BY GRD, BUT TOTAL FLOW IS BALANCED. ONCE DAMPER IS LOCATED AND ADJUSTED TO ALLOW FLOW FROM COMBI-OVEN, NO FURTHER CHANGES SHOULD BE NECESSARY.

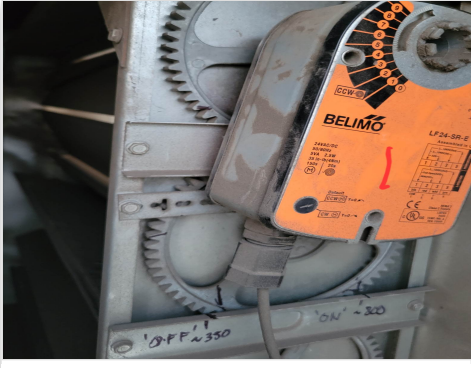
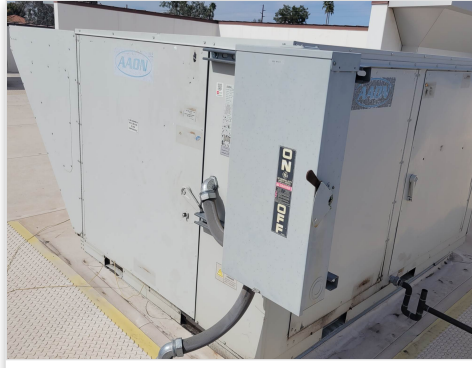
Asset: RT-1

Test Data		
	Design	Actual
SF CFM	4200	4608
SF RPM	-	32 HZ
OA CFM (Hoods On)	800	839
OA CFM (Hoods Off)	350	344
RL Voltage	-	66.2
RL Amperage	-	7.65
VFD Max SetPt	-	53.3
VFD Min SetPt	-	24.0
OA Damper Position (Hoods On)	-	0.5"
OA Damper Position (Hoods Off)	-	0 - SMALL OPENING AT BOTTOM OF DAMPER

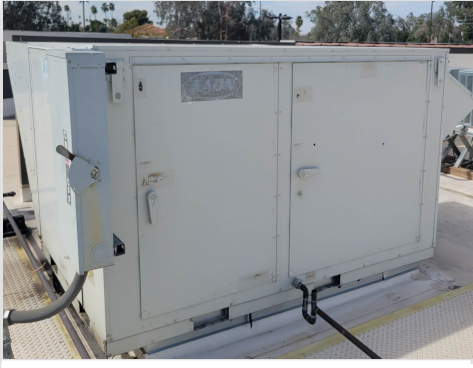
Asset: RT-2

Test Data		
	Design	Actual
SF CFM	4200	4604
SF RPM	-	32 HZ
OA CFM (Hoods On)	800	832
OA CFM (Hoods Off)	350	378
RL Voltage	-	66.6
RL Amperage	-	7.7
VFD Max SetPt	-	53.3
VFD Min SetPt	-	24.0
OA Damper Position (Hoods On)	-	0.5"
OA Damper Position (Hoods Off)	-	0 - SMALL CRACK AT BOTTOM OF DAMPER

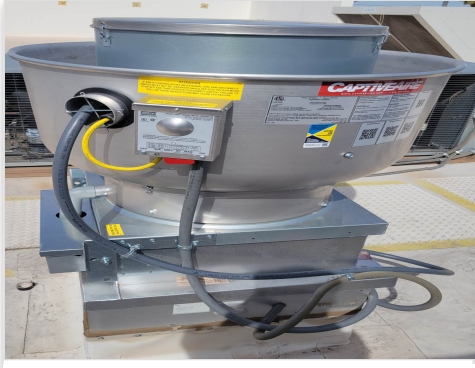
Asset: EF3

Test Data		
	Design	Actual
CFM	1350	1348
Fan RPM	-	1225
Fan Rotation	-	CCW
Motor RPM	-	1225
System SetPt	-	53.8 HZ
RL Voltage	-	215.0
RL Amperage	-	2.0
Total ESP	0.75"	0.55"
Fan Inlet SP	-	-0.55"
Fan Discharge SP	-
