Report: TAB REPORT
Function: Test, Adjust, & Balance
Date: 02/12/2025
Completed By: National TAB

PROJECT
02-03-25 WHATABURGER ALBUQUERQUE,
NM

Alameda and San Pedro

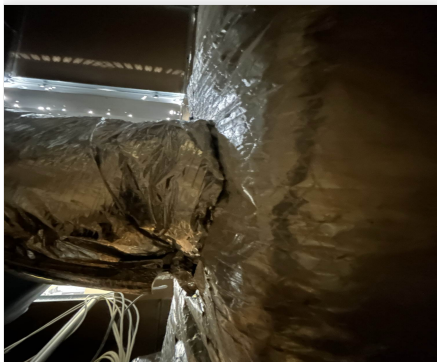
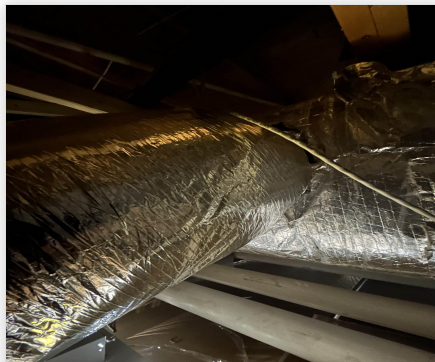
Issue Name : Damper not installed for diffuser 1-5 (Washroom)
Description : Damper is not installed. Airflow is 114 CFM out of design of 150 CFM.
Created By : National TAB **Assigned To :** National TAB - David Nicolas Sanchez
Status : Open
Priority : Low **Asset Tag :** SGRD5
Originated Date : 02/12/2025 - Will Turnbough - National TAB
