**Report: TAB REPORT**  
**Function: Test, Adjust, & Balance**  
**Date: 02/06/2025**  
**Completed By: National TAB**

**PROJECT**  
**02-03-25 WHATABURGER ALBUQUERQUE,**  
**NM**

Project: 02-03-25 WHATABURGER ALBUQUERQUE, NM

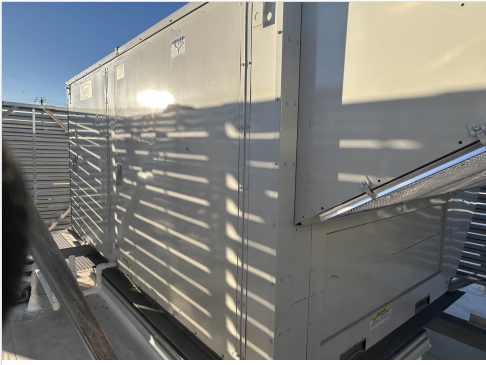
## Unit Data - PHOTO LOG

Asset: RTU1

AREA:KITCHEN

Supply duct traverse reading: 1221, 1179, 1198, 1196, 1194, 1156, 1161, 1113, 1143, 1106, 1126, 1111, 1127, 1111, 1138, 1144, 1116, 1143, 1099, 1119, 1160, 1158, 1157, 1143.  
 (20"X26")/144 \* 1146 FPM AVG = 4138 CFM

Unable to traverse return duct.  
 Return hood reading: 1404 CFM

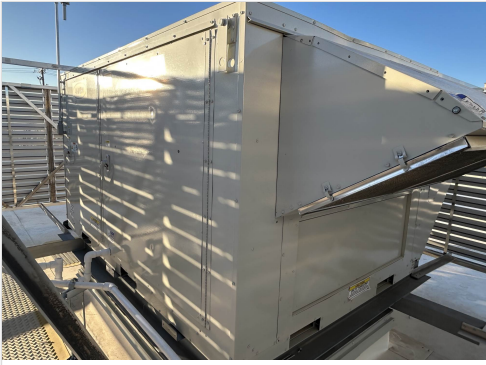
## Unit Data - PHOTO LOG

Asset: RTU2

AREA:DINING

Supply duct traversal readings: 861, 874, 880, 891, 882, 872, 897, 888, 913, 899, 902, 906, 873, 888, 887, 917, 923, 904, 901, 887, 897, 861, 874, 858.

$$(16"x22")/144 * 888.96 \text{ AVG FPM} = 2173 \text{ CFM}$$

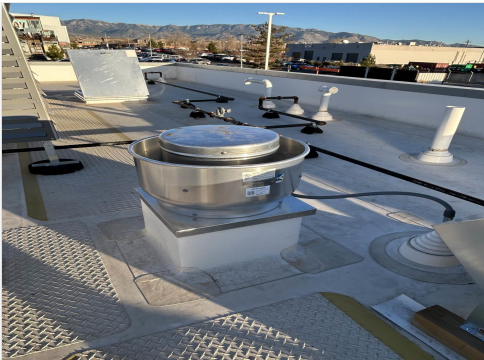
### Unit Data - PHOTO LOG

Asset: EF1

AREA:RESTROOMS

Test Data		
	Design	Actual
<b>CFM</b>	140	143
<b>Fan RPM</b>	1550	DD/1750
<b>Fan Rotation</b>	-	CW
<b>Motor RPM</b>	-	DD/1750
<b>System SetPt</b>	-	6.5
<b>RL Voltage</b>	-	NA
<b>RL Amperage</b>	-	NA
<b>Total ESP</b>	0.38"	0.25"
<b>Fan Inlet SP</b>	-	-0.25"
<b>Fan Discharge SP</b>	-	ATMS

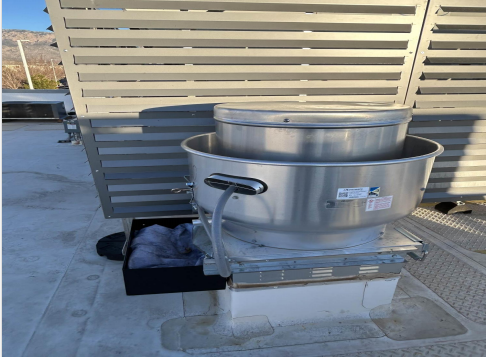
## Unit Data - PHOTO LOG

Asset: KEF1

AREA:HOOD 1

Test Data		
	Design	Actual
CFM	1995	2040
Fan RPM	1517	DD/1750
Fan Rotation	-	CW
Motor RPM	-	DD/1750
System SetPt	-	6.5
RL Voltage	-	120
RL Amperage	-	2.34
Total ESP	0.38"	0.43"
Fan Inlet SP	-	-0.43"
Fan Discharge SP	-	ATMS

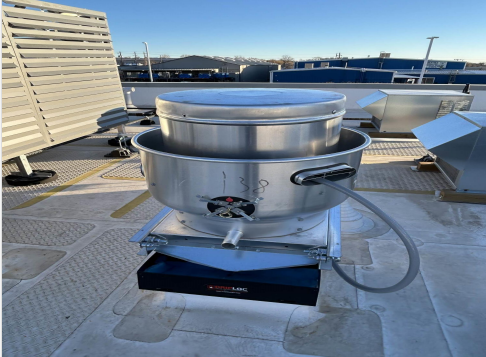
## Unit Data - PHOTO LOG

Asset: KEF2

AREA:HOOD 2

Test Data		
	Design	Actual
CFM	1216	1173
Fan RPM	1415	DD / 1750
Fan Rotation	-	CW
Motor RPM	-	DD/ 1750
System SetPt	-	6.5
RL Voltage	-	123
RL Amperage	-	1.31
Total ESP	0.75"	0.48"
Fan Inlet SP	-	-0.48"
Fan Discharge SP	-	ATMS

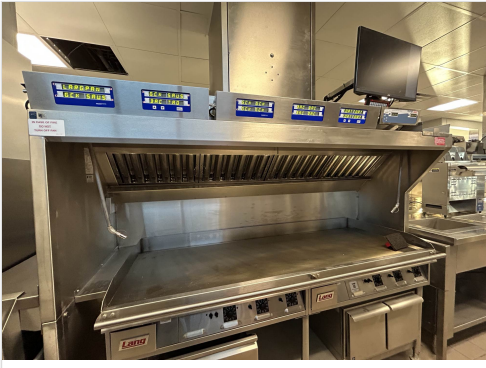
## Unit Data - PHOTO LOG

Asset: HD1

AREA:KITCHEN

Test Data Exhaust		
	Design	Actual
Filter Type	-	BAFFLE
Filter Size 1	-	19.5"X11.5"
Filter Qty 1	-	8
Filter AK factor size 1	-	1.50
Filter Total AK Area	-	12
Filter1 FPM	-	159
Filter2 FPM	-	183
Filter3 FPM	-	163
Filter4 FPM	-	156
Filter5 FPM	-	156
Filter6 FPM	-	190
Filter7 FPM	-	187
Filter8 FPM	-	166
Filter Ave FPM(corr)	-	170
CFM	1995	2040

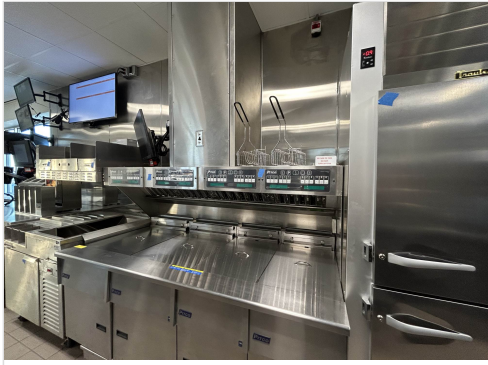
## Unit Data - PHOTO LOG

Asset: HD2

AREA:KITCHEN

Test Data Exhaust		
	Design	Actual
Filter Type	-	BAFFLE
Filter Size 1	-	19.5"X11.5"
Filter Size 2	-	15.75"X11.5"
Filter Qty 1	-	1
Filter Qty 2	-	3
Filter AK factor size 1	-	1.50
Filters AK factor size 2	-	1.20
Filter Total AK Area	-	5.1
Filter1 FPM	-	233
Filter2 FPM	-	229
Filter3 FPM	-	233
Filter4 FPM	-	228
Filter Ave FPM(corr)	-	230
CFM	1216	1173
