Report: TAB REPORT
Function: Test, Adjust, & Balance
Date: 02/12/2025
Completed By: National TAB

PROJECT
02-03-25 WHATABURGER ALBUQUERQUE,
NM

Project: 02-03-25 WHATABURGER ALBUQUERQUE, NM

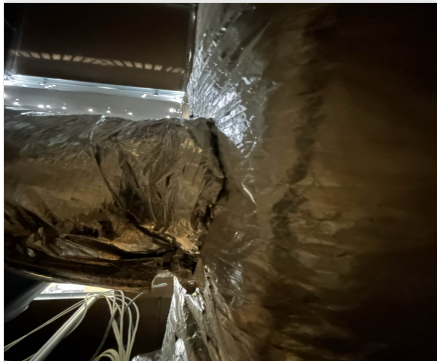
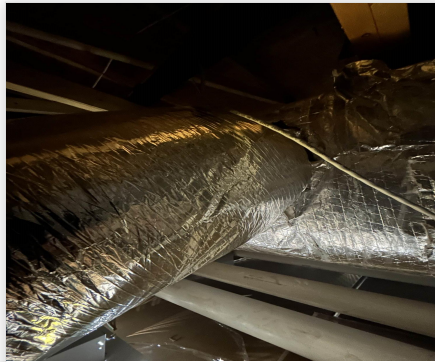
Project Issue File Details

Issue Name : Damper not installed for diffuser 1-5 (Washroom)
Description : Damper is not installed. Airflow is 114 CFM out of design of 150 CFM.
Created By : National TAB **Assigned To :** National TAB - David Nicolas Sanchez
Status : Open
Priority : Low **Asset Tag :** SGRD5
Originated Date : 02/12/2025 - Will Turnbough - National TAB

Asset	Notes	Date	Written By
SGRD5	Damper not installed.	02/12/2025	Will Turnbough
SGRD12	Unable to access damper.	02/05/2025	David Nicolas Sanchez
SGRD13	Unable to access damper.	02/05/2025	David Nicolas Sanchez
SGRD14	Unable to access damper.	02/05/2025	David Nicolas Sanchez

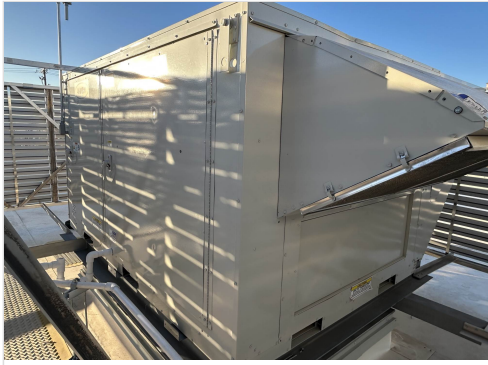
Unit Data - PHOTO LOG

Asset: RTU2

Unit Data		
	Design	Actual
MFG	AAON	AAON
Serial Num	-	202310-ANGK112700
Model Num	RN-013-9-0-GB04-3F9	RN-013-8-0-GB04-5F9
Type	-	RTU
Configuration	-	VERTICAL
Num OA Filters 1	-	2
OA Filter Size 1	-	24.75X20
Num Final Filter 1	-	4
Final Filter Size 1	-	20X25X2

Test Data		
	Design	Actual
SF CFM	2240	2219
SF RPM	-	909 (31HZ)
RA CFM	500	463
OA CFM	1740	1756
RL Voltage	-	60.7@VFD
RL Amperage	-	2.55 @VFD
SF Rotation	-	CCW
SF System SetPt	-	31HZ
RA Damper Position	-	15%
Min OA Damper Position	-	85%
Min OA Damper Type	-	MANUAL
OA Enthalpy Setpt	-	N/A
