Report: TAB Report
Function: Test, Adjust, & Balance
Date: 10/22/2025
Completed By: National TAB

PROJECT
01-12-26 QT #0415 SURPRISE, AZ

Project: 01-12-26 QT #0415 SURPRISE, AZ

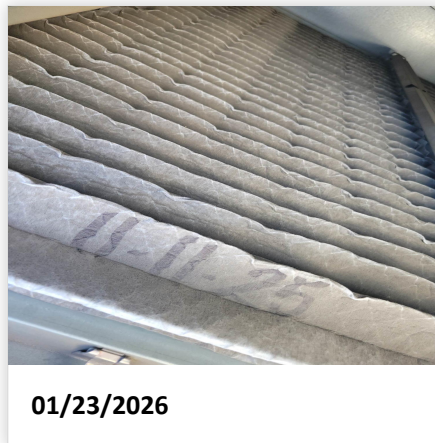
02/24/2026

Issue Name : DIRTY UNIT FILTERS
Description : Filters are extremely dirty. MSET shows mech contractor should be replacing these after project is complete.
Created By : National TAB **Assigned To :** National TAB - Dan Hertenstein
Status : Open
Priority : Low **Asset Tag :**
Originated Date : 01/23/2026 - Christine Weale - National TAB

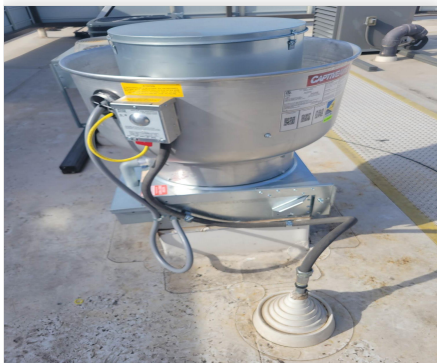
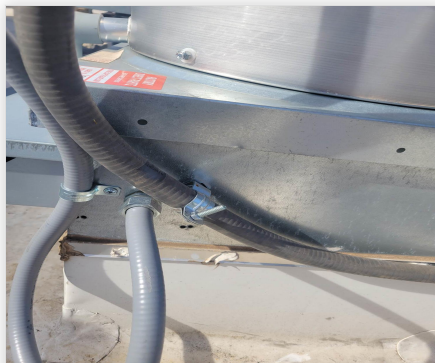
Issue Name : EF3 CAN'T BE TILTED BACK
Description : Electrical conduit is supposed to be long enough to tilt the fan back... but they have attached it to the base, which has made it almost completely immobile.
Created By : National TAB **Assigned To :** National TAB - Dan Hertenstein
Status : Open
Priority : Medium **Asset Tag :** EF3
Originated Date : 01/15/2026 - Christine Weale - National TAB

Conduit is probably long enough, but the techs mounted it to the base, so it is almost completely immobile.

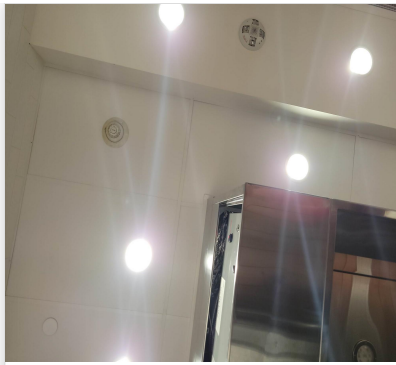
75 - there was a lot of smoke on left side. Light smoke, the dense smoke was pulled out.

90 - pizza oven fan pushes smoke out of right side (100 w/ fan off).

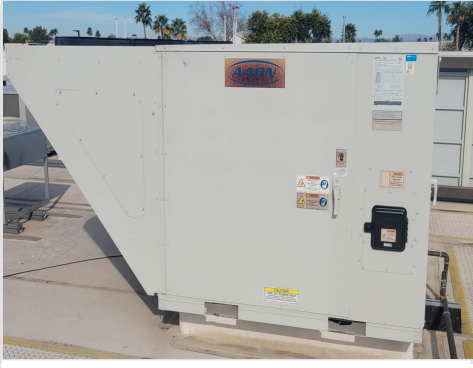
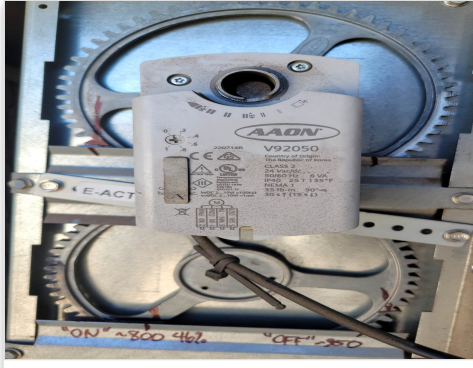
Asset: RT-1

Test Data		
	Design	Actual
SF CFM	4200	4658
SF RPM	-	47.4 HZ
OA CFM (Hoods On)	800	869
OA CFM (Hoods Off)	350	358
RL Voltage	-	165.9
RL Amperage	-	7.77
VFD Max SetPt	-	79
VFD Min SetPt	-	24
OA Damper Position (Hoods On)	-	0.5"
OA Damper Position (Hoods Off)	-	0.0 - GAP @BOTTOM

General	
	Actual
Fan Rotation Correct	YES
Unit Filters Clean	NO
Condensate Drain Installed	YES

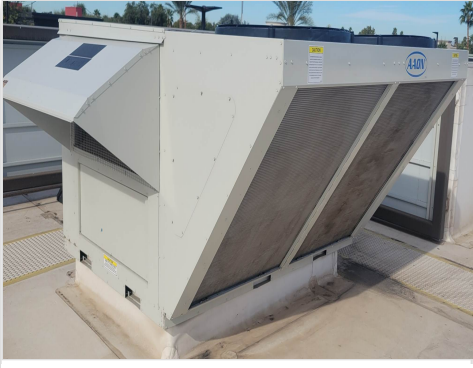
Asset: RT-2

Test Data		
	Design	Actual
SF CFM	4200	4407
SF RPM	-	48.6 HZ
OA CFM (Hoods On)	800	165.9
OA CFM (Hoods Off)	350	371
RL Voltage	-	220.0
RL Amperage	-	9.8
VFD Max SetPt	-	81.0
VFD Min SetPt	-	24.0
OA Damper Position (Hoods On)	-	0.5"
OA Damper Position (Hoods Off)	-	0-GAP @BOTTOM

General	
	Actual
Fan Rotation Correct	YES
Unit Filters Clean	NO
Condensate Drain Installed	YES

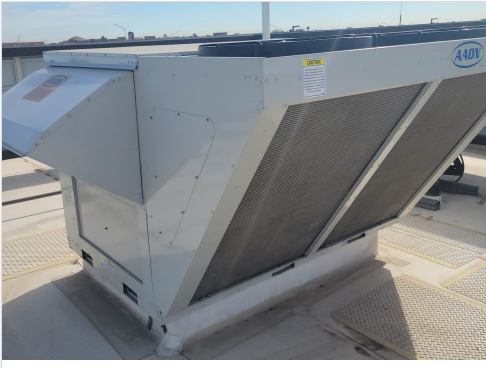
Asset: RT-3

Test Data		
	Design	Actual
SF CFM	4200	4436
SF RPM	-	49.98 HZ
OA CFM (Hoods On)	800	853
OA CFM (Hoods Off)	350	385
RL Voltage	-	183.0
RL Amperage	-	8.7
VFD Max SetPt	-	83.3
VFD Min SetPt	-	24
OA Damper Position (Hoods On)	-	0.5"
OA Damper Position (Hoods Off)	-	0.0 SMALL GAP

General	
	Actual
Fan Rotation Correct	YES
Unit Filters Clean	NO
Condensate Drain Installed	YES

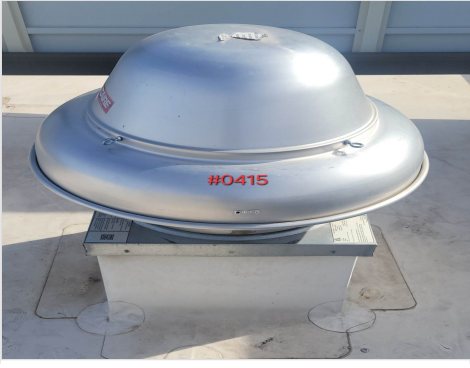
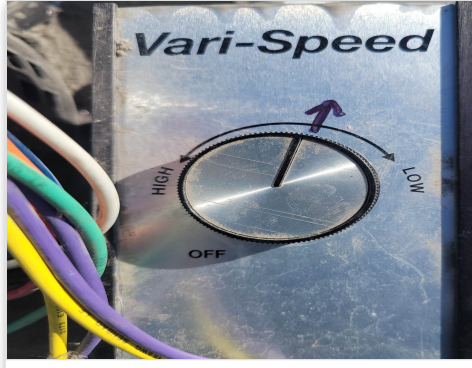
Asset: EF1

Design	Actual
CFM	750	762
Fan RPM	-	N/A
Fan Rotation	-	CCW
Motor RPM	-	N/A
System SetPt	-	MED-LOW
RL Voltage	-	74.3
RL Amperage	-	8.27
Total ESP	-	0.35"
Fan Inlet SP	-	-0.35"
Fan Discharge SP	-	ATMS

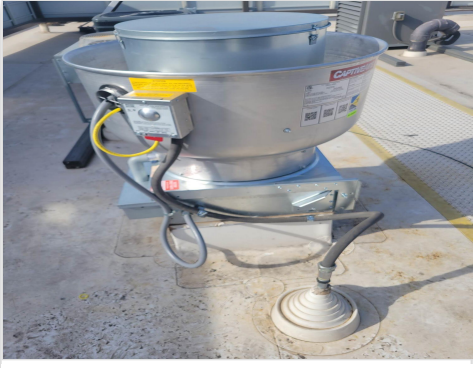
Asset: EF3

Design	Actual
CFM	1350	1406
Fan RPM	-	1218
Fan Rotation	-	CCW
Motor RPM	-	1218
System SetPt	-	51.8 HZ
RL Voltage	-	212.0
RL Amperage	-	1.62
Total ESP	-	0.75"
Fan Inlet SP	-	-0.75"
Fan Discharge SP	-	ATMS

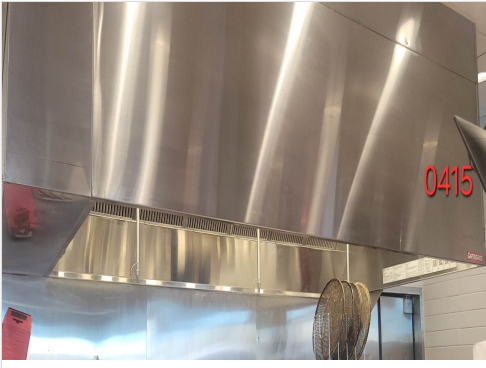
Asset: HD1

Test Data Exhaust		
	Design	Actual
Filter Type	-	CAPTRATE SOLO
Filter Size 1	-	16X20
Filter Qty 1	-	6
Filter AK factor size 1	-	2.08
Filter Total AK Area	-	12.48
Filter1 FPM	-	111
Filter2 FPM	-	112
Filter3 FPM	-	124
Filter4 FPM	-	112
Filter5 FPM	-	110
Filter6 FPM	-	107
Filter Ave FPM(corr)	-	112.67
CFM	1350	1406
