Report: TAB REPORT
Function: Test, Adjust, & Balance
Date: 10/31/2023

**10-23-23 CARMAX #7279 - FAYETTEVILLE,
NC**

521 NORTH MCHPERSON CHURCH RD

Project Summary

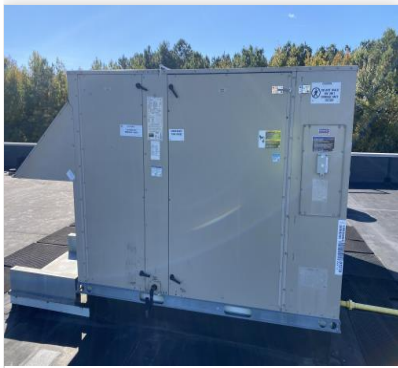
RTU-8
10/25/2023

[1] FILTERS ARE VERY DIRTY AND NEED TO BE REPLACED, FILTERS WERE PULLED OUT FOR TESTING.

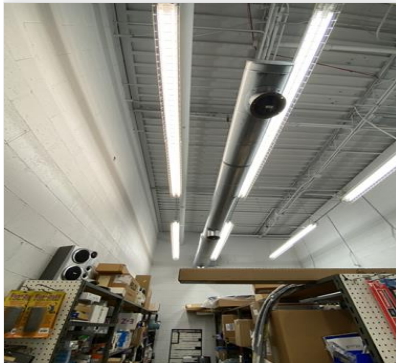
RTU7-SGRD1
10/26/2023

All diffusers and grilles are installed and match design? No

SGRD-1 TYPE IS DIFFERENT THAN MSET. DUCT IS EXTENDED INTO SPACE AND HAS 3 MINI-ROUND DIFFUSERS FROM THE BOTTOM OF THE DUCT.

SGRD-1 TYPE IS DIFFERENT THAN MSET. DUCT IS EXTENDED AND HAS 3 MINI-ROUND DIFFUSERS FROM THE BOTTOM OF THE DUCT.

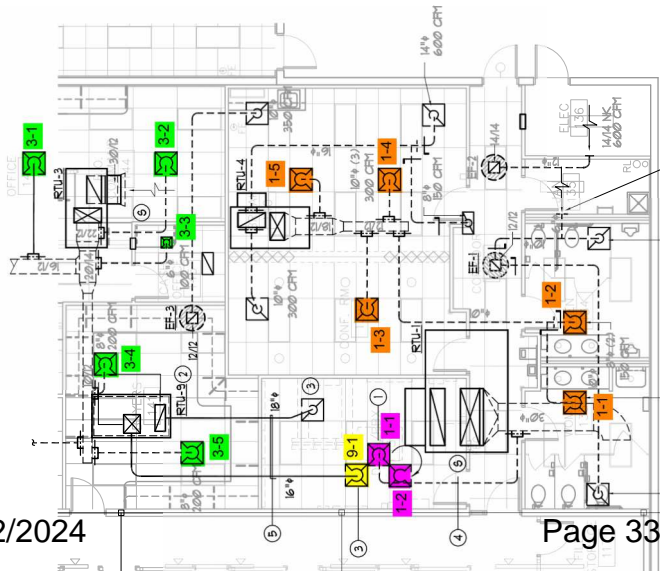
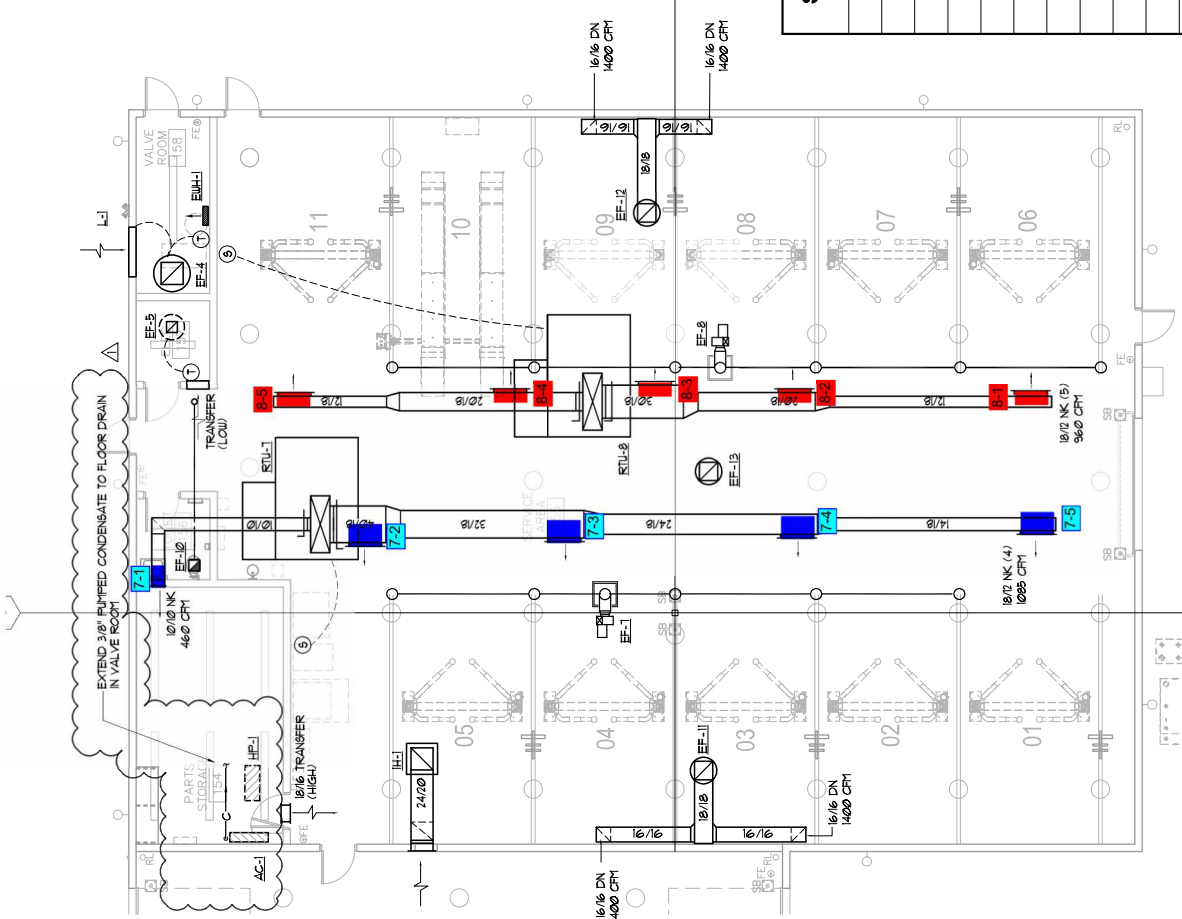
2 PART PLAN - HVAC

- SET NOTES:
- 1 RELOCATE EXISTING VAV DRIVER
 - 2 LINE SHEET METAL FLENNH RILL SIZE OF CONNECTION
 - 3 THIS CORE 90 24/24 LINED SHEET METAL FLENNH ROUND COLLAR SIZE AS NOTED
 - 4 RTU-9 SENSOR AT 18" AFF
 - 5 INSULATED ROUND FLEXIBLE DUCT THEREAFTER MAX LENGTH 6FT FOR CONNECTION TO CEILING SUPPLY/RETURN ONLY
