06-13 BLUE SUSHI - NASHVILLE, TN

Project Issue Information

Issue Name : Missing and loose cleanout door

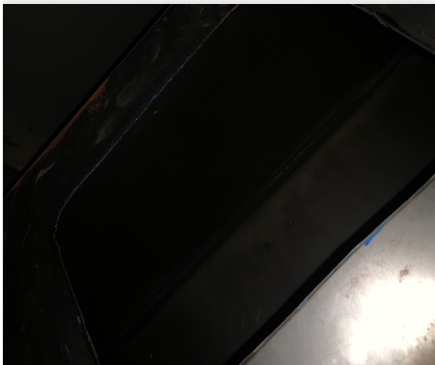
MicrosoftTeams_image_5_.png

Description : There is one missing cleanout door located in the discharge duct run of the pcu. There is also a loose cleanout door see pictures for locations

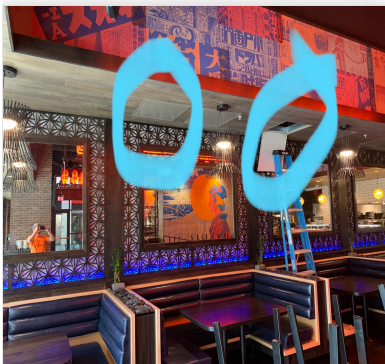
MicrosoftTeams_image_6_.png

- **06/05/2022** **National TAB - Will Turnbough**
 - Loose cleanout door and access panel locations to access both doors.
