Report: TAB REPORT
Function: Test, Adjust, & Balance
Date: 10/16/2024
Completed By: National TAB

10-14-24 WAWA #6601 RUTHER GLEN, VA

Project: 10-14-24 WAWA #6601 RUTHER GLEN, VA

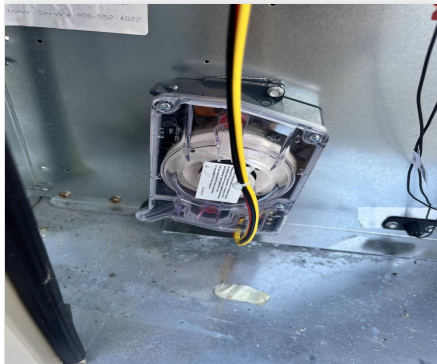
Issue Name : RTUs: Dust plugs are still in the smoke detectors
Description : The dust plugs are still in the RTU smoke detectors recommend having them removed.
Created By : National TAB **Assigned To :** National TAB - David Annan
Status : Open
Priority : Low **Asset Tag :**
Originated Date : 10/21/2024 - David Annan - National TAB
