Report: TAB REPORT
Function: Test, Adjust, & Balance
Date: 10/16/2024
Completed By: National TAB

10-14-24 WAWA #6601 RUTHER GLEN, VA

Project: 10-14-24 WAWA #6601 RUTHER GLEN, VA

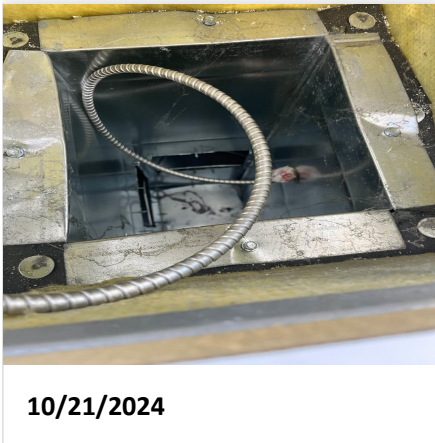
Issue Name : EFs: Backdraft dampers are not installed
Description : The backdraft dampers for the EFs are not installed. Recommend having them installed for all EFs
Created By : National TAB **Assigned To :** National TAB - David Annan
Status : Open
Priority : Medium **Asset Tag :**
Originated Date : 10/21/2024 - David Annan - National TAB

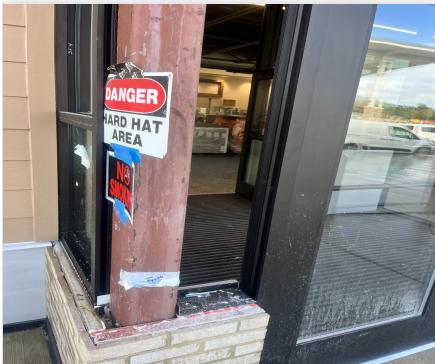
Issue Name : Missing glass windows by the front vestibule
Description : There are missing glass windows by the vestibule. Unable to measure building pressure.
Created By : National TAB **Assigned To :** National TAB - David Annan
Status : Open
Priority : InfoOnly **Asset Tag :**
Originated Date : 10/21/2024 - David Annan - National TAB

Building pressure could not be measured due to missing windows by the vestibule.

Unable to take building pressure due to missing windows by the front vestibule and front of the store

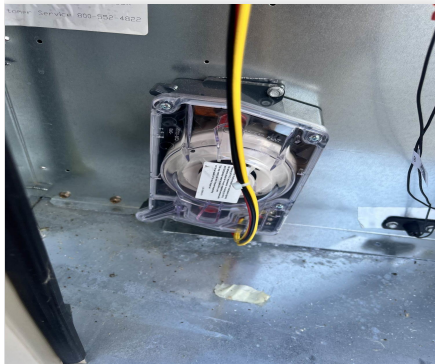
Issue Name : RTUs: Dust plugs are still in the smoke detectors
Description : The dust plugs are still in the RTU smoke detectors recommend having them removed.
Created By : National TAB **Assigned To :** National TAB - David Annan
Status : Open
Priority : Low **Asset Tag :**
Originated Date : 10/21/2024 - David Annan - National TAB
