**Report: TAB Report**  
**Function: Test, Adjust, & Balance**  
**Date: 01/08/2026**  
**Completed By: National TAB**

**PROJECT**  
**01-05-26 QT #1713 STONECREST, GA**

QUIKTRIP  
4705 SOUTH 129TH EAST AVENUE  
TULSA, OK 74134

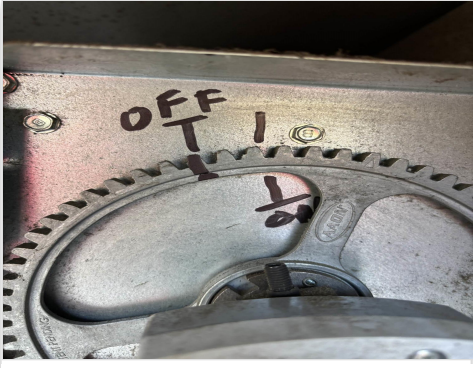
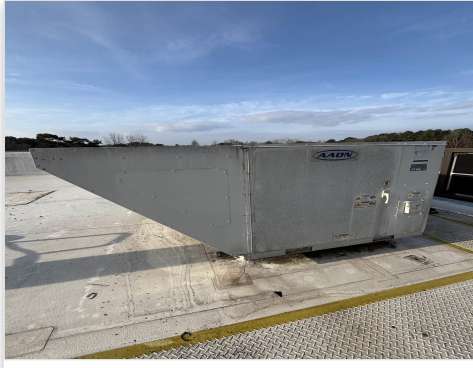
Asset: RT-1

Unit Data	
	Actual
MFG	AAON
Serial Num	202103-ANEK21820
Model Num	RN-013-8-0-EA0A-152
Num OA Filters 1	1
OA Filter Size 1	22X45
Num Final Filter 1	4
Final Filter Size 1	20X25X2

Test Data		
	Design	Actual
SF CFM	4200	4233
SF RPM	-	1408
OA CFM (Hoods On)	800	791
OA CFM (Hoods Off)	350	344
RL Voltage	-	170 VFD
RL Amperage	-	7.99 VFD
VFD Max SetPt	-	48 Hz
VFD Min SetPt	-	24 Hz
OA Damper Position (Hoods On)	-	46%
OA Damper Position (Hoods Off)	-	26%

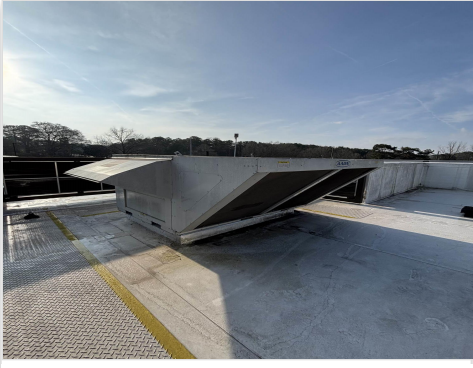
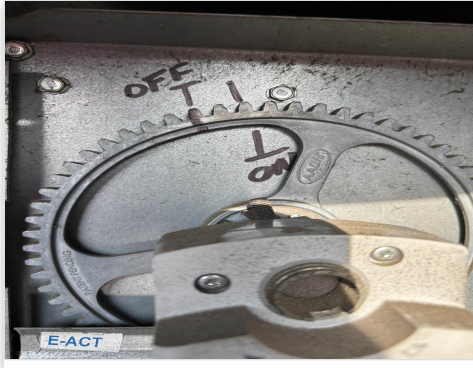
Asset: RT-2

Unit Data	
	Actual
MFG	AAON
Serial Num	202103-ANEK21822
Model Num	RN-013-8-0-EA0A-152
Num OA Filters 1	1
OA Filter Size 1	22X45
Num Final Filter 1	4
Final Filter Size 1	20X25X2

Test Data		
	Design	Actual
SF CFM	4200	4272
SF RPM	-	1408
OA CFM (Hoods On)	800	763
OA CFM (Hoods Off)	350	337
RL Voltage	-	170 VFD
RL Amperage	-	8.12 VFD
VFD Max SetPt	-	48 Hz
VFD Min SetPt	-	24 Hz
OA Damper Position (Hoods On)	-	46%
OA Damper Position (Hoods Off)	-	26%

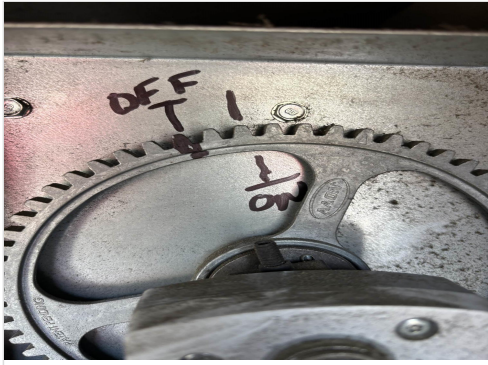
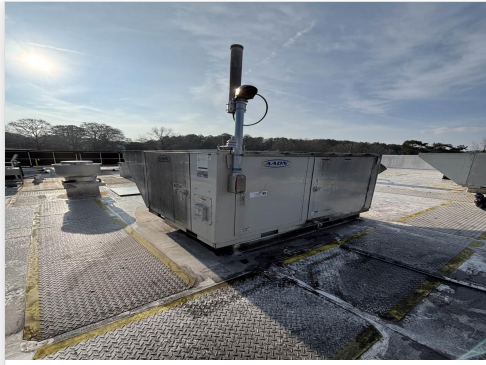
Asset: RT-3

Unit Data	
	Actual
MFG	AAON
Serial Num	202103-ANEK21821
Model Num	RN-013-8-0-EA0A-152
Num OA Filters 1	1
OA Filter Size 1	22X45
Num Final Filter 1	4
Final Filter Size 1	20X25X2

Test Data		
	Design	Actual
SF CFM	4200	4214
SF RPM	-	1408
OA CFM (Hoods On)	800	805
OA CFM (Hoods Off)	350	351
RL Voltage	-	170 VFD
RL Amperage	-	8.19 VFD
VFD Max SetPt	-	48 Hz
VFD Min SetPt	-	24 Hz
OA Damper Position (Hoods On)	-	46%
OA Damper Position (Hoods Off)	-	26%

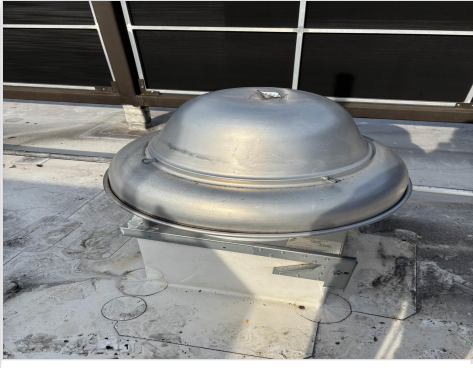
Asset: EF1

Unit Data		
	Design	Actual
MFG	NA	CAPTIVEAIRE
Model Num	NA	DR50HFA
Serial Num	-	4821037
Type	-	DOWNBLSAT
Configuration	-	VERTICAL

Test Data		
	Design	Actual
CFM	750	758
Fan Rotation	-	CCW
System SetPt	-	LOW
RL Voltage	-	[1]
RL Amperage	-	[1]
Total ESP	-	0.21"
Fan Inlet SP	-	-0.21"
Fan Discharge SP	-	ATM

Notes:  
[1] UNABLE TO READ VOLTS AND AMPS SAFELY

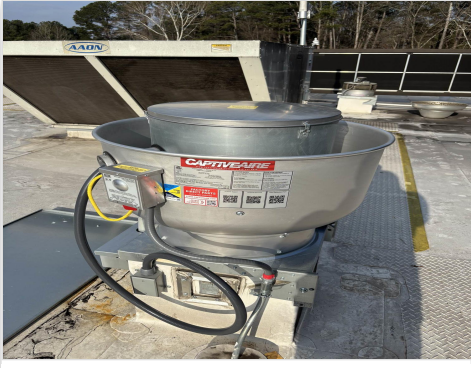
Asset: EF3

Unit Data		
	Design	Actual
MFG	NA	CAPTIVEAIRE
Model Num	NA	DU50HFA
Serial Num	-	7644847
Type	UPBLAST	UPBLAST
Configuration	VERTICAL	VERTICAL

Test Data		
	Design	Actual
CFM	1350	1348
Fan RPM	-	1175
Fan Rotation	-	CCW
Motor RPM	-	1175
System SetPt	-	51.8 Hz
RL Voltage	-	215
RL Amperage	-	1.5
Total ESP	-	0.28"
Fan Inlet SP	-	-0.28"
Fan Discharge SP	-	ATM

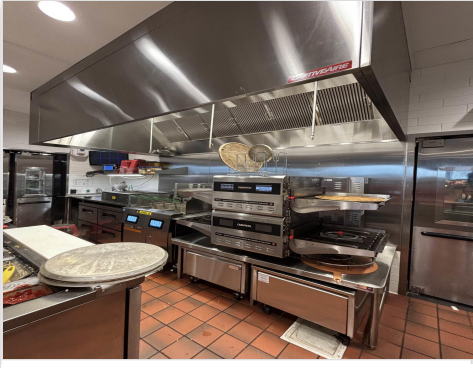
Asset: HD1

Design	Actual
MFG	CAPTIVEAIRE	CAPTIVEAIRE
Model Num	6030ND-2-F	6030ND-2-F
Job / Serial Num	-	7644847
Type	TYPE I CANOPY	TYPE I CANOPY
Hood length	-	108"
Hood Width	-	60"

Design	Actual
Filter Type	-	CAPTRATE SOLO FILTER
Filter Size 1	-	16X20
Filter Qty 1	-	6
Filter AK factor size 1	-	2.08
Filter Total AK Area	-	12.48
Filter1 FPM	-	99
Filter2 FPM	-	105
Filter3 FPM	-	119
Filter4 FPM	-	127
Filter5 FPM	-	107
Filter6 FPM	-	94
Filter Ave FPM(corr)	-	108
CFM	1350	1348
