Report: TAB REPORT
Function: Test, Adjust, & Balance
Date: 11/07/2024
Completed By: National TAB

**11-04-24 CHIPOTLE #5453 MINNEAPOLIS,
MN (DINKYTOWN)**

1425 4TH STREET SE

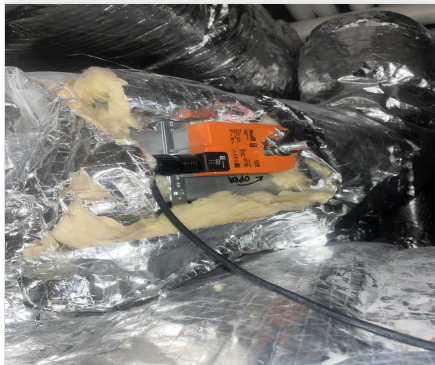
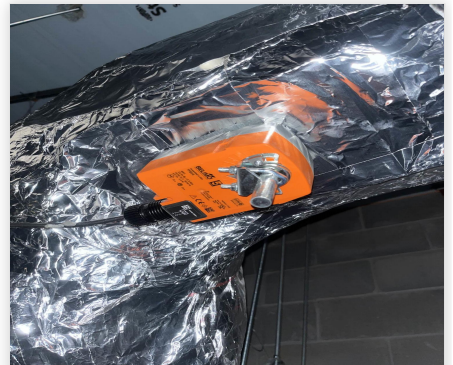
Issue Name : FCUs 1-2-3: OA Damper / Actuator Orientation
Description : OA Dampers on FCUs 1,2, and 3 appear oriented incorrectly. The actuator opens the opposite way the damper needs to be moved. Was able to adjust damper position so actuators appear to open damper to correct position when energized. They do not all appear to be fully closing when unit is not running.
Created By : National TAB **Assigned To :** National TAB - Michael McDonnell
Status : Open
Priority : Medium **Asset Tag :**
Originated Date : 11/07/2024 - Michael McDonnell - National TAB

- **11/07/2024 National TAB - Michael McDonnell**
 - Recommend this is corrected and dampers are set to 75% open on FCU-1 and 2, and 66% open on FCU-3.

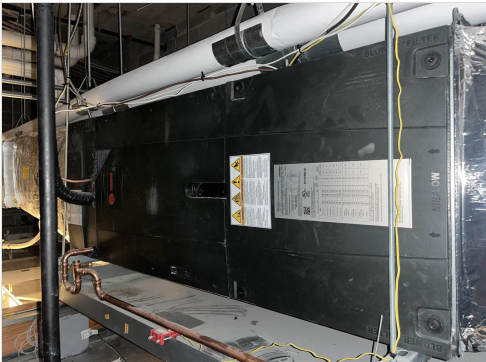
IMG_1981_1767581787.j..

Asset: FCU1

Test Data		
	Design	Actual
SF CFM	1500	1486
SF RPM	-	DD
RA CFM	1240	1208
OA CFM	260	278
RL Voltage	-	211
RL Amperage	-	2.1
SF Rotation	-	CORRECT
SF System SetPt	-	TAPS 4/5
RA Damper Position	-	100%
Min OA Damper Position	-	~75% OPEN
Min OA Damper Type	-	MOTORIZED DAMPER

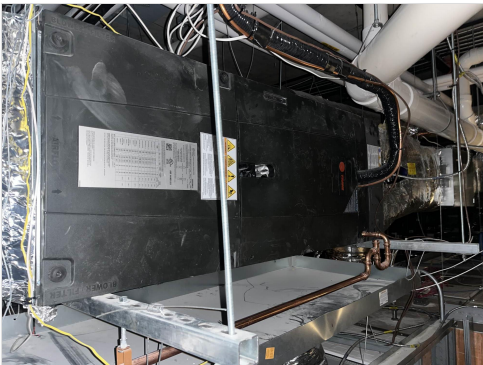
IMG_1982_1898809051.j..

Asset: FCU2

Test Data		
	Design	Actual
SF CFM	1500	1419
SF RPM	-	DD
RA CFM	1240	1167
OA CFM	260	252
RL Voltage	-	210
RL Amperage	-	2.2
SF Rotation	-	CORRECT
SF System SetPt	-	SPEED TAPS 4/5
RA Damper Position	-	100% OPEN
Min OA Damper Position	-	~75% OPEN
Min OA Damper Type	-	MOTORIZED DAMPER

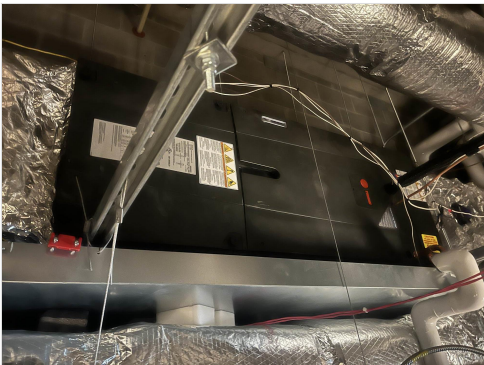
IMG_2022_96998542.jpe..

Asset: FCU4

Test Data		
	Design	Actual
SF CFM	1500	1414
SF RPM	-	DD
RA CFM	1225	1148
OA CFM	275	266
RL Voltage	-	210
RL Amperage	-	2.2
SF Rotation	-	CORRECT
SF System SetPt	-	SPEED TAPS 4/5
RA Damper Position	-	100% OPEN
Min OA Damper Position	-	~66% OPEN
Min OA Damper Type	-	MOTORIZED DAMPER

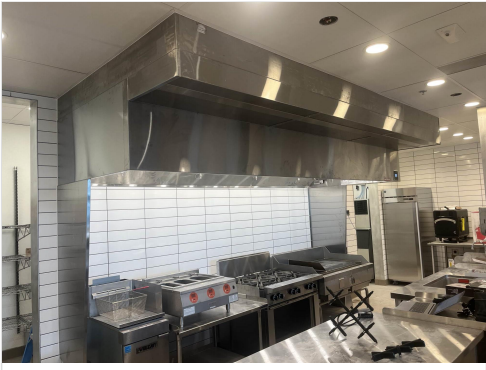
IMG_1997_1656706498.j..

Asset: HD1

Test Data Exhaust		
	Design	Actual
Filter Type	CAPTRATE SOLO	CAPTRATE SOLO
Filter Size 1	16X16	16X16
Filter Qty 1	9	9
Filter AK factor size 1	1.62	1.62
Filter Total AK Area	14.58	14.58
Filter1 FPM	-	170
Filter2 FPM	-	178
Filter3 FPM	-	188
Filter4 FPM	-	202
Filter5 FPM	-	200
Filter6 FPM	-	200
Filter7 FPM	-	170
Filter8 FPM	-	160
Filter9 FPM	-	152
Filter Ave FPM(corr)	-	180
CFM	2550	2624
