**Report: TAB REPORT**  
**Function: Test, Adjust, & Balance**  
**Date: 04/04/2024**

**PROJECT**  
**LHM Dodge RTU Repl (Albuquerque, NM)**

8528 Lomas Blvd NE

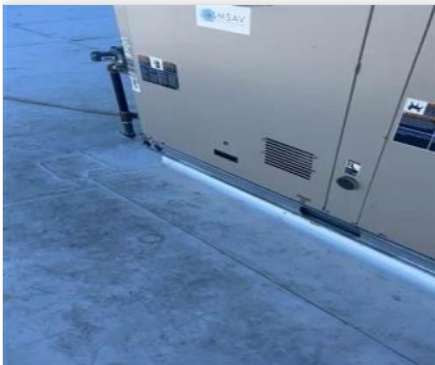
**Membrane**  
**04/04/2024**

**Issue Name :** RTU-1 (B): CURB NOT PROPERLY SEALED  
**Description :** When RTU is operating, the roof membrane inflates (see video). Suspect supply discharge is not properly sealed at curb and air is leaking into roof.  
**Created By :** National TAB                      **Assigned To :** National TAB - Michael McDonnell  
**Status :** Open  
**Priority :** Medium                                      **Asset Tag :**  
**Originated Date :** 04/04/2024 - Michael McDonnell - National TAB

[1] RTU SUPPLY IS INFLATING ROOF MEMBRANE; SEE ISSUE. SUSPECT LEAKAGE AT CURB CONNECTION.

Each RTU was measured at its supply drop via traverse. RTUs were adjusted to within tolerance of the engineer's design flow. Outside air was measured by reading the intake air opening with a velocity grid and multiplying by the free area. The outside air damper was adjusted until the airflow was within the design requirements. Any equipment that fell outside of that tolerance is noted throughout the report. Each RTU is controlled by a wall thermostat and is interlocked with CO2 monitoring. When the area each RTU serves reads above CO2 setpoint, the interlocked EF energizes and the RTU fully economizes. This control was tested and is fully functional. RTU-1, serving the service receiving area, is inflating the surrounding roof membrane when operational. We suspect this is due to improper curb alignment, or a leak at the curb. We recommend this issue is addressed.
