**Report: TAB REPORT**  
**Function: Test, Adjust, & Balance**  
**Date: 04/04/2024**

**PROJECT**  
**LHM Dodge RTU Repl (Albuquerque, NM)**

8528 Lomas Blvd NE

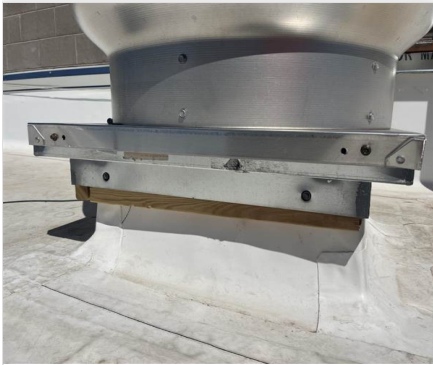
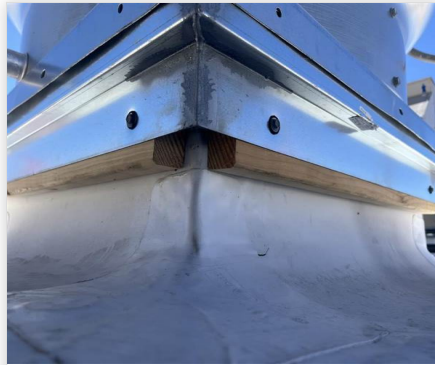
**Issue Name :** EFs: CURB ADAPTERS INCORRECT SIZE  
**Description :** Several EFs do not match existing curb sizes. EF submittals indicate curb adapters, but these are oversized, typically by 2". Untreated lumber used on fan curbs to fill gap.  
**Created By :** National TAB      **Assigned To :** National TAB - Michael McDonnell  
**Status :** Open  
**Priority :** InfoOnly      **Asset Tag :**  
**Originated Date :** 04/04/2024 - Michael McDonnell - National TAB

EF\_CURB  
04/04/2024

EF\_CURB\_1  
04/04/2024

Each exhaust fan was measured by reading the intake air opening with a velocity grid and multiplying by the free area. The exhaust fan was then adjusted to within tolerance of the engineer's design flow. Any equipment that fell outside of that tolerance is noted throughout the report. Several of the fans do not fit existing curbs, even with curb adapters installed. Lumber was used to fill in the gap between each curb and adapter. Despite this, all fans were able to be adjusted into design airflow.

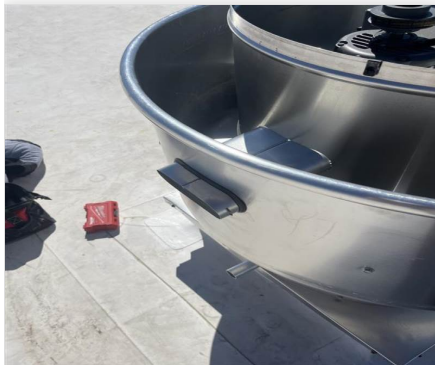
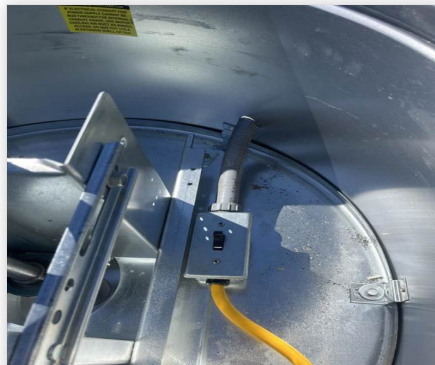
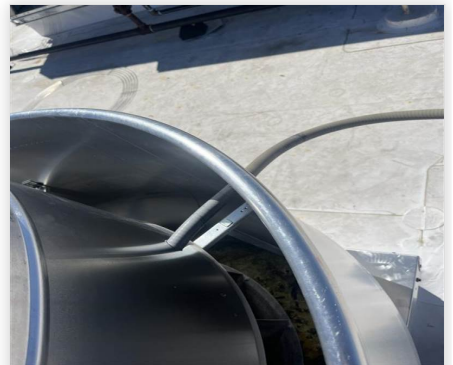
**Issue Name :** EFs: ELECTRICAL CONDUIT ROUTING  
**Description :** Electrical Conduit to all exhaust fans was drilled through the fan housing to supply power. Per Greenheck, power should be routed through motor vent, no need to drill through fan housing.  
**Created By :** National TAB                      **Assigned To :** National TAB - Michael McDonnell  
**Status :** Open  
**Priority :** InfoOnly                                      **Asset Tag :**  
**Originated Date :** 04/04/2024 - Michael McDonnell - National TAB

**Motor\_Vent**  
04/04/2024

**Conduit\_Routing**  
04/04/2024

**Conduit\_Drilled**  
04/04/2024
