Report: TAB REPORT
Function: Test, Adjust, & Balance
Date: 04/04/2024

PROJECT
LHM Dodge RTU Repl (Albuquerque, NM)

Project: LHM Dodge RTU Repl (Albuquerque, NM)

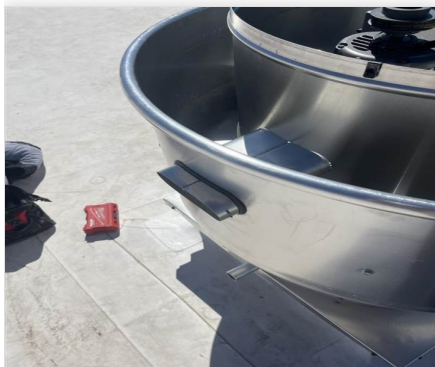
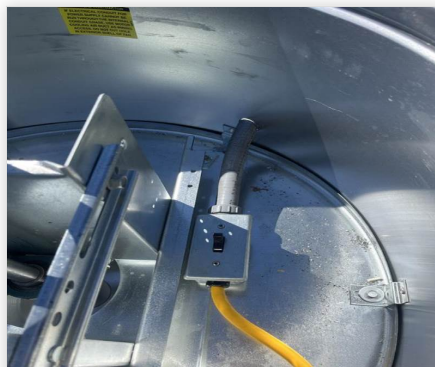
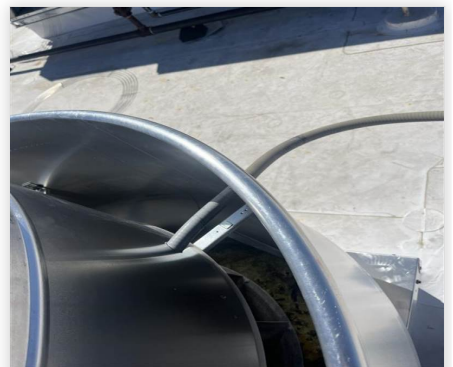
Conduit_Routing
04/04/2024

Issue Name : EFs: ELECTRICAL CONDUIT ROUTING
Description : Electrical Conduit to all exhaust fans was drilled through the fan housing to supply power. Per Greenheck, power should be routed through motor vent, no need to drill through fan housing.
Created By : National TAB **Assigned To :** National TAB - Michael McDonnell
Status : Open
Priority : InfoOnly **Asset Tag :**
Originated Date : 04/04/2024 - Michael McDonnell - National TAB
