Report: TAB Reports
Function: Test, Adjust, & Balance
Date: 02/18/2026
Completed By: National TAB

PROJECT
02-16-26 QT #1074 MONROE, NC

Project: 02-16-26 QT #1074 MONROE, NC

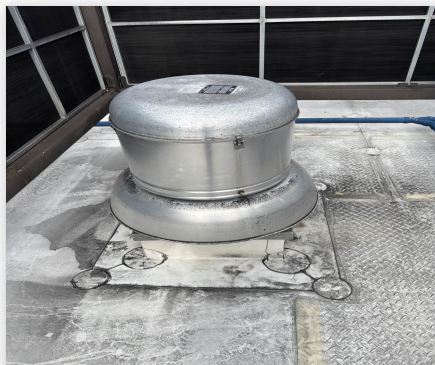
Issue Name : EF-2 speed controller doesn't work
Description : The speed controller on EF-2 does not work. The combi oven grille is under design, and the men's restroom cannot spare enough air to bring it to design. The fan must be sped up.
Created By : National TAB **Assigned To :** National TAB - Dan Hertenstein
Status : Open
Priority : High **Asset Tag :** EF2
Originated Date : 02/18/2026 - Christian Moller - National TAB

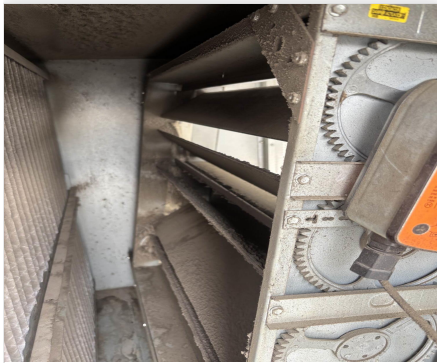
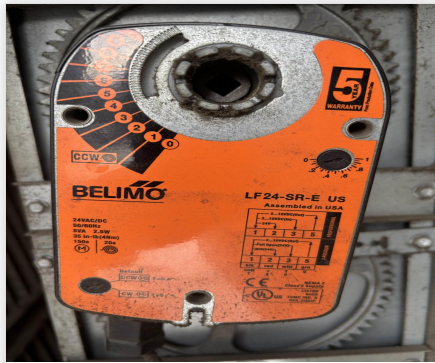
Issue Name : RTU 3 economizer not working
Description : The economizer on RTU 3 does not respond to the Emerson board setpoints. For balancing purposes, the OA was set and left at the high speed position so is bringing in extra when the hood is off. Position was physically marked in the unit.
Created By : National TAB **Assigned To :** National TAB - Dan Hertenstein
Status : Open
Priority : Urgent **Asset Tag :** RT-3
Originated Date : 02/18/2026 - Christian Moller - National TAB

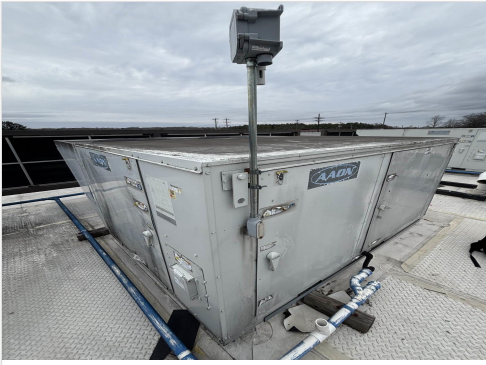
Asset: RT-3

Test Data		
	Design	Actual
SF CFM	4200	4382
SF RPM	-	DD
OA CFM (Hoods On)	800	795
OA CFM (Hoods Off)	350	632
RL Voltage	-	214/215/215
RL Amperage	-	5.9/5.7/5.6
VFD Max SetPt	-	35Hz
VFD Min SetPt	-	24Hz
OA Damper Position (Hoods On)	-	46%
OA Damper Position (Hoods Off)	-	46%

[2] Economizer does not respond to the Emerson Board, OA manually set and left at high speed setpoint. SEE ISSUES.

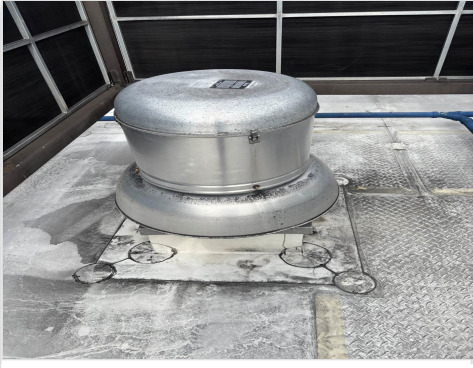
Asset: EF2

Test Data		
	Design	Actual
CFM	525	367
Fan RPM	-	DD
Fan Rotation	-	CORRECT
Motor RPM	-	DD
System SetPt	-	SINGLE SPEED
RL Voltage	-	112
RL Amperage	-	1.8
Total ESP	-	0.39"
Fan Inlet SP	-	-0.39"
Fan Discharge SP	-	ATM

[1]Speed controller is not working. SEE ISSUES.

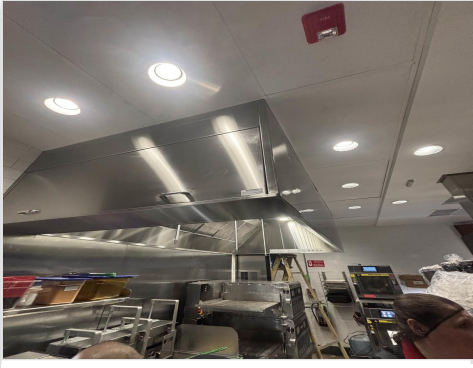
Asset: HD1

Unit Data		
	Design	Actual
MFG	CAPTIVEAIRE	CAPTIVEAIRE
Model Num	6030ND-2-F	6030ND-2
Job / Serial Num	-	8424865
Type	-	TYPE I CANOPY
Hood length	-	108"
Hood Width	-	60"

Test Data Exhaust		
	Design	Actual
Filter Type	-	BAFFLE FILTERS
Filter Size 1	-	16X20
Filter Qty 1	-	6
Filter AK factor size 1	-	2.08
Filter Total AK Area	-	12.48
Filter1 FPM	-	86
Filter2 FPM	-	98
Filter3 FPM	-	114
Filter4 FPM	-	116
Filter5 FPM	-	125
Filter6 FPM	-	101
Filter Ave FPM(corr)	-	106
CFM	1350	1322

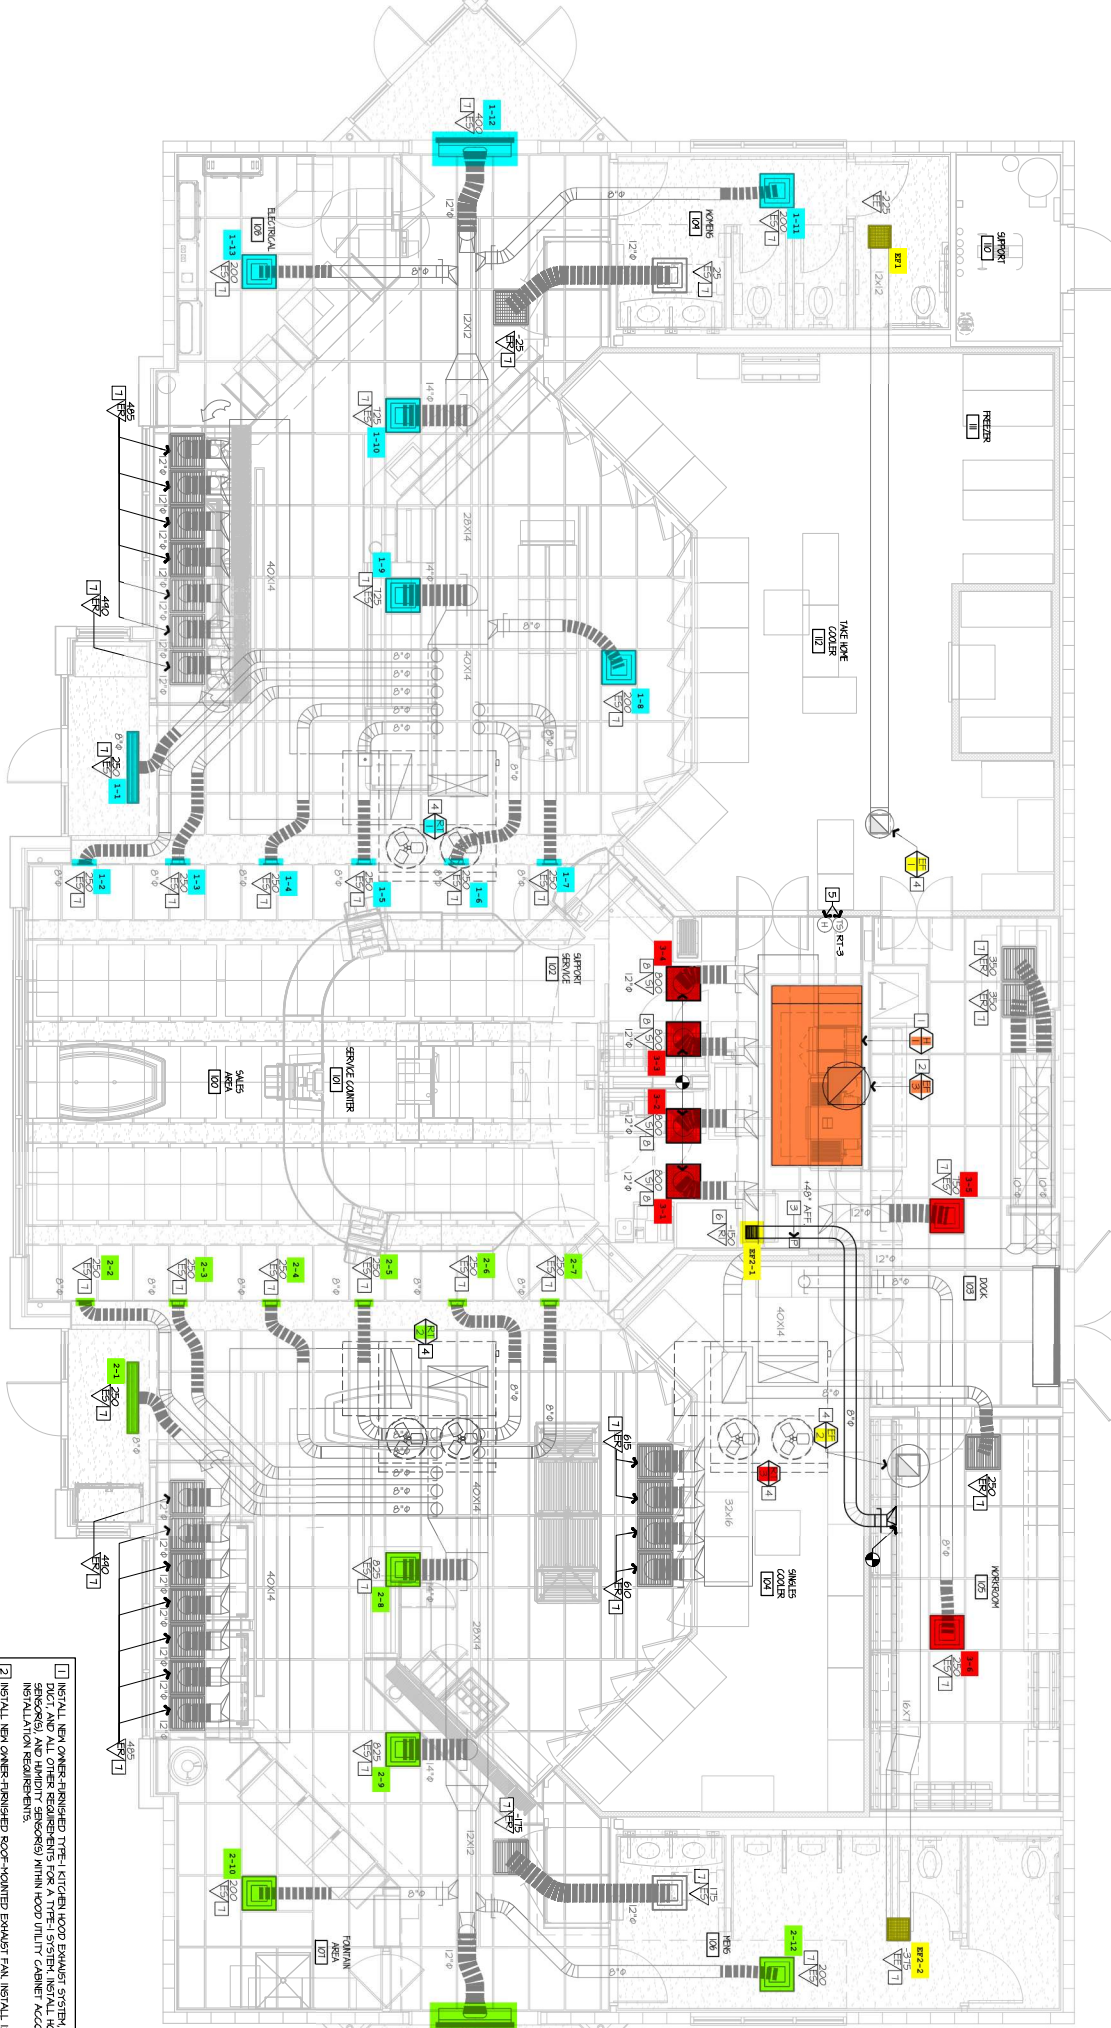
- [1] INSTALL NEW OWNER-FURNISHED TYPE-I KITCHEN HOOD EXHAUST SYSTEM LINE SUPPLEMENTARY DUCT, AND ALL OTHER REQUIREMENTS FOR A TYPE-I SYSTEM. INSTALL HOOD CONTROL PANEL, SENSORS, AND HUMIDITY SENSORS WITHIN HOOD CABINET ACCORDING TO MANUFACTURER'S INSTALLATION REQUIREMENTS.
- [2] INSTALL NEW OWNER-FURNISHED ROOF-MOUNTED EXHAUST FAN. INSTALL D7 60" Ø DUCT.
